INVESTIGATION NO. 2625
THE ILLINOIS CENTRAL SYSTEM
REPORT IN RE ACCIDENT
AT SIOUX FALLS, S. DAK., ON
SEPTEMBER 3, 1942

Kind of accident: Head-end collision

Accident at Sioux Falls, S. Dak., on September 3, 1942,
caused by failure properly to control speed of No.
791 within yard limits.

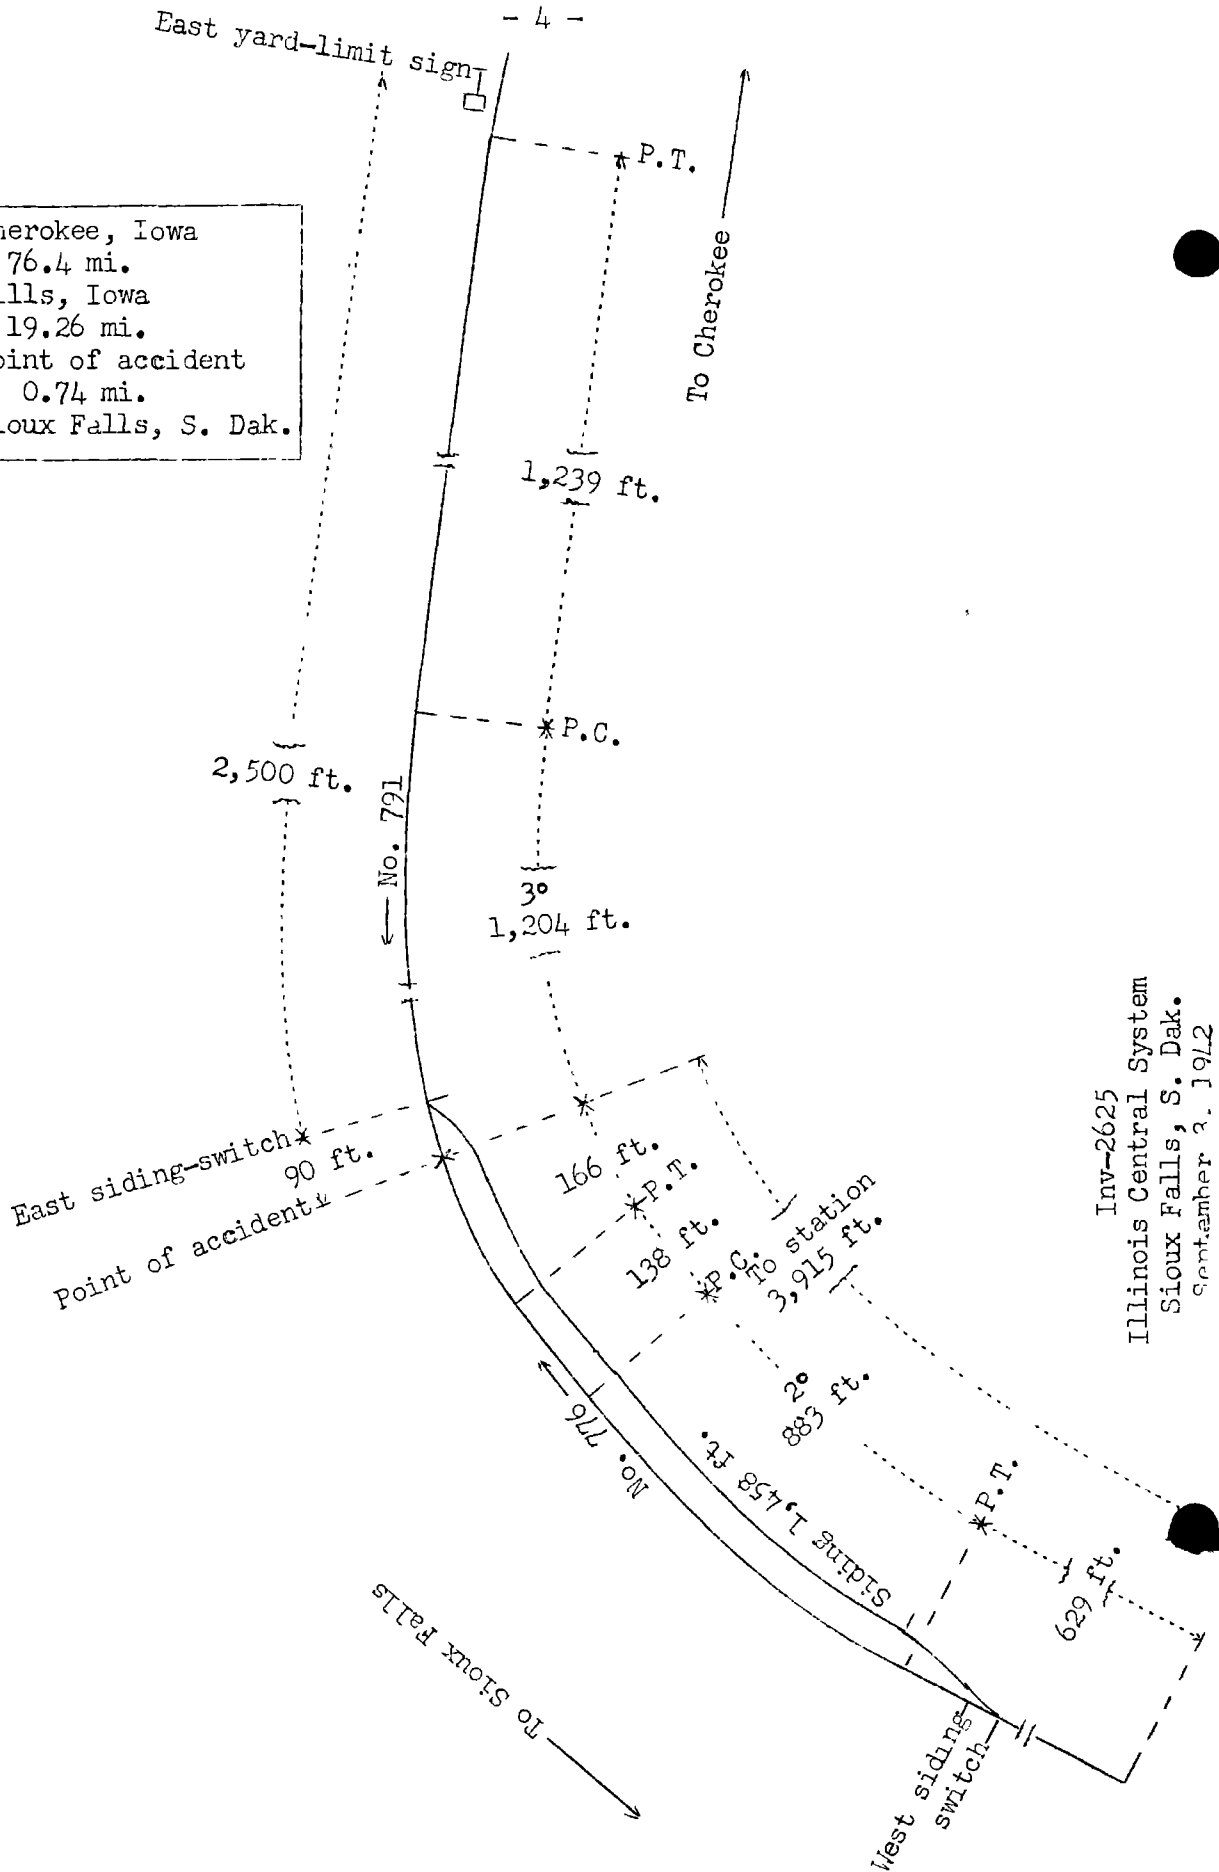
Inv-2625
Illinois Central System
Sioux Falls, S. Dak.
September 2, 1942

- Cherokee, Iowa
76.4 mi.
- Hills, Iowa
19.26 mi.
- X Point of accident
0.74 mi.
- Sioux Falls, S. Dak.
