INVESTIGATION NO. 2604
THE ILLINOIS CENTRAL SYSTEM
REPORT IN RE ACCIDENT
AT ST. ROSE, LA., ON
JULY 19, 1942

SUMMARY

Kind of accident: Head-end collision

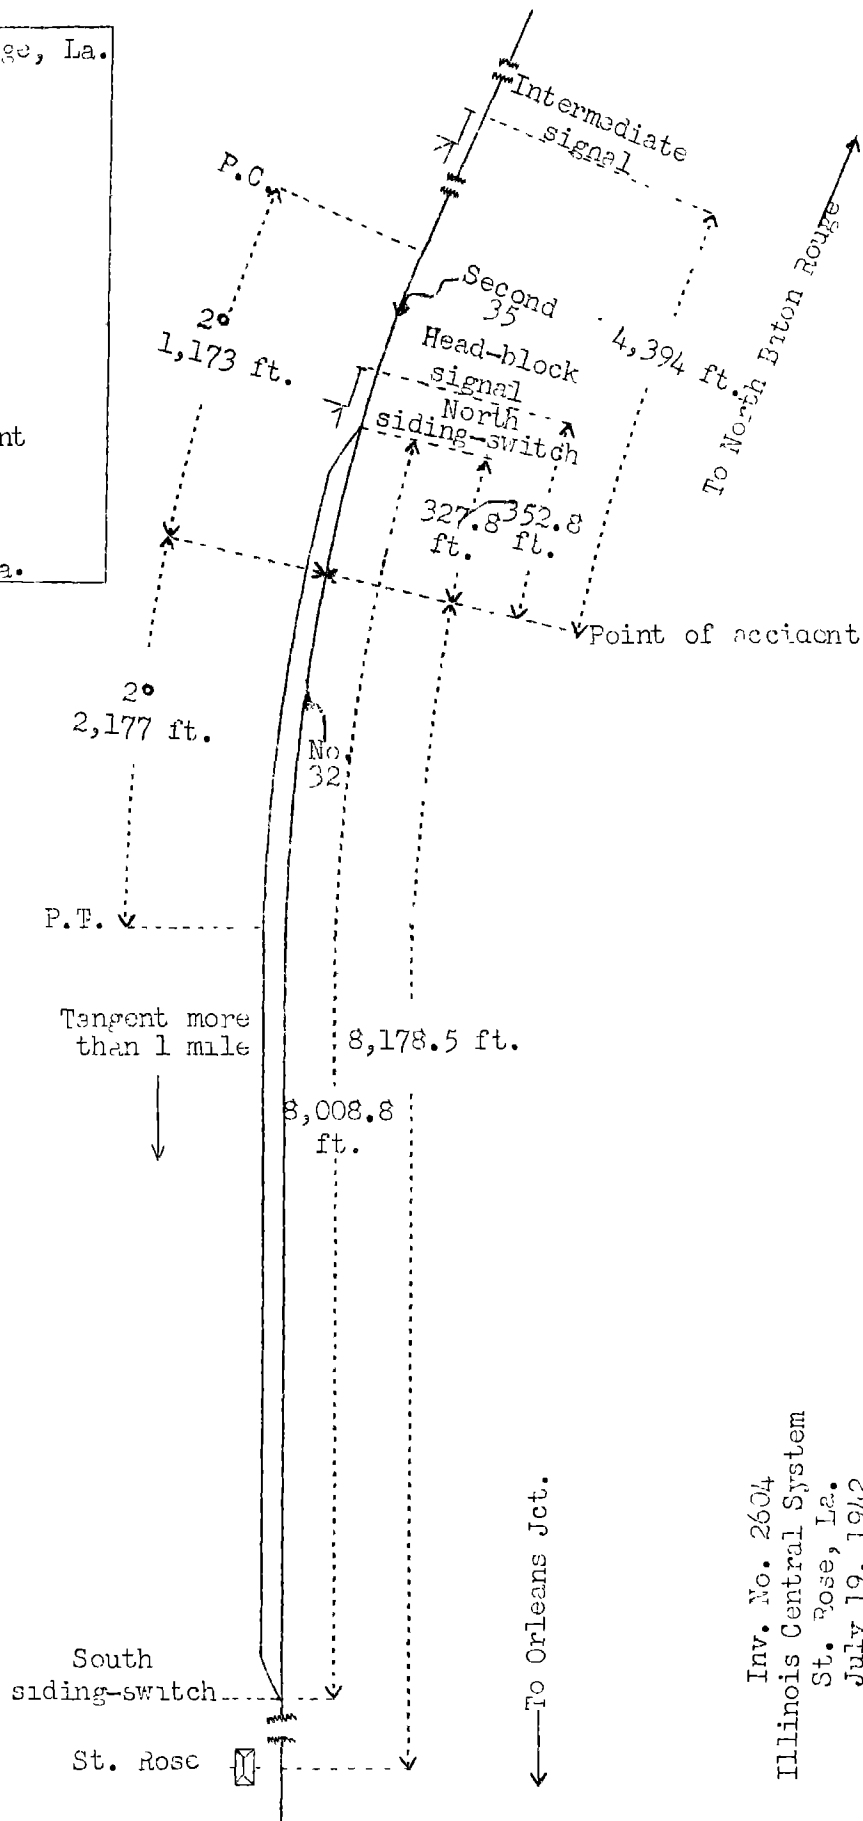
Inv. No. 2604
 Illinois Central System
 St. Rose, La.
 July 19, 1942

○	North Baton Rouge, La.	2.6 mi.
○	Baton Rouge	27.8 mi.
○	Burnside	19.2 mi.
○	Lutcher	20.2 mi.
○	Good Hope	4.0 mi.
○	Destrehan	1.16 mi.
X	Point of accident	1.54 mi.
○	St. Rose	4.1 mi.
○	Orleans Jct., La.

Location of Accident and Method of Operation
