REPORT OF THE DIRECTOR
BUREAU OF SAFETY

ACCIDENT ON THE
ILLINOIS CENTRAL SYSTEM

TALLAHATCHIE, MISS

INVESTIGATION NO. 2217

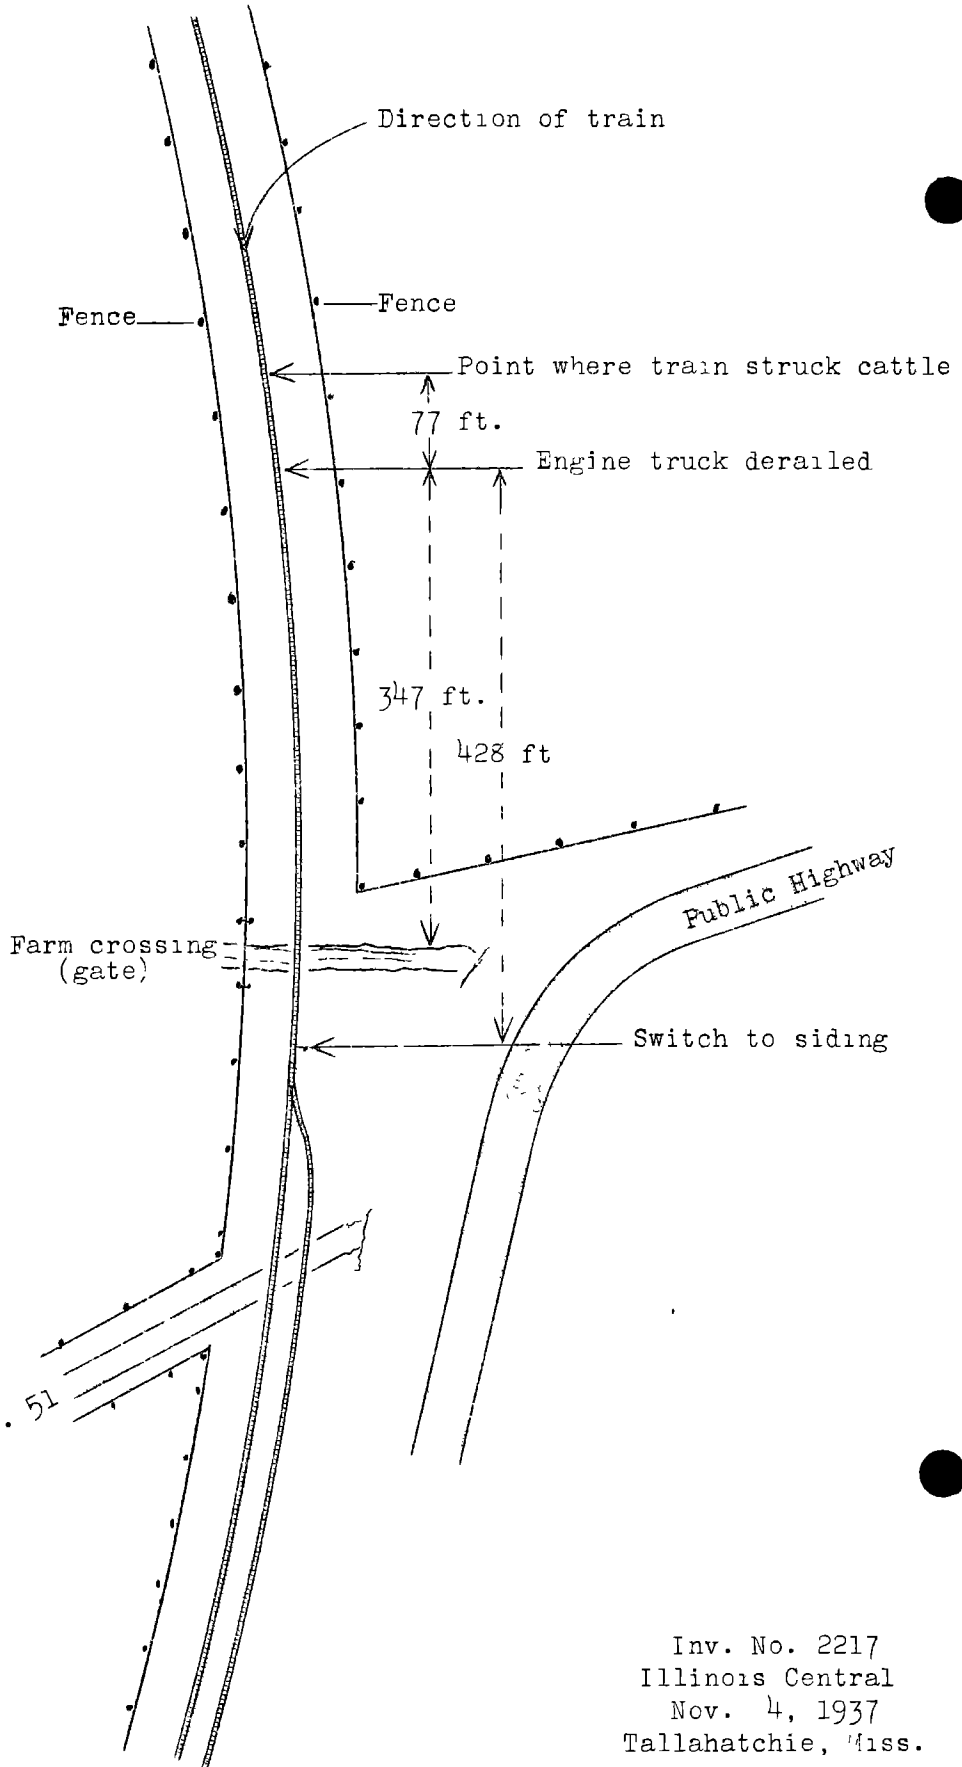
Inv. No. 2217
 Illinois Central
 Nov. 4, 1937
 Tallahatchie, Miss.

○	Memphis, Tenn.
	4.3 mi.
○	East Junction
	45.4 mi.
○	Sardis, Miss.
	4.7 mi.
○	Tallahatchie,
	1.4 mi.
X	Point of accident
	42.0 mi.
○	Memphis Jct., Miss.
