INVESTIGATION NO. 2470

THE ILLINOIS CENTRAL RAILROAD COMPANY

REPORT IN RE ACCIDENT

NEAR TAMAROA, ILL., ON

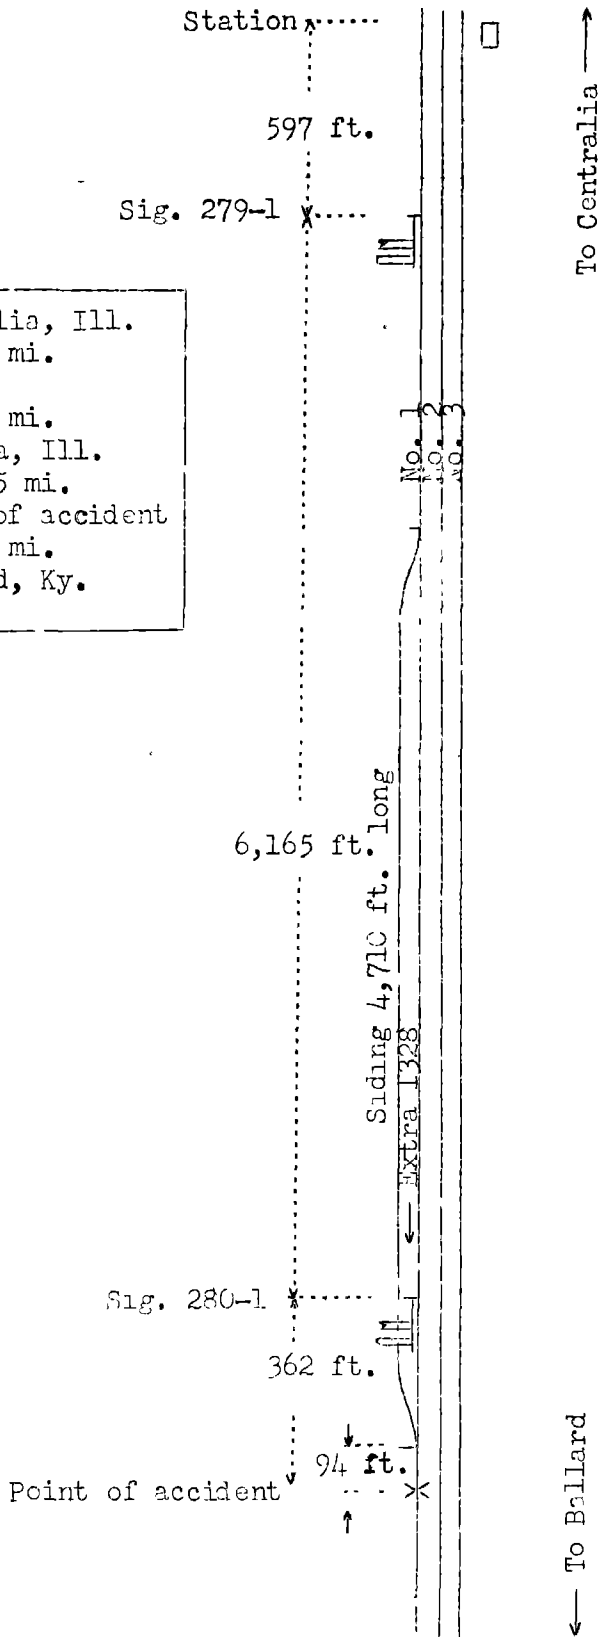
Inv. No. 2470  
 Illinois Central Railroad  
 Tamaroa, Ill.  
 December 20, 1940

- Centralia, Ill. 13.9 mi.
- Ashley 13.5 mi.
- Tamaroa, Ill. 1.35 mi.
- ⊠ Point of accident 83.7 mi.
- Ballard, Ky.
