INVESTIGATION NO. 2636
THE ILLINOIS CENTRAL SYSTEM
REPORT IN RE ACCIDENT
NEAR TATUM, MISS., ON
OCTOBER 15, 1942

Accident near Tatum, Miss., on October 15, 1942, caused
by lap of authority between two opposing extra trains.

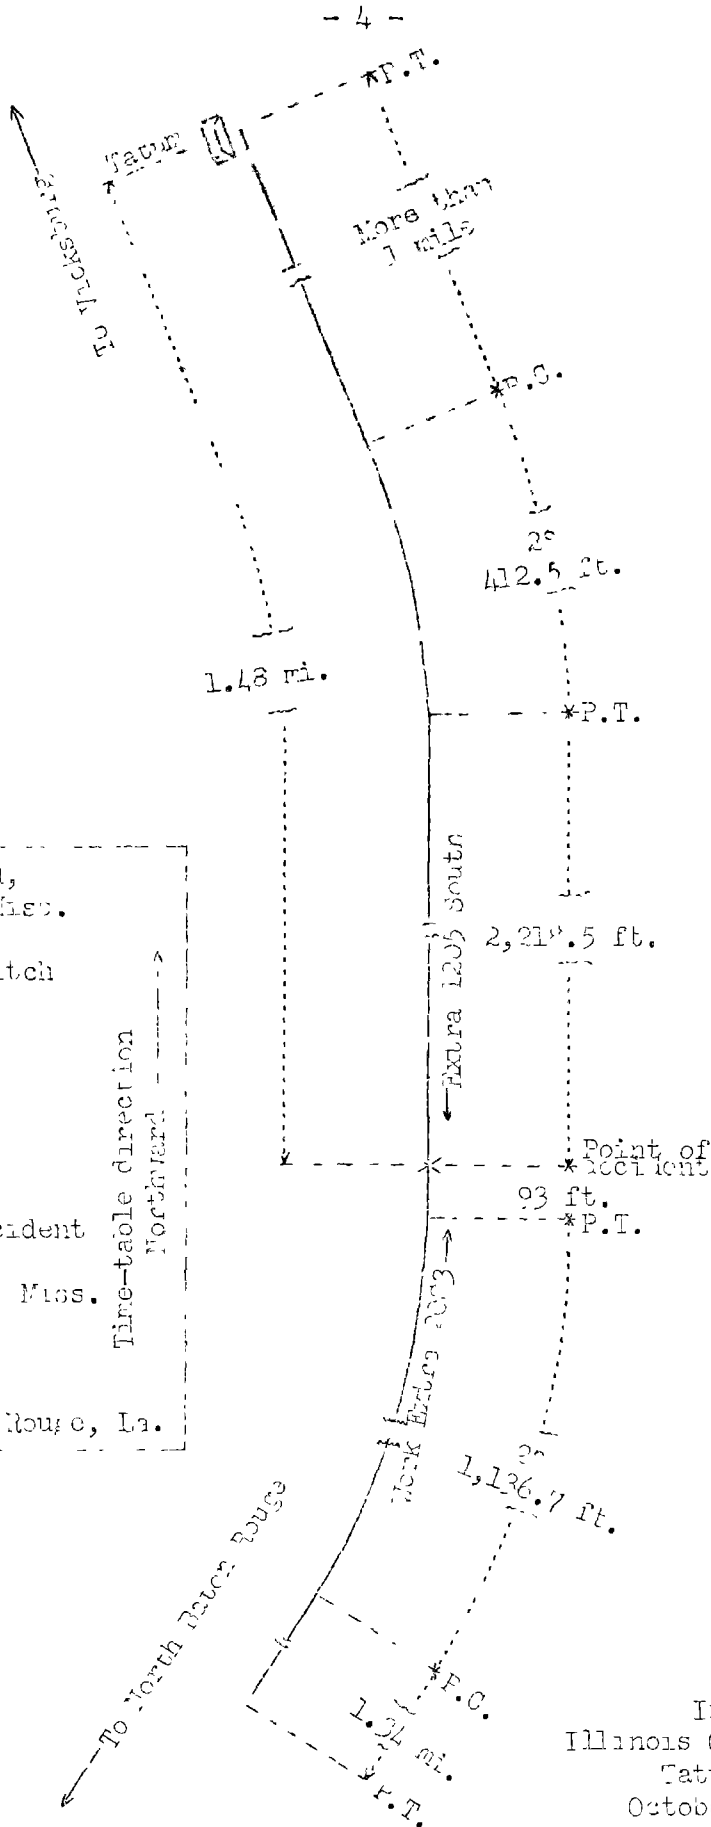
○	Front Yard, Vicksburg, Miss.	0.60 mi.
○	Junction Switch	82.50 mi.
○	Crosby	7.90 mi.
○	Gloster	4.30 mi.
○	Tatum	1.48 mi.
X	Point of Accident	2.82 mi.
○	Centreville, Miss.	9.30 mi.
○	Forwood, La.	32.90 mi.
○	North Baton Rouge, La.

This accident occurred on the Vicksburg District, which extends between Junction Switch, Vicksburg, Miss., and North Baton Rouge, La., a distance of 142.2 miles. In the vicinity of the point of accident this is a single-track line over which trains are operated by timetable and train orders. There is no block system in use. The accident occurred on the main track at a point 1.48 miles south of the station at Tatum. Approaching from the north there are, in succession, a tangent more than 1 mile in length, a 2° curve to the right 412.5 feet in length and a tangent 2,218.5 feet to the point of accident. Approaching from the south there are, in succession, a tangent 1.34 miles in length, a 2° curve to the left 1,136.7 feet in length and a tangent 93 feet to the point of accident. The grade for south-bound trains is, successively, 0.78 percent descending 1,400 feet, 0.2 percent ascending 200 feet, 0.794 percent ascending 1,400 feet and level 200 feet to the point of accident. The grade for north-bound trains is, successively, 0.55 percent ascending 400 feet, 0.15 percent descending 200 feet, 0.563 percent descending 1,900 feet and 0.092 percent ascending 1,500 feet to the point of accident.
