REPORT OF THE DIRECTOR

ACCIDENT ON THE

ILLINOIS CENTRAL RAILROAD

TOONE, TENN.

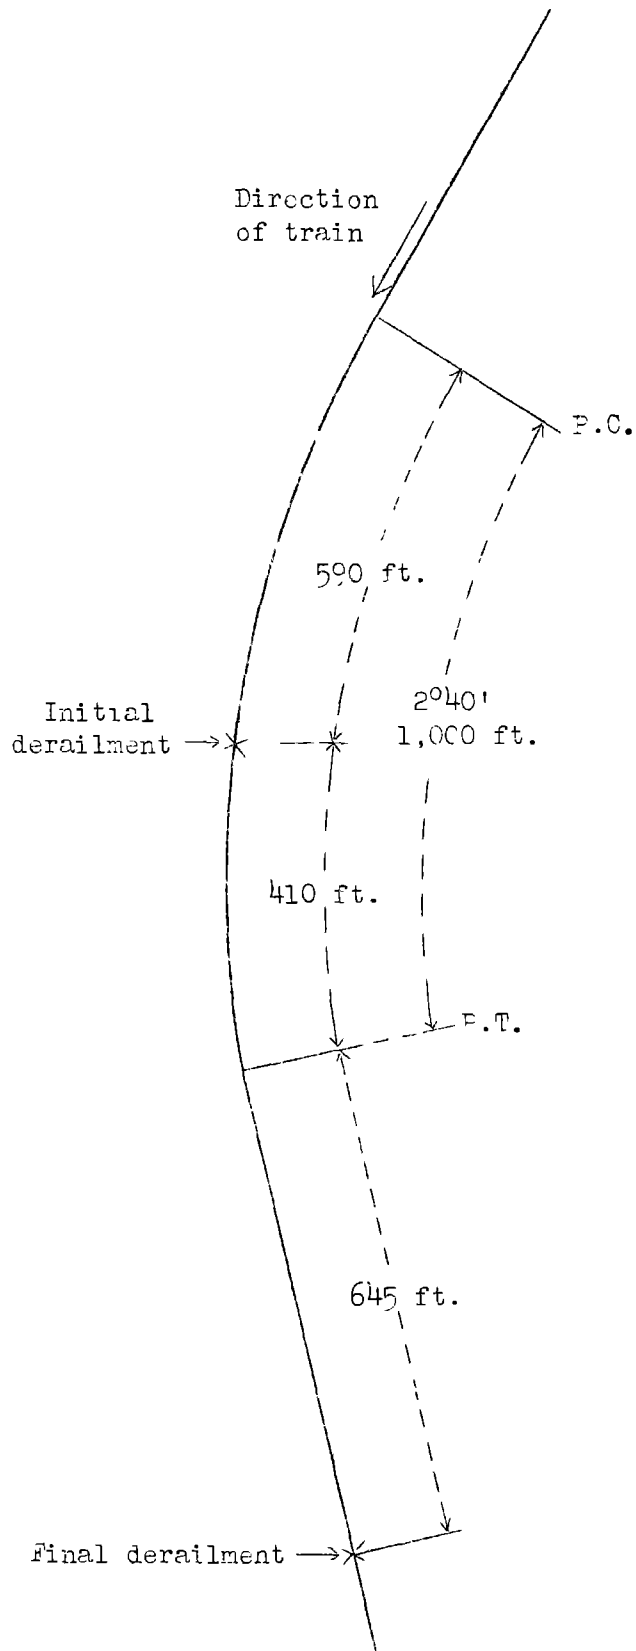
Inv. No. 2100
Illinois Central RR,
Toone, Tenn.
Sept. 15, 1936

o	Frogmoor, Tenn.
	18.5 mi.
o	Toone, Tenn.
X	(Point of accident)
	97.2 mi.
o	Water Valley, Miss.

The engine, with its right front driving wheel derailed, ran a distance of 1,055 feet to the point where the track was torn out for a distance of 317 feet, and finally stopped bottom up, down a 10-foot fill on the west side of the track, with its front end 1,362 feet south of the initial point of derailment. The tender remained attached to the engine, while the first 19 cars were piled up on both sides of the track within a space of 300 feet behind the engine; the next 2 derailed cars remained upright on the roadbed. The employees killed were the engine-man and fireman, while the employee injured was the head brakeman.

Examination of the track at the initial point of derailment by the Commission's inspectors disclosed that it was in good condition, with no indication of anything dragging or of any track condition that would have contributed to the accident. The first mark appeared on the gauge side of the east rail and had the appearance of having been made by the rim of a wheel dropping off the ball of rail. At a point 8 feet 6 inches from the beginning of this mark there was a distinct but light flange mark on two ties, $5\frac{3}{4}$ inches from the rail, while at the first joint, about 25 feet south of the beginning of this mark, the receiving end of the angle bar was badly scarred and particles sheared off, and two angle-bar bolts had been broken. On the west rail there was a mark, apparently made by the flange of the corresponding wheel, on the ball of the rail, $\frac{1}{2}$ inch from the outside of rail and 17 inches south of the beginning of the one on the east rail; this mark ran diagonally toward the outside of the rail and dropped off within a distance of 9 inches, then

at the joint 10 feet from the beginning of this mark the receiving end of the angle bar was scarred and sheared, and two angle-bar bolts broken off. There was a light flange mark about $\frac{5}{8}$ inch from the outside edge on the base of the west rail, which appeared at intervals on the curve only, from a few inches to several feet in length, having intervening spaces of from 2 to 15 feet where the mark did not appear. The track at the first joint of the west rail south of the initial point of derailment was knocked slightly out of line; at the first joint in the east rail the distance was about $1\frac{1}{2}$ inches and at the next joint the track was about 6 inches out of line toward the east. The conditions as represented by the flange mark on the ties above mentioned, striking a few ties and missing a few ties, the damage to the angle bars and bolts, and track knocked out of line at joints from $1\frac{1}{2}$ to 6 inches, continued for a distance of 1,055 feet to the point of final derailment, where the track was completely torn up; within that distance all of the angle bars on the east rail and 25 bolts in the 34 angle bars on the west rail were broken off.
