ACCIDENT ON THE  
ILLINOIS CENTRAL RAILROAD

UNIONVILLE, INDIANA

JUNE 4, 1939

INVESTIGATION NO. 2361

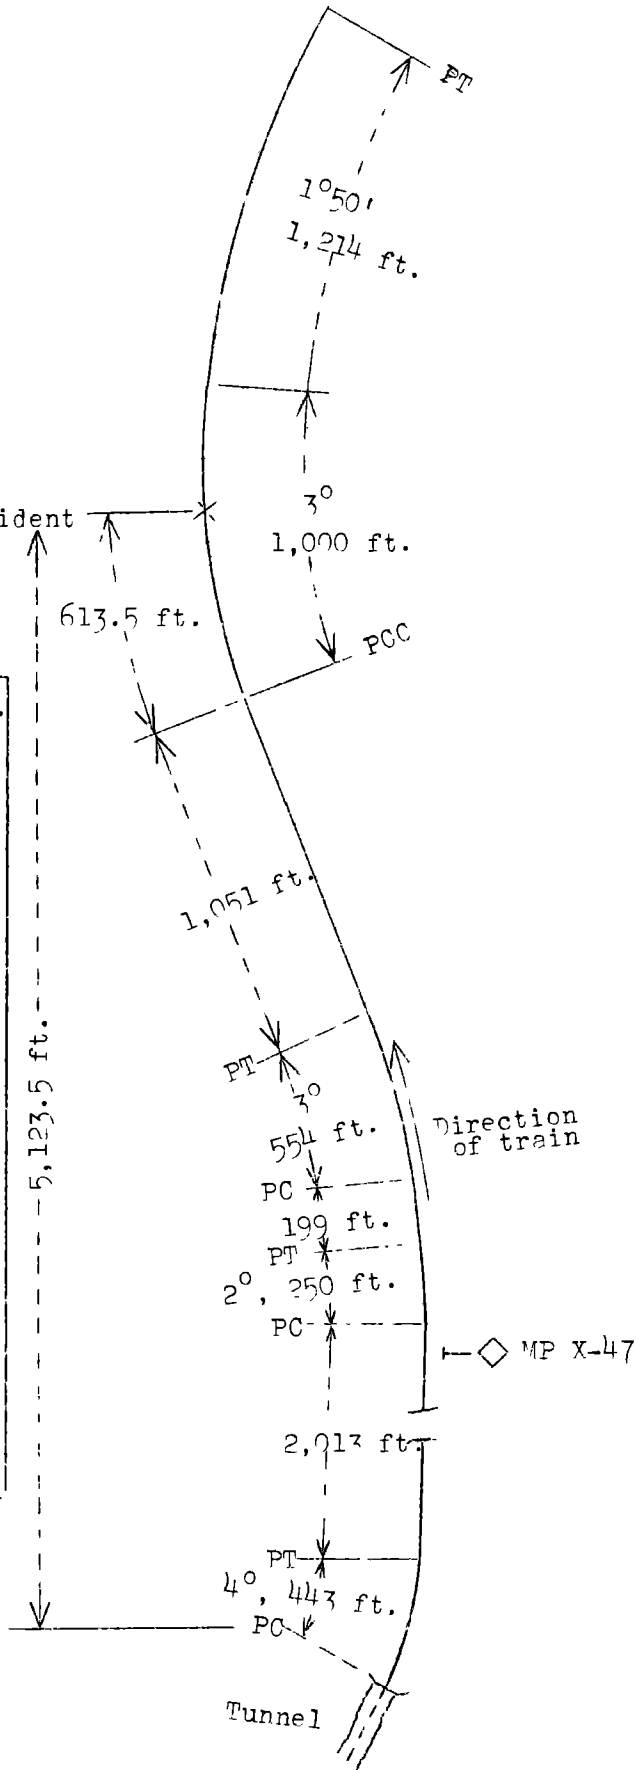
Inv. No. 2361  
 Illinois Central R.R.  
 Unionville, Indiana  
 June 4, 1939

o Indianapolis, Ind.
41.30 mi.
o Trevlac
5.15 mi.
X Point of accident
3.25 mi.
o Unionville
6.20 mi.
o Bloomington
39.50 mi.
o Linton, Ind.
27.90 mi.
o Palestine, Ill.

This accident occurred on that part of the Illinois Division designated as the Indianapolis District, which extends between Palestine, Ill., and Indianapolis, Ind., a distance of 123.3 miles. In the vicinity of the point of accident this is a single-track line over which trains are operated by timetable and train orders, no block-signal system being in use. The accident occurred at a point 3.25 miles north of Unionville.
