REPORT No. 3612
ILLINOIS TERMINAL RAILROAD COMPANY
IN RE ACCIDENT
AT REUTERS, ILL., ON
FEBRUARY 3, 1955

Kind of accident: Head-end collision

Accident at Reuters, Ill., on February 3, 1955, caused by improper handling of a train order and failure properly to control the speed of a train moving within yard limits.

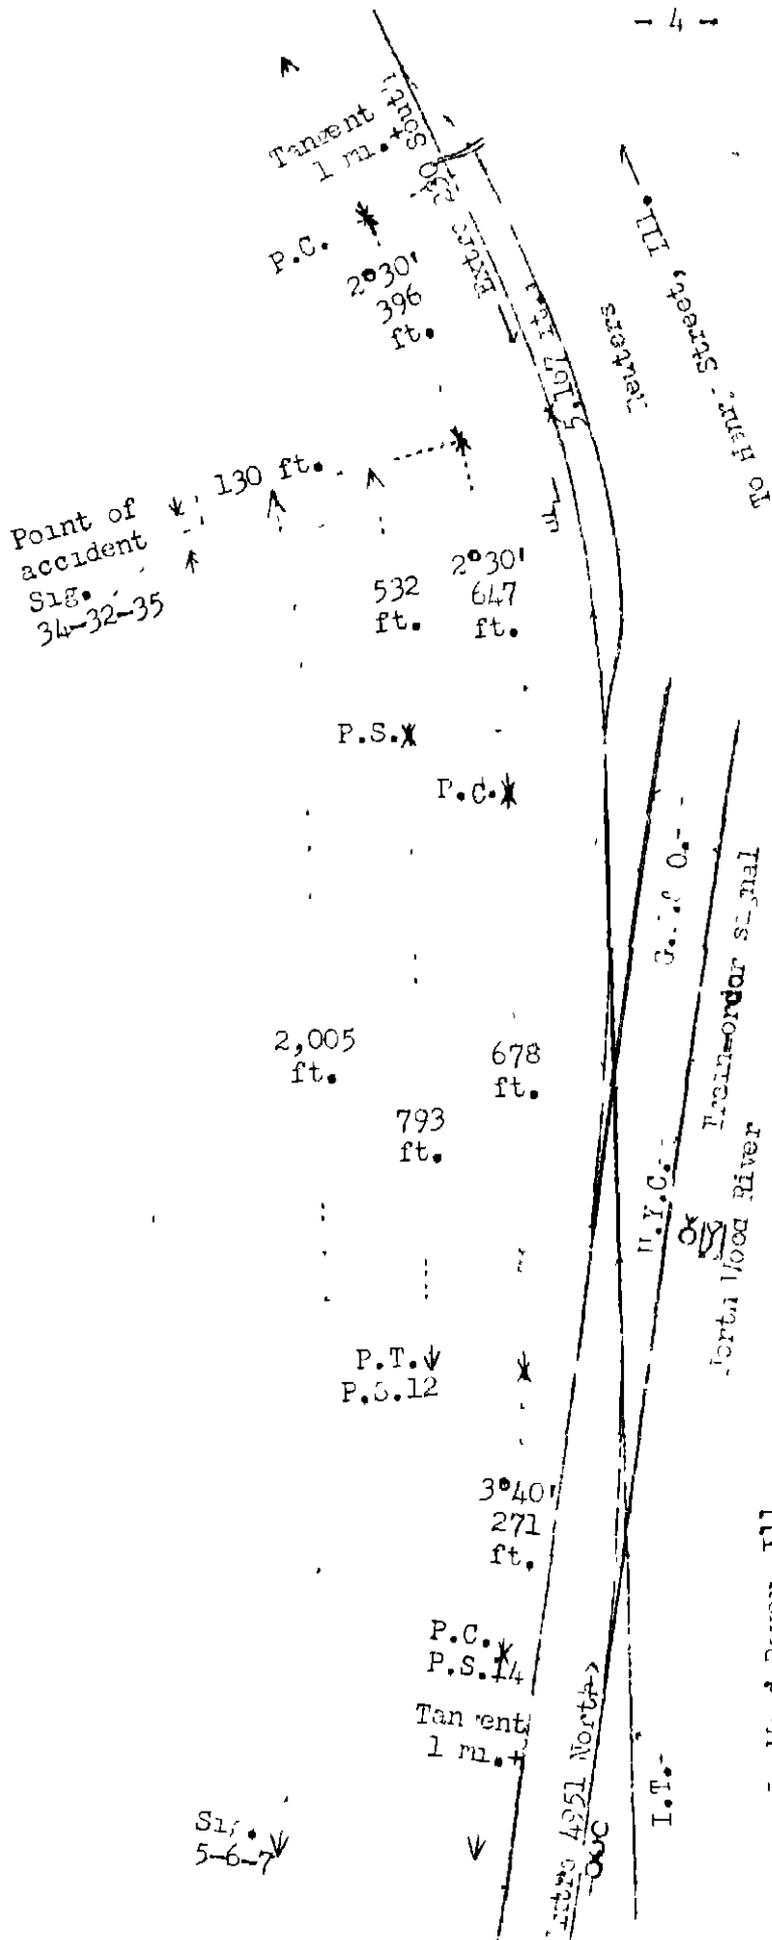
Report No. 3612
 Illinois Terminal Railroad
 Reuters, Ill.
 February 3, 1955

- West Alton, Mo. -- ^
- | 2.8 mi. Alton, M.I.B.& B.
- Henry Street, Ill. X
- | 1.3 mi.
- Federal
- | 2.4 mi.
- X Reuters
- | (Point of accident) I.T.
- | 1.0 mi.
- North Wood River
- | 0.2 mi.
- Wood River, Ill. v
