INVESTIGATION NO. 2565  
THE INDIANA HARBOR BELT RAILROAD COMPANY  
REPORT IN RE ACCIDENT  
AT ARGO, ILL., ON  
JANUARY 28, 1942

Railroad: Indiana Harbor Belt  
Date: January 28, 1942  
Location: Arzo, Ill.  
Kind of accident: Rear-end collision  
Trains involved: Freight : Freight  
Train numbers: Extra 1473 West : Extra 401 West  
Engine numbers: 1473 : 401  
Consist: 29 cars, cabooses : 61 cars, cabooses  
Speed: Standing : 3-7 m. p. h.  
Operation: Operating rules without  
train orders  
Track: Double; 2° left curve; 0.35  
percent descending grade westward  
Weather: Clear  
Time: About 3:25 p. m.  
Casualties: 2 killed; 2 injured  
Cause: Accident caused by failure properly  
to control speed of following  
train moving within yard limits

Accident at Argo, Ill., on January 28, 1942, caused by failure properly to control speed of following train moving within yard limits.

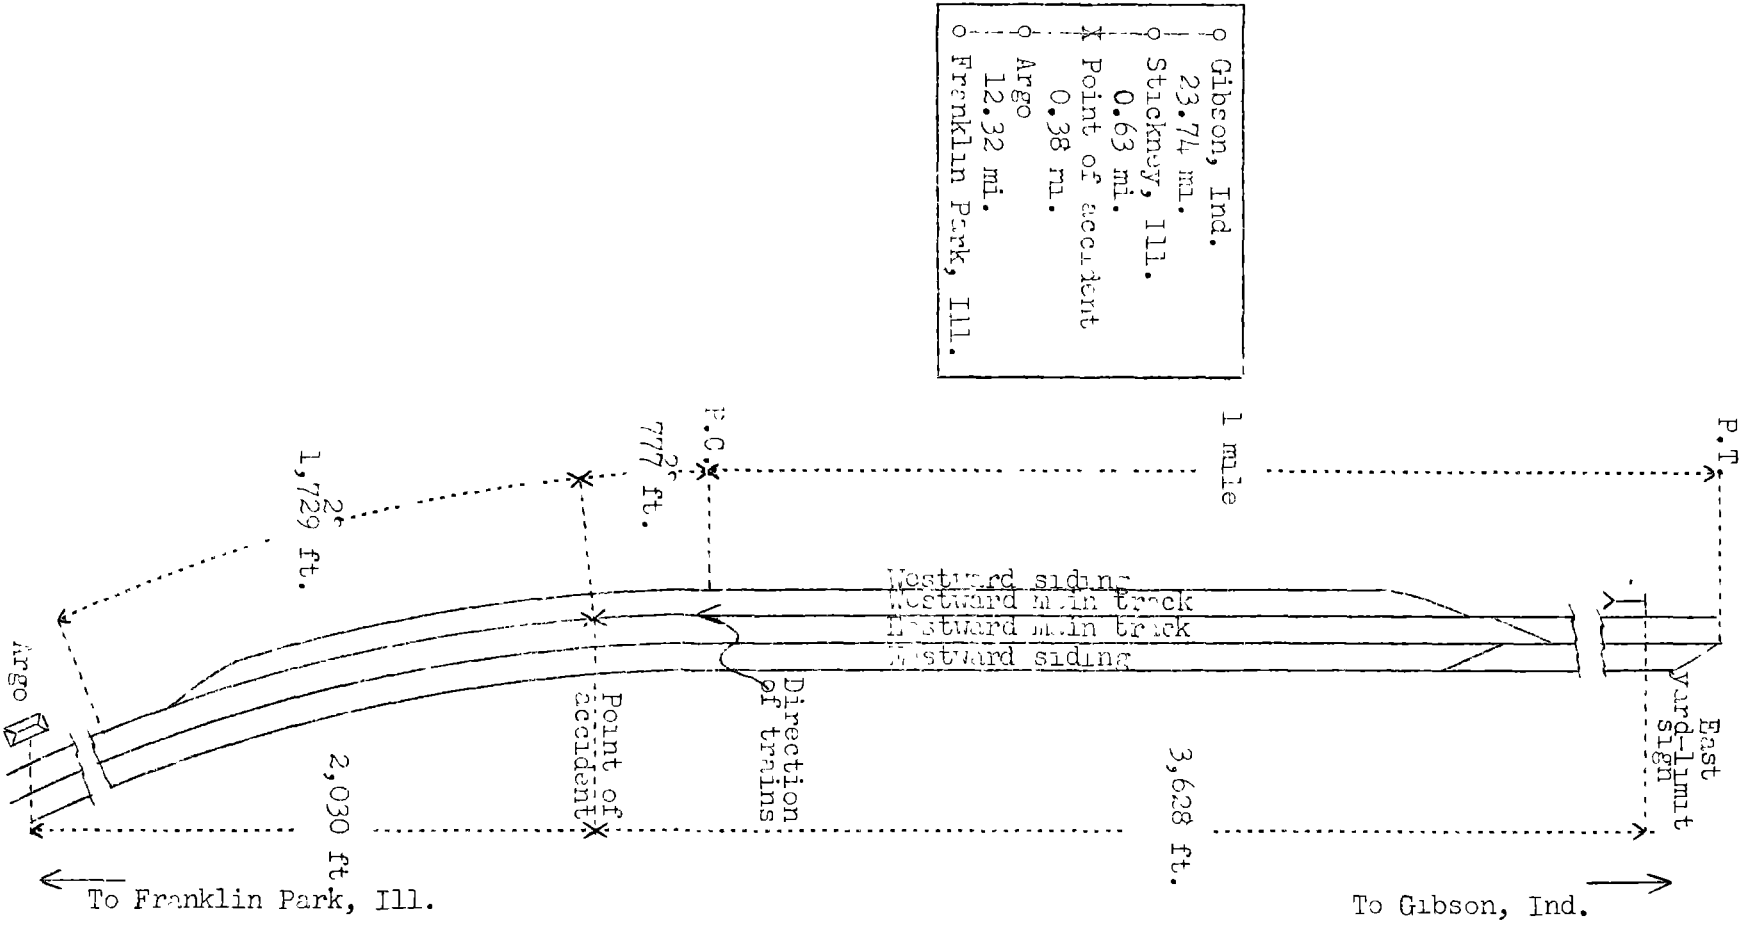
Inv. No. 2565  
 Indiana Harbor Belt Railroad  
 Argo, Ill.  
 January 28, 1942

○ Gibson, Ind.  
 23.74 mi.  
 ○ Stickney, Ill.  
 0.63 mi.  
 \* Point of accident  
 0.38 mi.  
 ○ Argo  
 12.32 mi.  
 ○ Franklin Park, Ill.
