REPORT OF THE DIRECTOR

ACCIDENT ON THE

INDIANA RAILROAD

INVESTIGATION NO. 2114

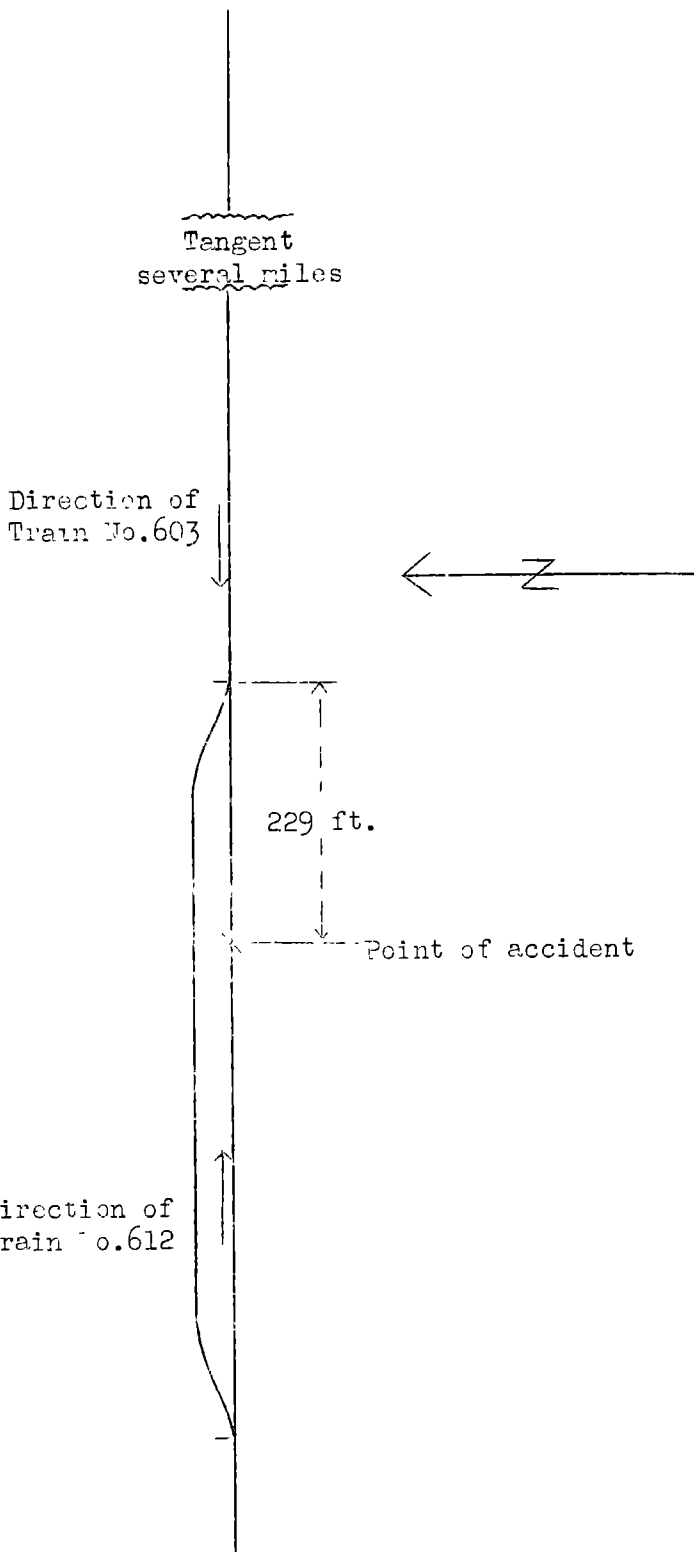
Inv. No. 2114
 Indiana Railroad
 East Germantown, Indiana
 Nov. 12, 1936

o Dayton, Ohio
29.6 mi.
o Hope, Ohio
4.6 mi.
o New Westville, Ohio
5.3 mi.
o Richmond, Indiana
1.1 mi.
o Ohio, Indiana
4.7 mi.
o Centerville, Indiana
7.1 mi.
X East Germantown (Point of accident)
2.2 mi.
o Cambridge City
69.7 mi.
o Indianapolis, Ind.

This accident occurred on the Indianapolis-Richmond-Dayton Division, extending between Indianapolis, Ind., and Dayton, Ohio, a distance of 124.3 miles; in the vicinity of the point of accident this is a single-track electric line over which trains are operated by timetable and train orders, no block-signal system being in use. The accident occurred on the main track at a point 229 feet west of the east switch of the passing siding at East Germantown. Approaching the point of accident from the east the track is tangent for several miles; the grade for west-bound trains is descending for almost 1 mile, varying from 0.06 to 3.54 percent and extending to within 350 feet of the point of accident, then it ascends slightly, being 0.036 percent ascending at the point of accident.

The passing siding involved is 717 feet in length and parallels the main track on the north; it was unoccupied at the time of the accident. The view of the point of accident is unrestricted.
