INTERSTATE COMMERCE COMMISSION

REPORT OF THE DIRECTOR OF THE BUREAU OF SAFETY CONCERNING AN
ACCIDENT ON THE INDIANAPOLIS UNION RAILWAY AT INDIAN-
APOLIS, IND., ON OCTOBER 31, 1934.

December 12, 1934.

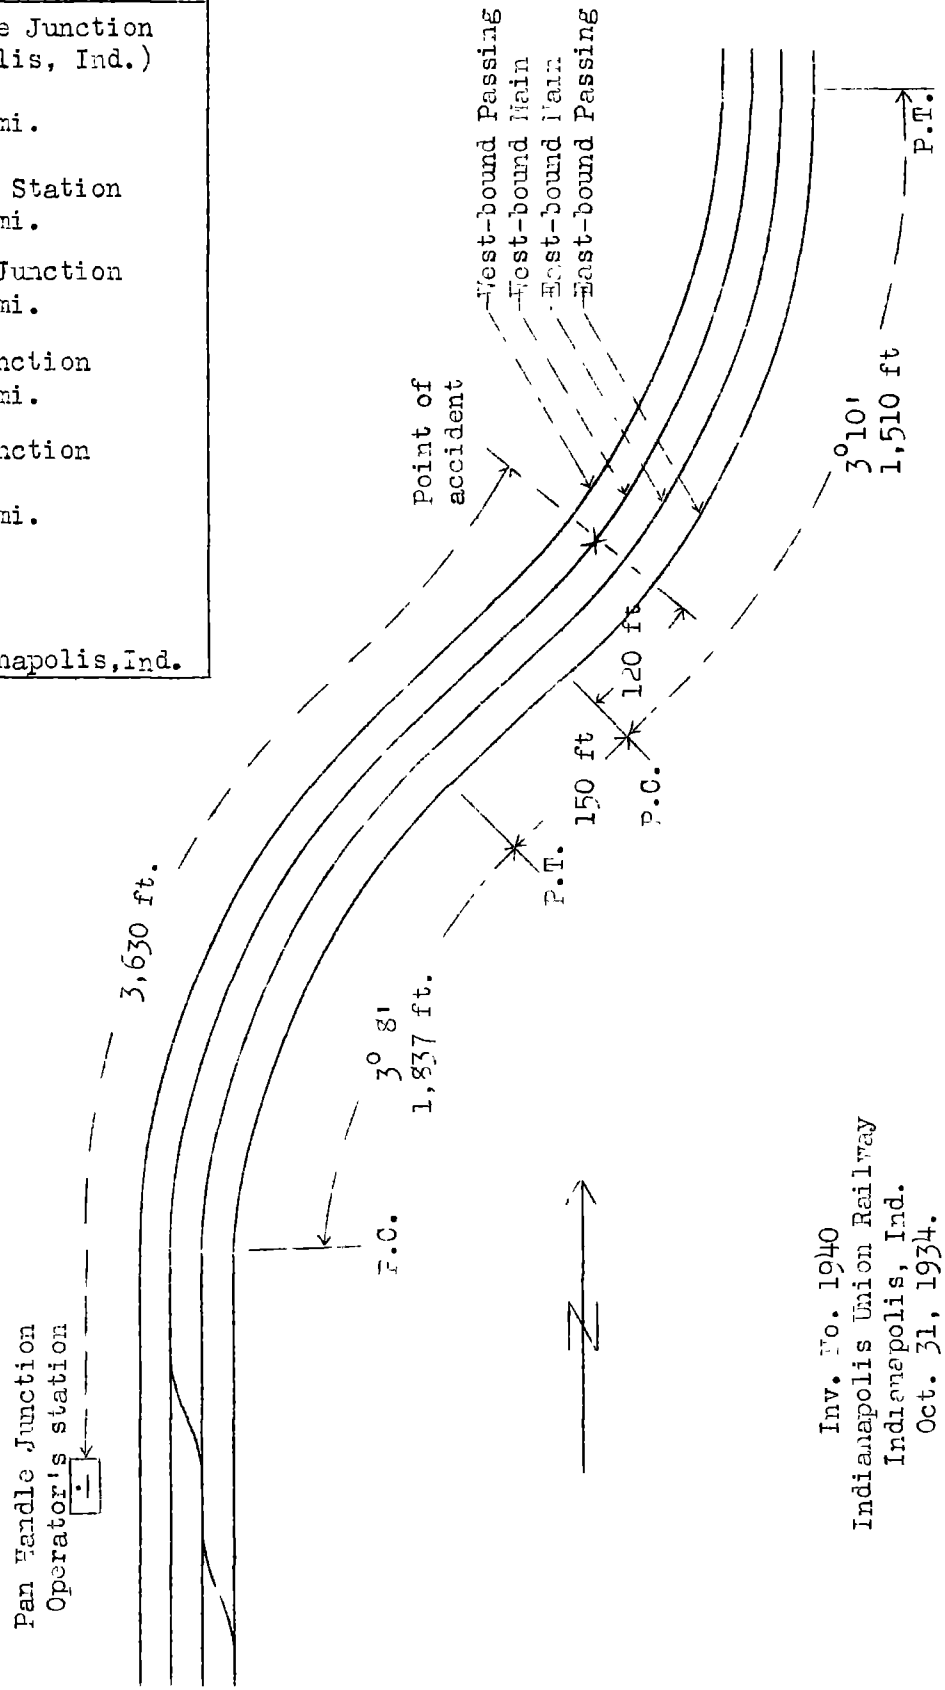
Inv. No. 1940
 Indianapolis Union Railway
 Indianapolis, Ind.
 Oct. 31, 1934.

• Nickel Plate Junction (Indianapolis, Ind.)	
	3.91 mi.
• 13th Street Station	1.00 mi.
• Pan Handle Junction	0.67 mi.
• Hamilton Junction	0.71 mi.
• Prospect Junction	7.20 mi.
• North Indianapolis, Ind.

The Belt Railroad extends between North Indianapolis, and Nickel Plate Junction, a distance of 13.49 miles, and connects with several railroads at various points. This line is entirely within yard limits and trains are operated by book of rules and general orders, no time table or train orders being in use, all trains being considered as extras and required to run under control at all times. Between Pan Handle Junction and 13th Street station, a distance of 1 mile, within which territory this accident occurred, there are four tracks designated, from north to south, as the west-bound passing track, west-bound main track, east-bound main track and east-bound passing track; the accident occurred on the west-bound main track at a point approximately 3,630 feet east of Pan Handle Junction. There is an interlocking plant at Pan Handle Junction which controls the movement of trains through cross-overs at that point. Trains approaching these cross-overs in either direction are governed by 3-indication color-light dwarf signals which display red, yellow and green, for stop, proceed with caution, and proceed, respectively; a train receiving either a yellow or a green indication is authorized to proceed on the route lined for it, regardless of track or direction. Operators may allow reverse movements only after communicating with the station in advance. Approaching the point of accident from the west, there is a 3°8' curve to the right 1,837 feet in length and then the track is tangent for a distance of about 150 feet, followed by a 3°10' curve to the

left 1,510 feet in length, the accident occurring on this latter curve at a point about 120 feet from its western end. Approaching from the east, the track is tangent for a distance of 970 feet to the curve on which the accident occurred. The grade at the point of accident is 0.27 percent ascending for east-bound trains.
