INVESTIGATION NO. 2520
THE KANSAS CITY SOUTHERN RAILWAY COMPANY
REPORT IN RE ACCIDENT
NEAR SHORELINE, LA., ON
AUGUST 18, 1941

Kind of accident: Rear-end collision

Accident near Shoreline, La., on August 18, 1941, caused by an inferior train occupying main track on the time of a following superior train.

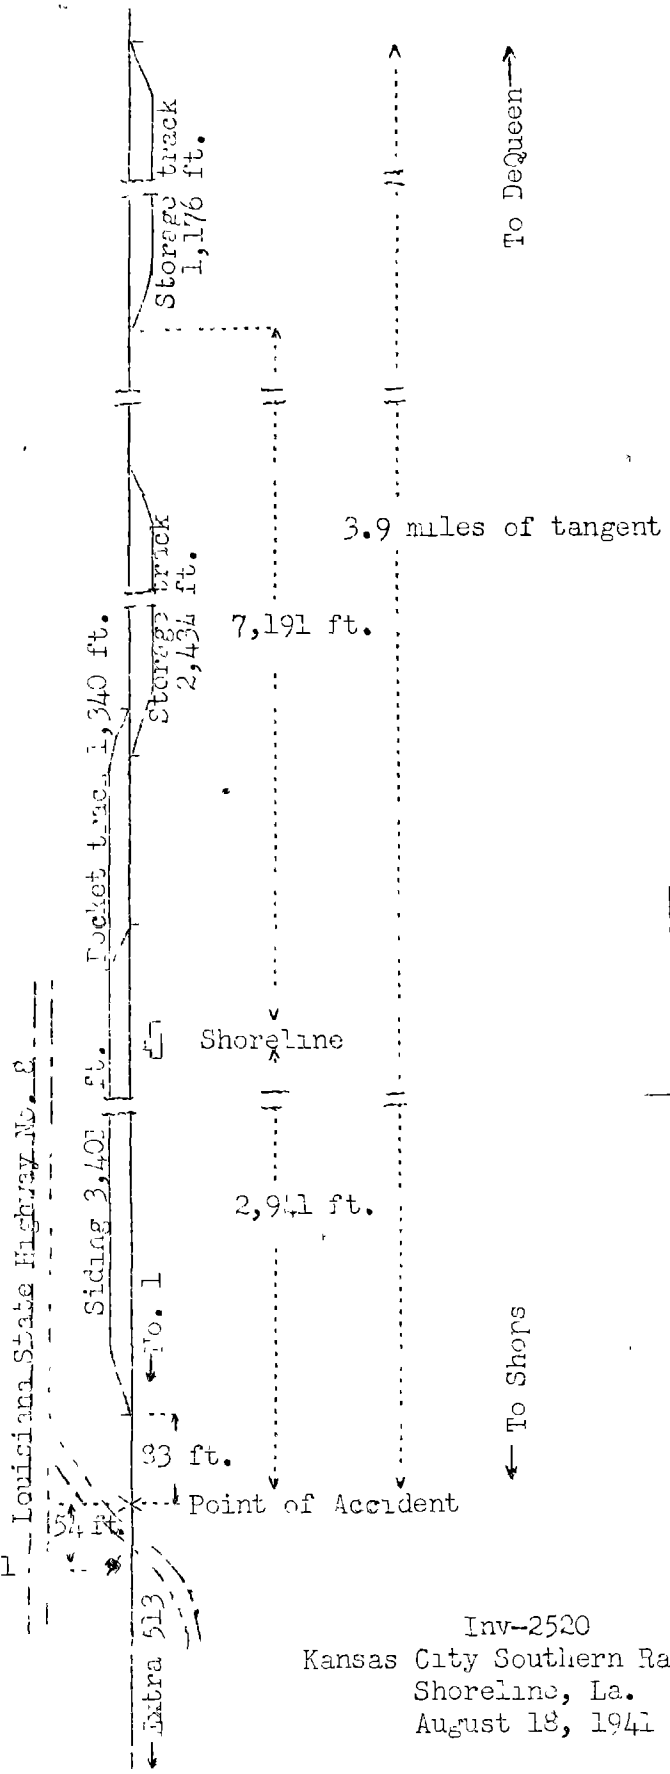
Inv-2520
 Kansas City Southern Railway
 Shoreline, La.
 August 18, 1941

- DeQueen, Ark. 53.90 mi.
- Depot Jct. 0.60 mi.
- Texarkana, Ark. 38.90 mi.
- Vivian, La. 5.00 mi.
- Shoreline 0.55 mi.
- X Point of Accident 25.55 mi.
- Shops, La.

Wig-wag crossing signal

Location of Accident and Method of Operation
