INVESTIGATION NO. 2556 THE LEHIGH VALLEY RAILROAD COMPANY REPORT IN RE ACCIDENT AT RANSOM, PA., ON JANUARY 4, 1942

Accident at Ransom, Pa., on January 4, 1942, caused by a passenger train striking an automobile which had stalled on a highway grade crossing.

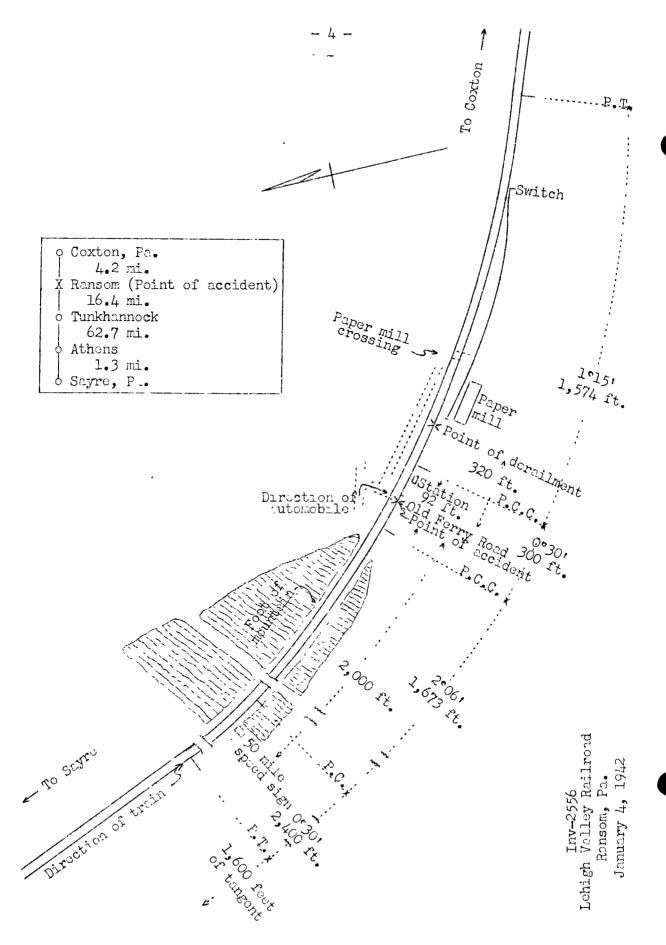
This accident occurred on that part of the Wyoming Division which extends between Sayre and Coxton, Pa., a distance of 84.6 miles. In the vicinity of the point of accident this is a double-track line over which trains are operated by timetable, train orders and an automatic block-signal system. The main tracks from north to south are No. 1, westward main, and No. 2, eastward main. The accident occurred on the eastward main track at a point 92 feet west of Ransom station, at which point the railroad is crossed at grade by Old Ferry Road, As the point of accident is approached from the west on the railroad there are, in succession, a tangent 1,660 feet in length and a compound curve to the left 5,947 feet in length, the curvature of which varies from 0°30' to 2°06'. The accident occurred on this curve at a point 4,217 feet east of its western end where the curvature is 0°30'. The grade for east-bound trains is, successively, 0.034 percent descending 4,782 feet, level 3,766 feet and 0.09 percent descending 42 feet to the point of accident and a considerable distance beyond. The highway crosses the tracks at right angles and terminates just south of the tracks. As the point of accident is approached from the north on Old Ferry Road there are, in succession, a slight curve to the left 150 feet in length and a tangent 125 feet to the crossing. The grade for south-bound vehicles on Old Ferry Road is level throughout a distance of 40 feet to the north rail of the westward main track and slightly ascending across the tracks. The highway is surfaced with macadam and is 14 feet in width at the crossing. At a point 1,360 feet east of the crossing a trailingpoint turnout to the south leads off the eastward main track to a spur track serving a paper mill located south of the tracks and 386 feet east of the crossing.

Because of track curvature and the cut at the foot of the mountain, a view of the crossing, under the most favorable weather conditions, can be had from the left side of an east-bound engine a distance of only 800 feet, and from the right side only 321 feet. Falling snow at the time of the accident restricted visibility.

The automobile was demolished and most of its wreckage was thrown to a point 285 feet east of the crossing and just south of the tracks. The right half of the rear axle and its housing were found at a point 986 feet east of the crossing and on the south side of the tracks. These portions of the automobile bore abrasions indicating that they had slid on the rails after they became lodged beneath the front pair of engine-truck wheels.

reversed in direction, stopped against the north side of the fifth car and leaned at an angle of 15 degrees. The seventh car was practically destroyed and it stopped across both main tracks. The eighth car, badly damaged, stopped across both tracks and leaned to the right at an angle of 15 degrees. The ninth car, considerably damaged, stopped almost upright, with its front end just south of the eastward main track and its rear end on the track. The tenth car, slightly damaged, stopped upright on the roadbed. The front wheels of the front truck of the eleventh car were derailed.
