INTERSTATE COMMERCE COMMISSION

REPORT OF THE DIRECTOR

ACCIDENT ON THE
LEHIGH VALLEY RAILROAD

INVESTIGATION NO. 2418

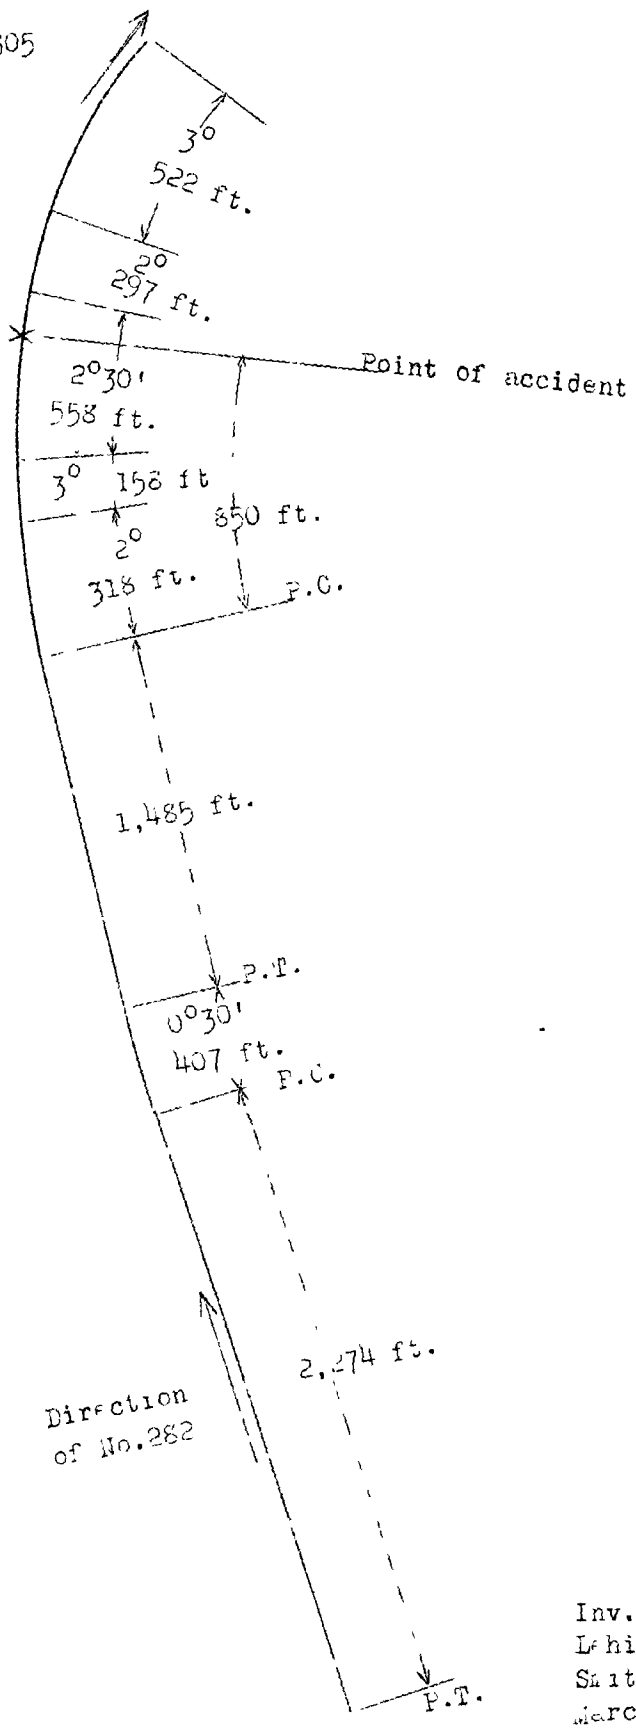
Inv. No. 2418
 High Valley R.R.
 Smithboro, N.Y.
 March 10, 1940

o	Sevre, Pa.	
		9.0 mi.
o	Smithboro, N.Y.	
		2.1 mi.
X	Point of accident	
		2.0 mi.
o	Tioga Center	
		5.5 mi.
o	Cwego	
		97.1 mi.
o	Fair Haven, N.Y.

This accident occurred on that part of the Buffalo Division designated as the Auburn Branch which extends between Sayre, Pa., and Fair Haven, N. Y., a distance of 115.7 miles. This is a single-track line over which trains are operated by timetable, train orders, and a manual block system. The accident occurred at a point 2.14 miles west of Smithboro. Approaching this point from the west there are, in succession, a tangent 2,274 feet in length, a $0^{\circ}30'$ curve to the right 407 feet in length, a tangent 1,485 feet long, and a compound curve to the right 1,853 feet in length, the maximum curvature of which was 3° ; the accident occurred on the compound curve at a point 850 feet east of its western end where the curvature is $2^{\circ}30'$. The grade for east-bound trains is, successively, level a distance of 1.53 miles, 0.65 percent descending a distance of 2,125 feet, and level a distance of 106 feet to the point of accident and 594 feet beyond, 0.39 percent ascending a distance of 3,150 feet, level a distance of 350 feet, and 0.437 percent descending a considerable distance beyond.
