INTERSTATE COMMERCE COMMISSION

REPORT OF THE DIRECTOR OF THE BUREAU OF SAFETY CONCERNING AN
ACCIDENT ON THE LONG ISLAND RAILROAD AT VANDEVEER PARK,
LONG ISLAND, N. Y., ON DECEMBER 4, 1934.

Inv. No. 1949
 Long Island R.R.,
 Vanderveer Park, L. I.,
 Dec. 4, 1934

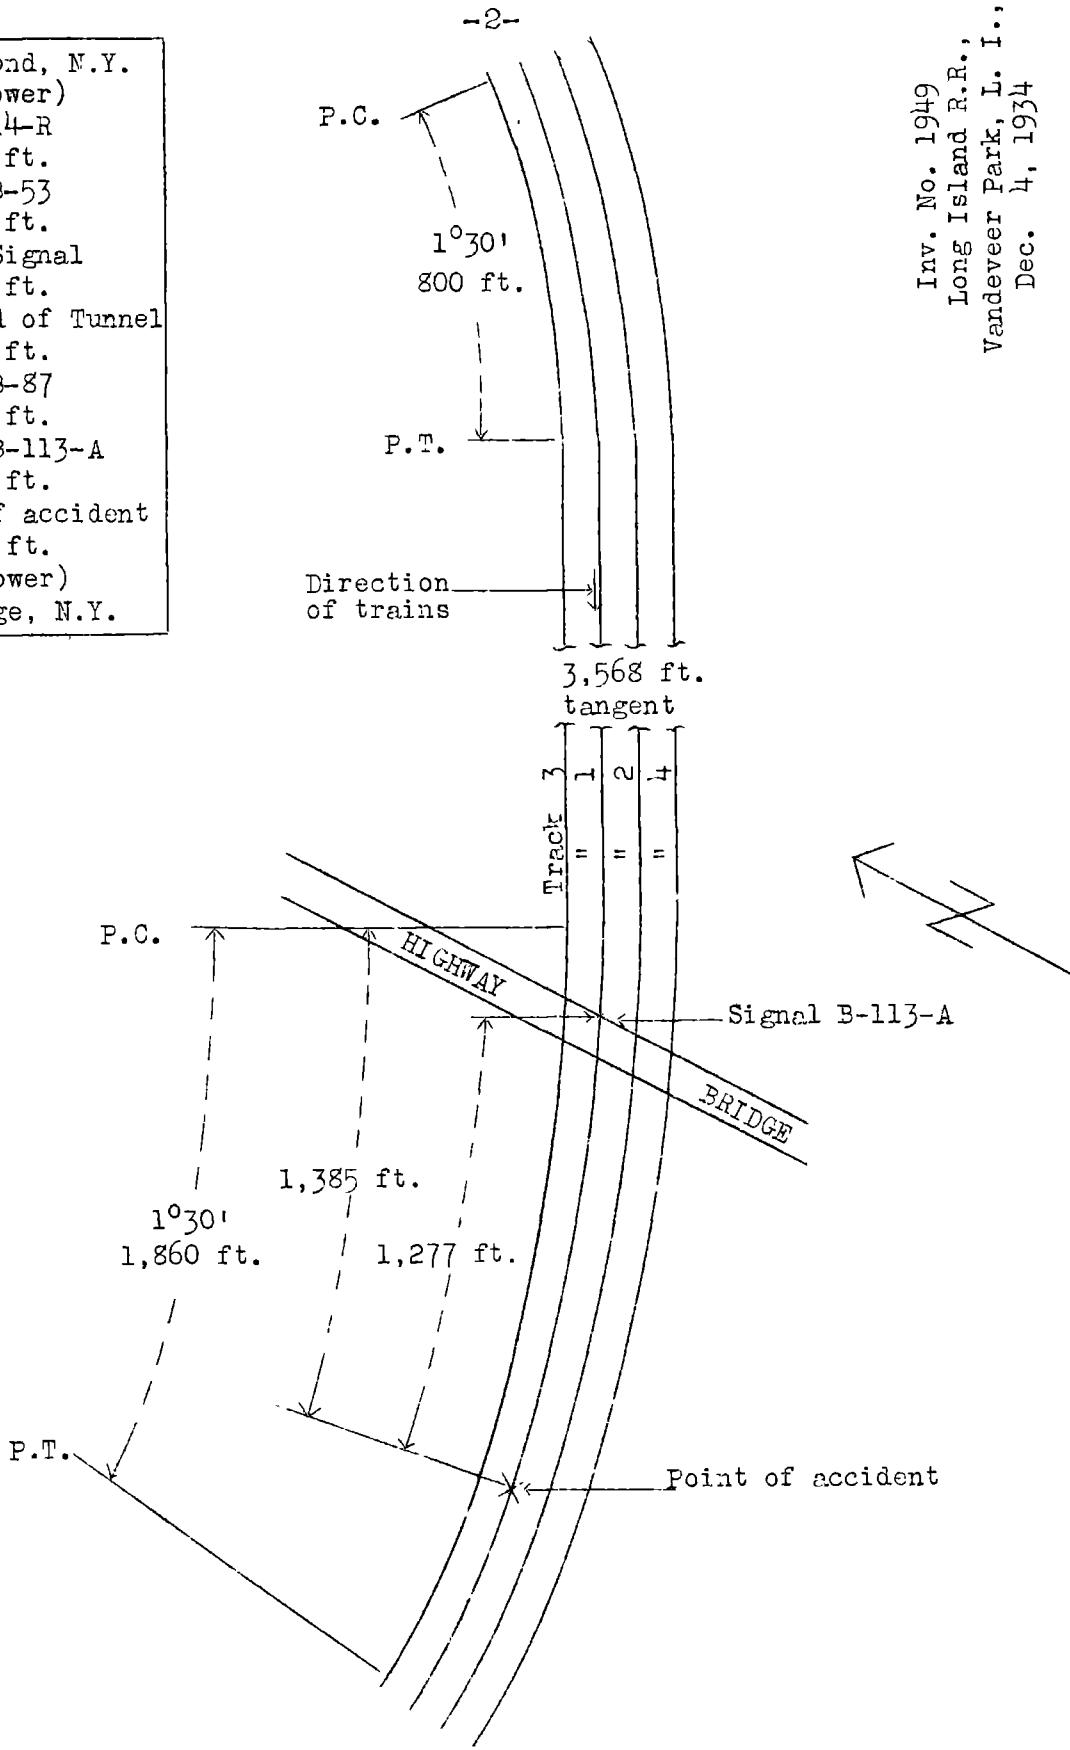
Fresh Pond, N.Y.
 (FN Tower)
 Signal 14-R
 1,815 ft.
 Signal B-53
 4,660 ft.
 Tunnel Signal
 3,535 ft.
 West end of Tunnel
 9,320 ft.
 Signal B-87
 11,575 ft.
 Signal B-113-A
 1,277 ft.
 X Point of accident
 3,538 ft.
 (MJ Tower)
 Bay Ridge, N.Y.

The block signal at FN Tower governing track 1 between that point and MJ Tower, a distance of 7.1 miles, is a 3-indication color-light signal, known as signal 14-R; it displays red for stop, yellow for other than passenger trains to proceed with caution prepared to stop short of a train or obstruction, and green for proceed. In addition, there are four signals within the block as follows: Signal B-53, located 1,815 feet west of signal 14-R, is a distant signal for East New York tunnel, the tunnel signal being 4,660 feet farther west; then comes the tunnel, which is 3,535 feet in length, and nearly 2 miles west of the

tunnel is signal B-87, giving advance information as to the position of hand-thrown cross-over switches near New Lots yard, approximately 3,000 feet west of signal B-87; more than 2 miles farther west is signal B-113A, the distant signal for MJ Tower. Signal B-113A is 1,277 feet east of the point of accident and is mounted on Albany Avenue overhead bridge. Approaching this point the engineman of a west-bound train obtains practically no view of the track ahead until after passing under this bridge, and then his view of a train standing at the point of accident is restricted by curvature and an embankment on the inside of the curve to a distance of less than 1,000 feet. The maximum authorized speed for freight trains on track 1 is 45 miles per hour.
