REPORT NO. 3302
THE LONG ISLAND RAILROAD COMPANY
IN RE ACCIDENT
NEAR WOODSIDE, N. Y., ON
DECEMBER 22, 1949

Accident near Woodside, N. Y., on December 22, 1949,
caused by failure to operate the following train
in accordance with signal indications.

Report No. 3302
Long Island Railroad
Woodside, N. Y.
December 22, 1949

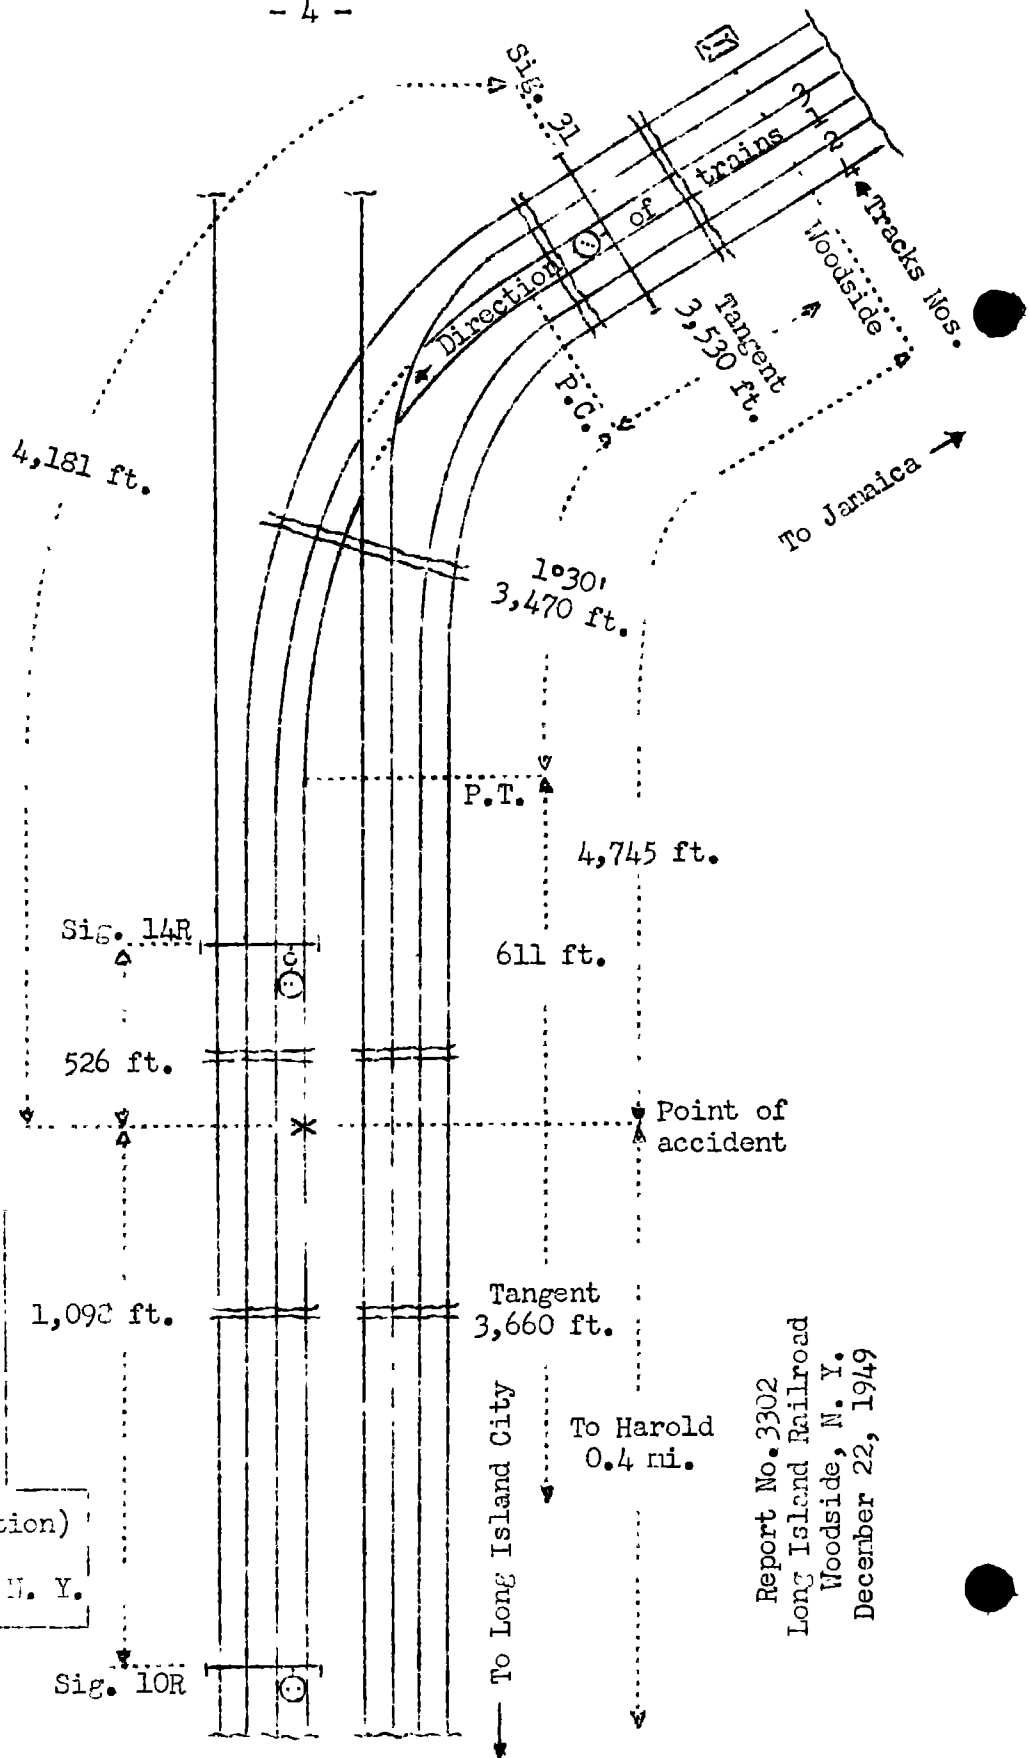
- o Jamaica, N. Y.
5.5 mi.
- o Win
0.7 mi.
- o Woodside
0.9 mi.
- X Point of accident
0.4 mi.
- o Harold
(interlocking station)
1.8 mi.
- o Long Island City, N. Y.

Location of Accident and Method of Operation
