INTERSTATE COMMERCE COMMISSION

REPORT NO. 3663

LOUISIANA & ARKANSAS RAILWAY COMPANY

NEAR SULPHUR SPRINGS, TEX., ON

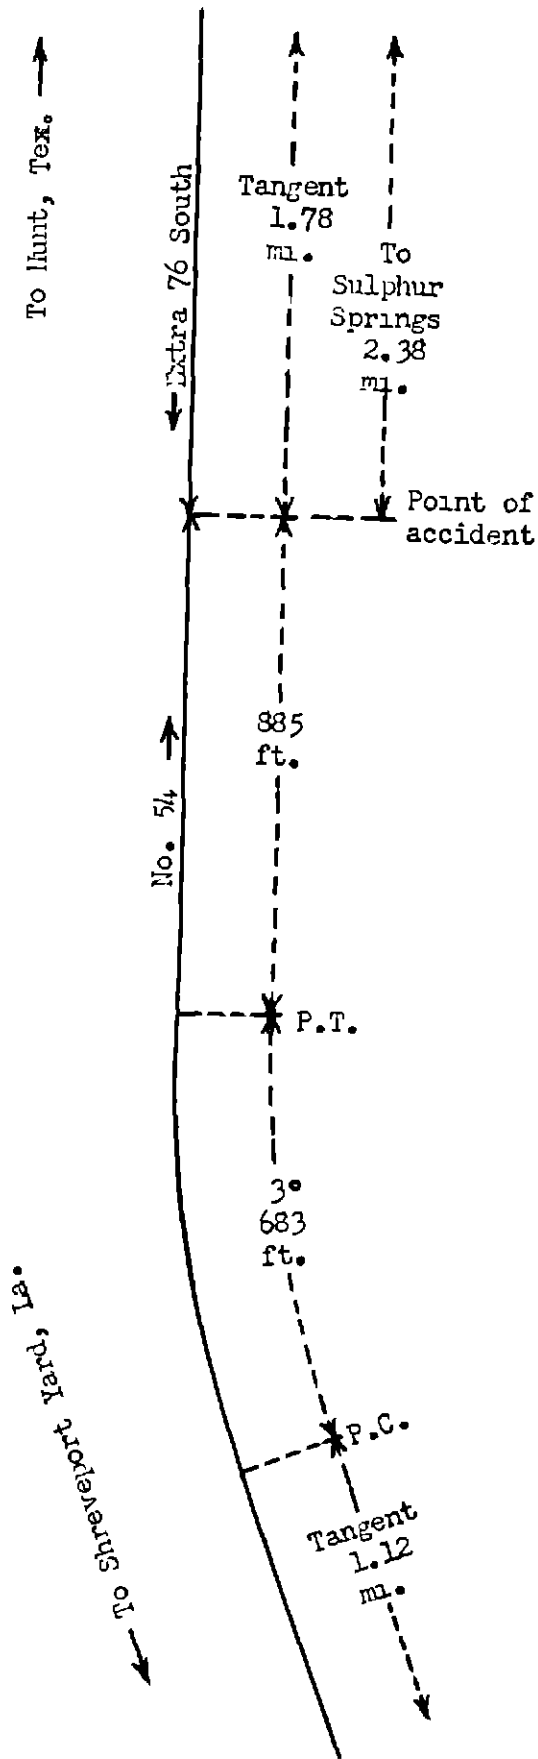
Report No. 3663  
 Louisiana & Arkansas Railway  
 Near Sulphur Springs, Tex.  
 October 12, 1955

•	Hunt, Tex.	23.4 mi.
•	Brashear	7.9 mi.
•	Sulphur Springs	2.38 mi.
X	Point of accident	7.02 mi.
•	Como	54.6 mi.
•	Hughes Spring, Tex.	75.4 mi.
•	Shreveport Yard, La.
