REPORT NO. 3627  
LOUISVILLE AND NASHVILLE RAILROAD COMPANY  
IN RE ACCIDENT  
AT ARTEMUS, KY., ON  
APRIL 23, 1955

Kind of accident: Collision

Cause: Malicious tampering with switch

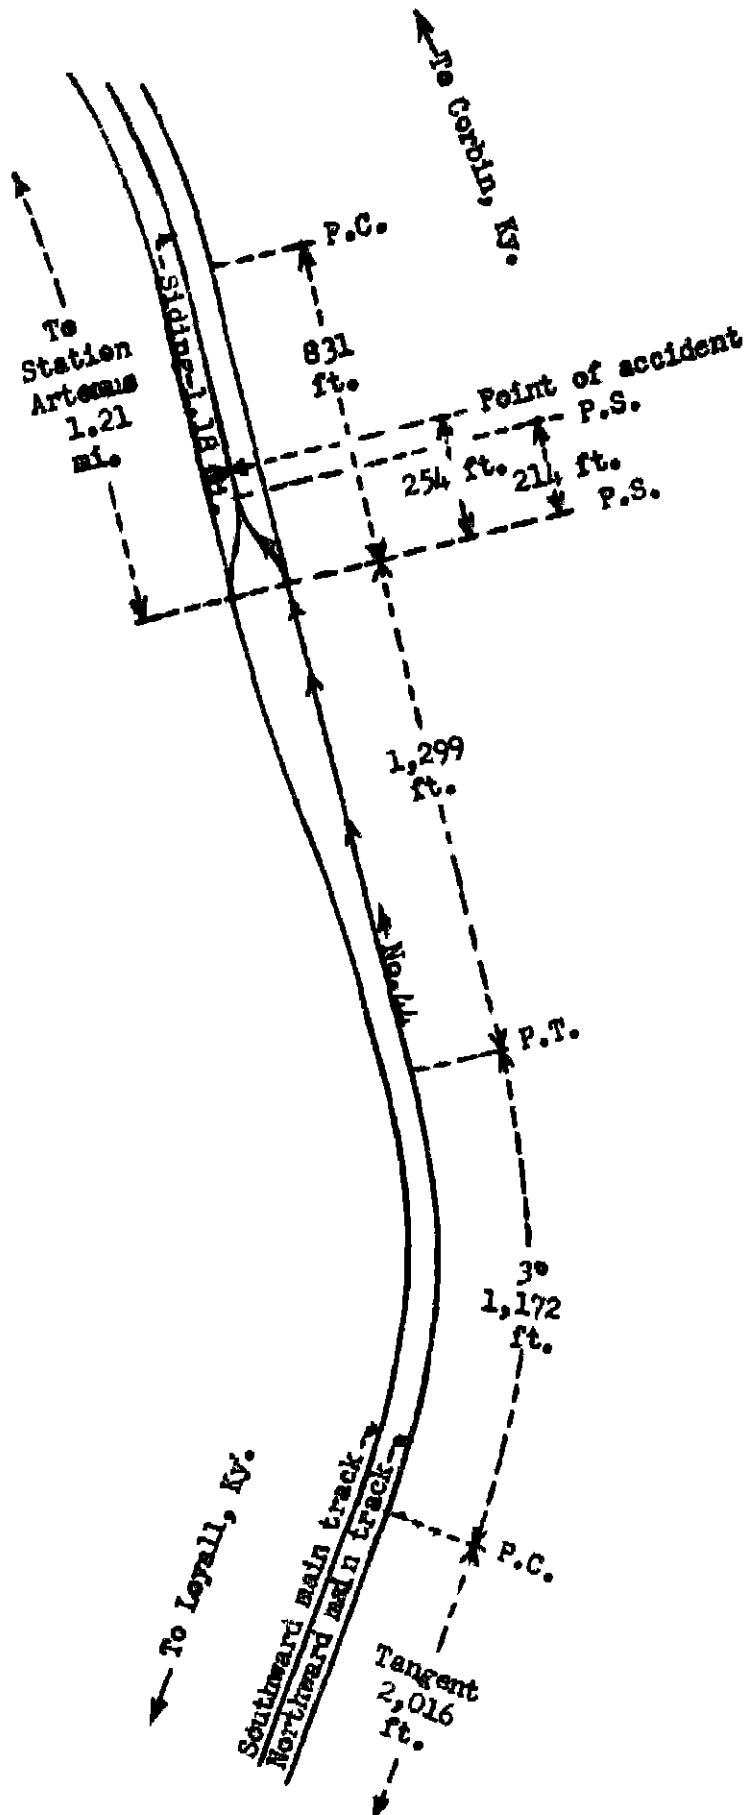
Report No. 3627  
 Louisville and Nashville Railroad  
 Artemus, Ky.  
 April 23, 1955

•	Corbin, Ky.	19.59 mi.
×	Artemus (Point of accident)	10.28 mi.
•	Walsend	37.61 mi.
•	Loyall, Ky.

After the accident occurred the south crossover-switch was found to be lined for entry to the siding. This switch previously had been spiked in position for movement on the northward main track. Examination of the switch disclosed that the switch points were undamaged. Two spikes which had been driven into the head block tie to secure the switch point against the stock rail had been removed. One spike was found between the ties at the switch. Marks on the switch plate through which the spikes had been driven indicated that the spikes had been removed by use of a claw bar. The switch lock had been removed from the keeper and was found on the embankment about 20 feet east of the switch. A claw bar, which evidently had been used to pull the spikes, was found on the embankment east of the track at a point approximately 30 feet from the switch.
