INVESTIGATION NO. 2608  
THE LOUISVILLE & NASHVILLE RAILROAD COMPANY  
REPORT IN RE ACCIDENT  
NEAR CYPRESS, FLA., ON  
JULY 29, 1942

Railroad:	Louisville & Nashville
Date:	July 29, 1942
Location:	Cypress, Fla.
Kind of accident:	Rear-end collision
Trains involved:	Freight : Freight
Train numbers:	Extra 1128 South : Extra 177-298 South
Engine numbers:	1128 : 177-298
Consist:	34 cars, caboose : 38 cars, caboose
Speed:	20 m. p. h. : 35-40 m. p. h.
Operation:	Timetable and train orders
Track:	Single; tangent; 1.49 percent ascending grade southward
Weather:	Clear
Time:	About 12:42 a. m.
Casualties:	1 killed; 5 injured
Cause:	Accident caused by failure to provide adequate protection for preceding train
Recommendation:	That the Louisville & Nashville Railroad Company establish an adequate block system on the line involved in this accident

Accident near Cypress, Fla., on July 29, 1942, caused by  
failure to provide adequate protection for preceding  
train.

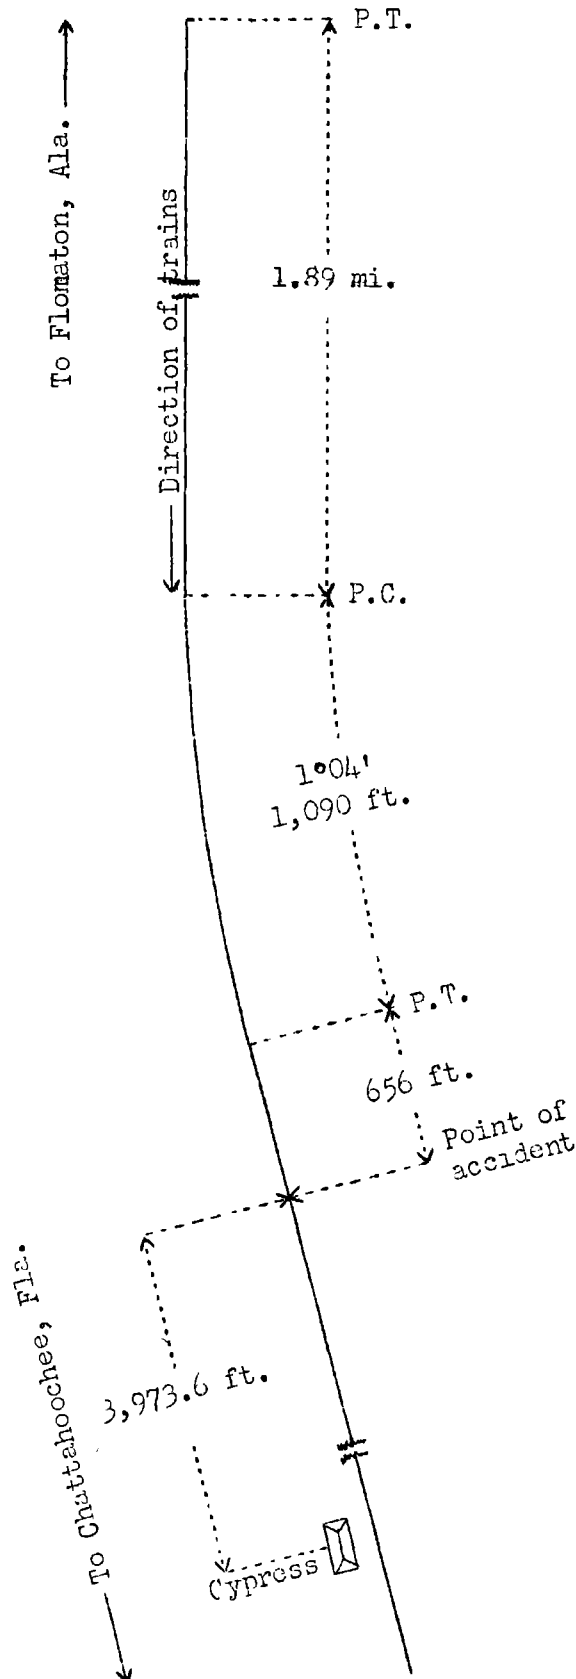
Inv. No. 2608  
Louisville & Nashville Railroad  
Cypress, Fla.  
July 29, 1942

o	Flomaton, Ala.	43.75 mi.
o	Pensacola, Fla.	135.12 mi.
o	Marianna	2.69 mi.
o	Spring Creek Jct.	2.57 mi.
o	Bridge Creek W.T.	4.68 mi.
x	Point of accident	0.75 mi.
o	Cypress	14.86 mi.
o	Chattahoochee, Fla.

Extra 1128 South departed from Spring Creek Junction, 8 miles north of Cypress, at 12:20 a. m. This train consisted of a caboose, engine 1128, moving backward, and 34 cars, in the order named. The rear car was a gondola and a lighted red lantern was displayed on the rear end. At Bridge Creek Water Tank, 5.43 miles north of Cypress, a stop was made for water. As this train was approaching the point where the accident occurred, the speed was about 20 miles per hour. The engineer observed the headlight of a following train moving rapidly and closely approaching the rear of his train. He opened the throttle fully in an attempt to equal the speed of the following train; however, before the speed was materially increased the rear end was struck by Extra 177-298 South at a point  $\frac{3}{4}$  mile north of the station at Cypress.
