INVESTIGATION NO. 3130
LOUISVILLE AND NASHVILLE RAILROAD COMPANY
REPORT IN RE ACCIDENT
AT ELMORE, ALA., ON
MAY 8, 1948

Kind of accident: Head-end collision

Accident at Elmore, Ala., on May 8, 1948, caused by failure properly to control the speed of a train in accordance with signal indications and approaching a meeting point.

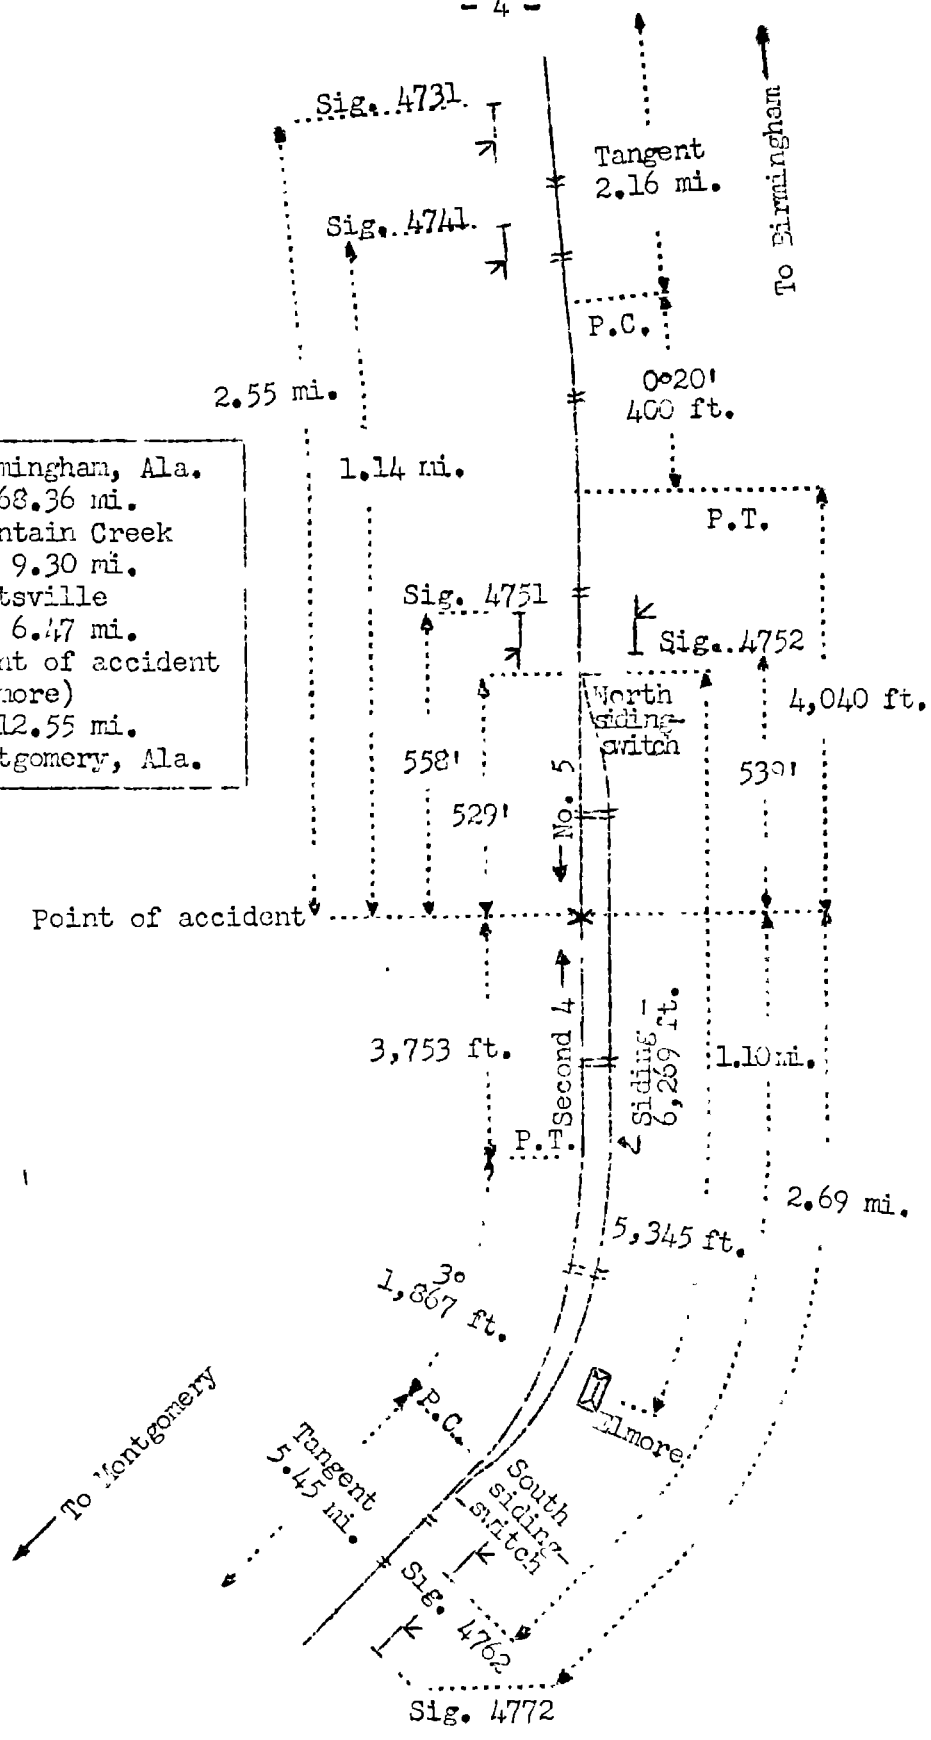
Inv. No. 318C
 Louisville and Nashville Railroad
 Elmore, Ala.
 May 8, 1948

- o Birmingham, Ala. 68.36 mi.
- o Mountain Creek 9.30 mi.
- o Deatsville 6.47 mi.
- X Point of accident (Elmore) 12.55 mi.
- o Montgomery, Ala.

Location of Accident and Method of Operation
