INVESTIGATION NO. 2700  
THE LOUISVILLE & NASHVILLE RAILROAD COMPANY  
REPORT IN RE ACCIDENT  
AT HAZEL PATCH, KY., ON  
MAY 20, 1943

Accident at Hazel Patch, Ky., on May 20, 1943, caused by  
failure to provide adequate flag protection for a  
work train.

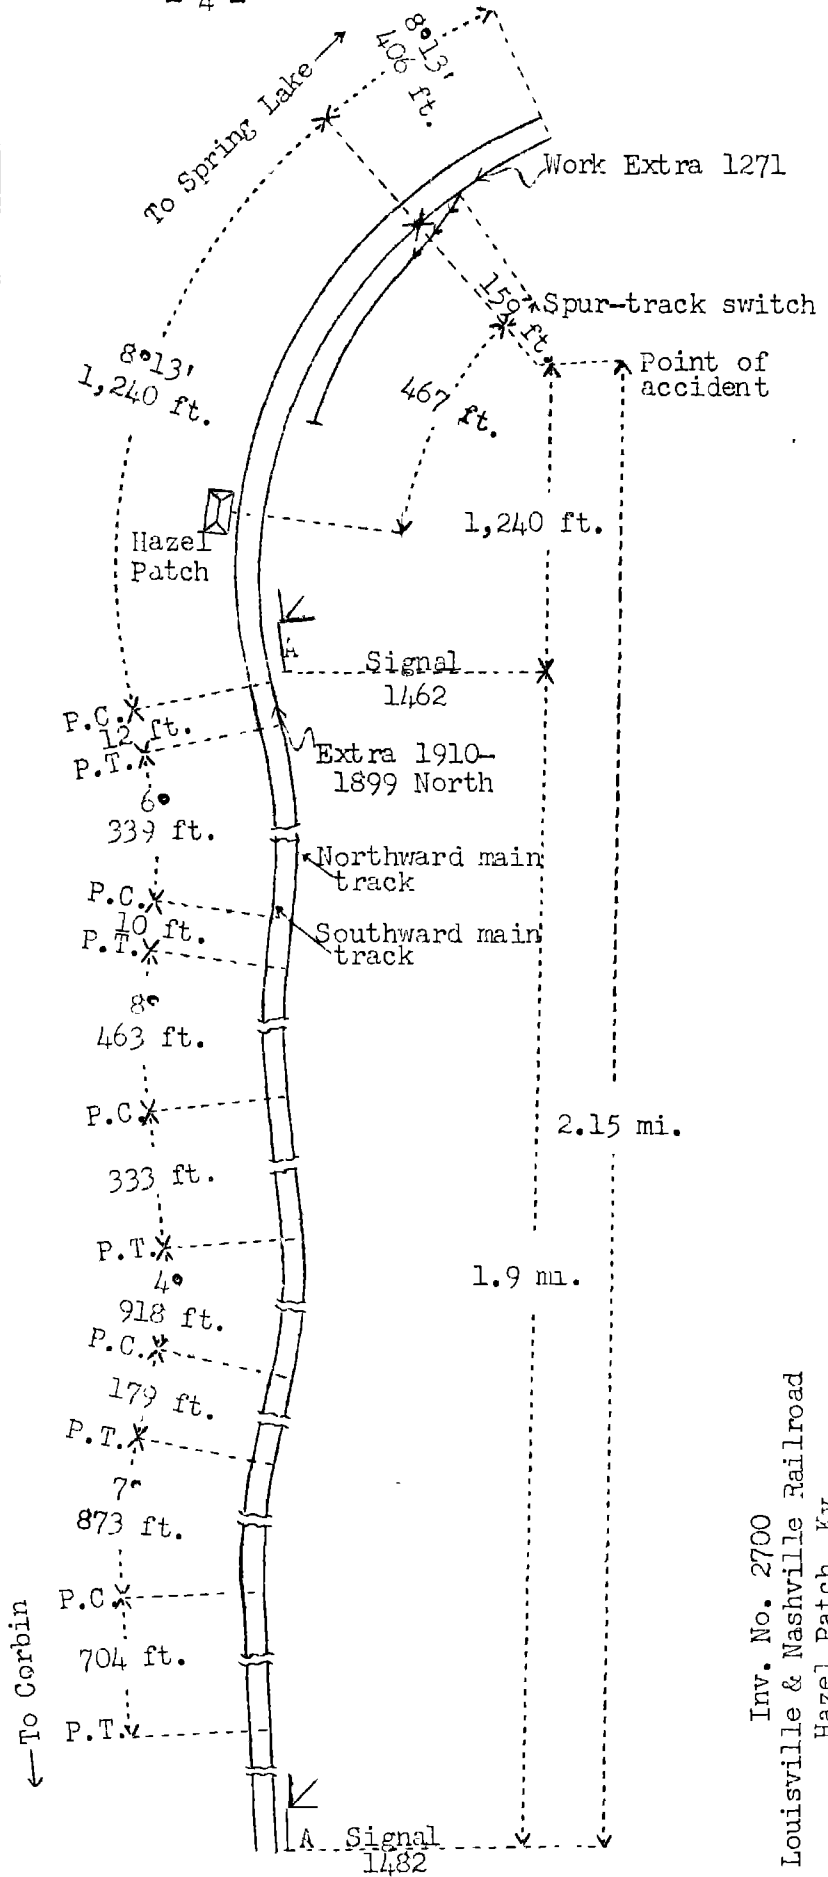
Inv. No. 2700  
Louisville & Nashville Railroad  
Hazel Patch, Ky.  
May 20, 1943

- Spring Lake, Ky.  
143.17 mi.
- Sinks  
3.20 mi.
- Livingston  
5.80 mi.
- ✱ Hazel Patch (P. of A.)  
6.40 mi.
- East Bernstadt  
19.90 mi.
- Corbin, Ky.

Location of Accident and Method of Operation
