REPORT NO. 3403
LOUISVILLE AND NASHVILLE RAILROAD COMPANY
IN RE ACCIDENT
NEAR HEMATITE, TENN., ON
JUNE 7, 1951

Kind of accident: Head-end collision

Accident near Hematite, Tenn., on June 7, 1951, caused by
failure to obey a meet order.

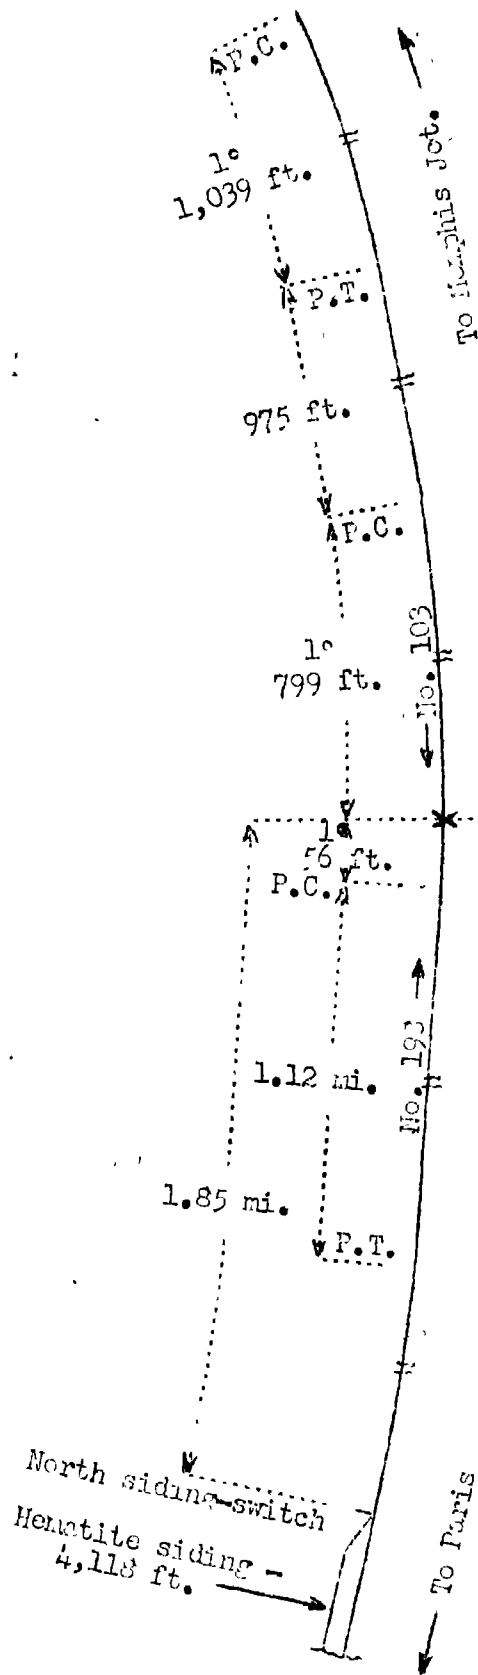
○ Memphis Jct., Ky.	45.90 mi.
○ Guthrie, Ky.	14.12 mi.
○ Clarksville Freight Station	5.92 mi.
X Point of accident	1.85 mi.
○ Henatite, Tenn.	19.70 mi.
○ Erin	4.71 mi.
○ Tennessee Ridge	14.49 mi.
○ Faxon	21.59 mi.
○ Paris, Tenn.
