## INTERSTATE COMMERCE COMMISSION

REPORT OF THE DIRECTOR OF THE BUREAU OF SAFETY IN RE  
INVESTIGATION OF AN ACCIDENT WHICH OCCURRED ON THE  
LOUISVILLE & NASHVILLE RAILROAD NEAR HURRICANE, ALA.,  
ON FEBRUARY 25, 1931.

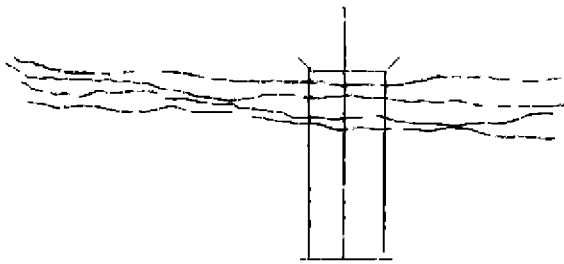
→ → →

Mobile River

Bridge No. 193 is a steel drawbridge, 1,050 feet 6 inches in length. It consists of one through girder span 80 feet in length, at the south end of the bridge, and four through truss spans, the draw span, of the pivot type, is 330 feet in length, and is the fourth span from the south end of the bridge, while the other three truss spans are each 208 feet in length. The bridge operator's tower is located near the top of the central part of the draw span, about 35 feet above the rails. When the draw span is closed it is secured to the fixed spans by means of rail locks and wedges. The spans rest on concrete piers and there is a clearance of 147 feet between the fenders of the pier upon which the draw span rests and the pier south thereof. The draw span is about 16½ feet above the mean low water level; the channel on the south side of the draw span, where the accident occurred, which channel is ordinarily used by

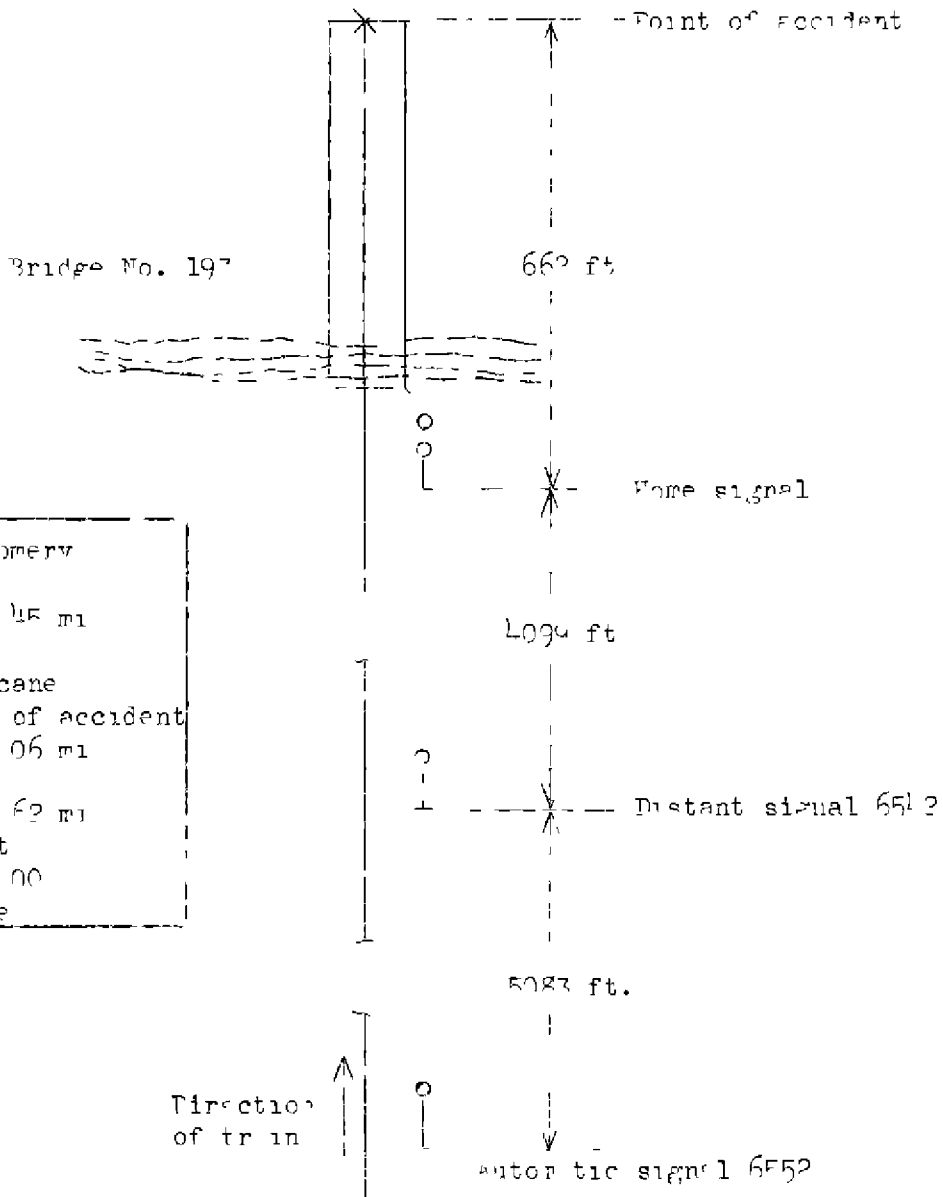
Inv. no. 1693  
 Louisville & Nashville  
 Hurricane, Al  
 Feb. 25, 1931

o	Montgomery
	162 1/2 mi
o	Hurricane
X	Point of accident
	5 06 mi
o	Crtiz
	8 62 mi
o	Sibert
	2 00
o	Mobile

This accident occurred on the Mobile and Montgomery Division, extending between Sibert and Montgomery, Ala., a distance of 176.13 miles; in the vicinity of the point of accident this is a single-track line over which trains are operated by time-table, train orders, and an automatic block-signal system. In the vicinity of the point of accident the line extends east and west by compass directions, but time-table directions are north and south, and the latter directions are used in this report. The accident occurred 2.18 miles south of Hurricane, at the south end of the draw span of bridge No. 193 over the Mobile River; approaching this point from the south, the track is tangent for a distance of about 2 miles. The grade for northbound trains is practically level to the south approach of the bridge; it is then ascending at the rate of 0.40 per cent for a distance of about 2,000 feet to the bridge, being level across the bridge.
