INVESTIGATION NO. 2794  
THE LOUISVILLE & NASHVILLE RAILROAD COMPANY  
REPORT IN RE ACCIDENT  
NEAR KEELING, TENN., ON  
APRIL 27, 1944

Accident near Keeling, Tenn., on April 27, 1944, caused by a combination of flange wear on gage side of high rail of curve and irregularities in alinement, surface and gage of track.

Inv. No. 2794  
 Louisville & Nashville Railroad  
 Keeling, Tenn.  
 April 27, 1944

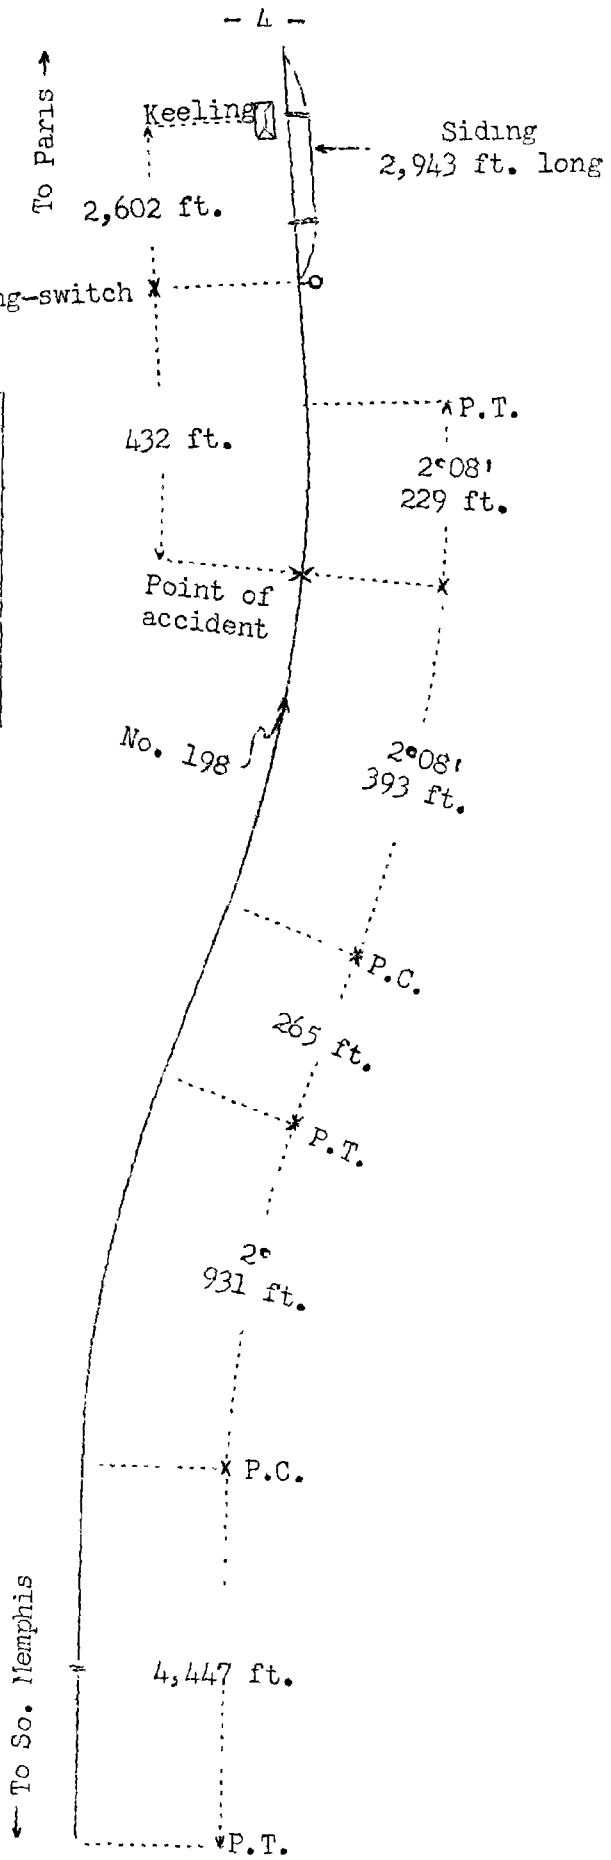
- Paris, Tenn.  
90.30 mi.
- Keeling  
0.57 mi.
- ✕ Point of accident  
3.52 mi.
- Mason  
38.03 mi.
- So. Memphis, Tenn

Location of Accident and Method of Operation
