INVESTIGATION NO. 2673
THE LOUISVILLE & NASHVILLE RAILROAD COMPANY
REPORT IN RE ACCIDENT
NEAR PANA, ALA., ON
FEBRUARY 11, 1943

Accident near Pana, Ala., on February 11, 1943, caused by
failure properly to control speed of No. 92 in accord-
ance with flagging instructions.

Inv-2673
 Louisville & Nashville Railroad
 Pana, Ala.
 February 11, 1943

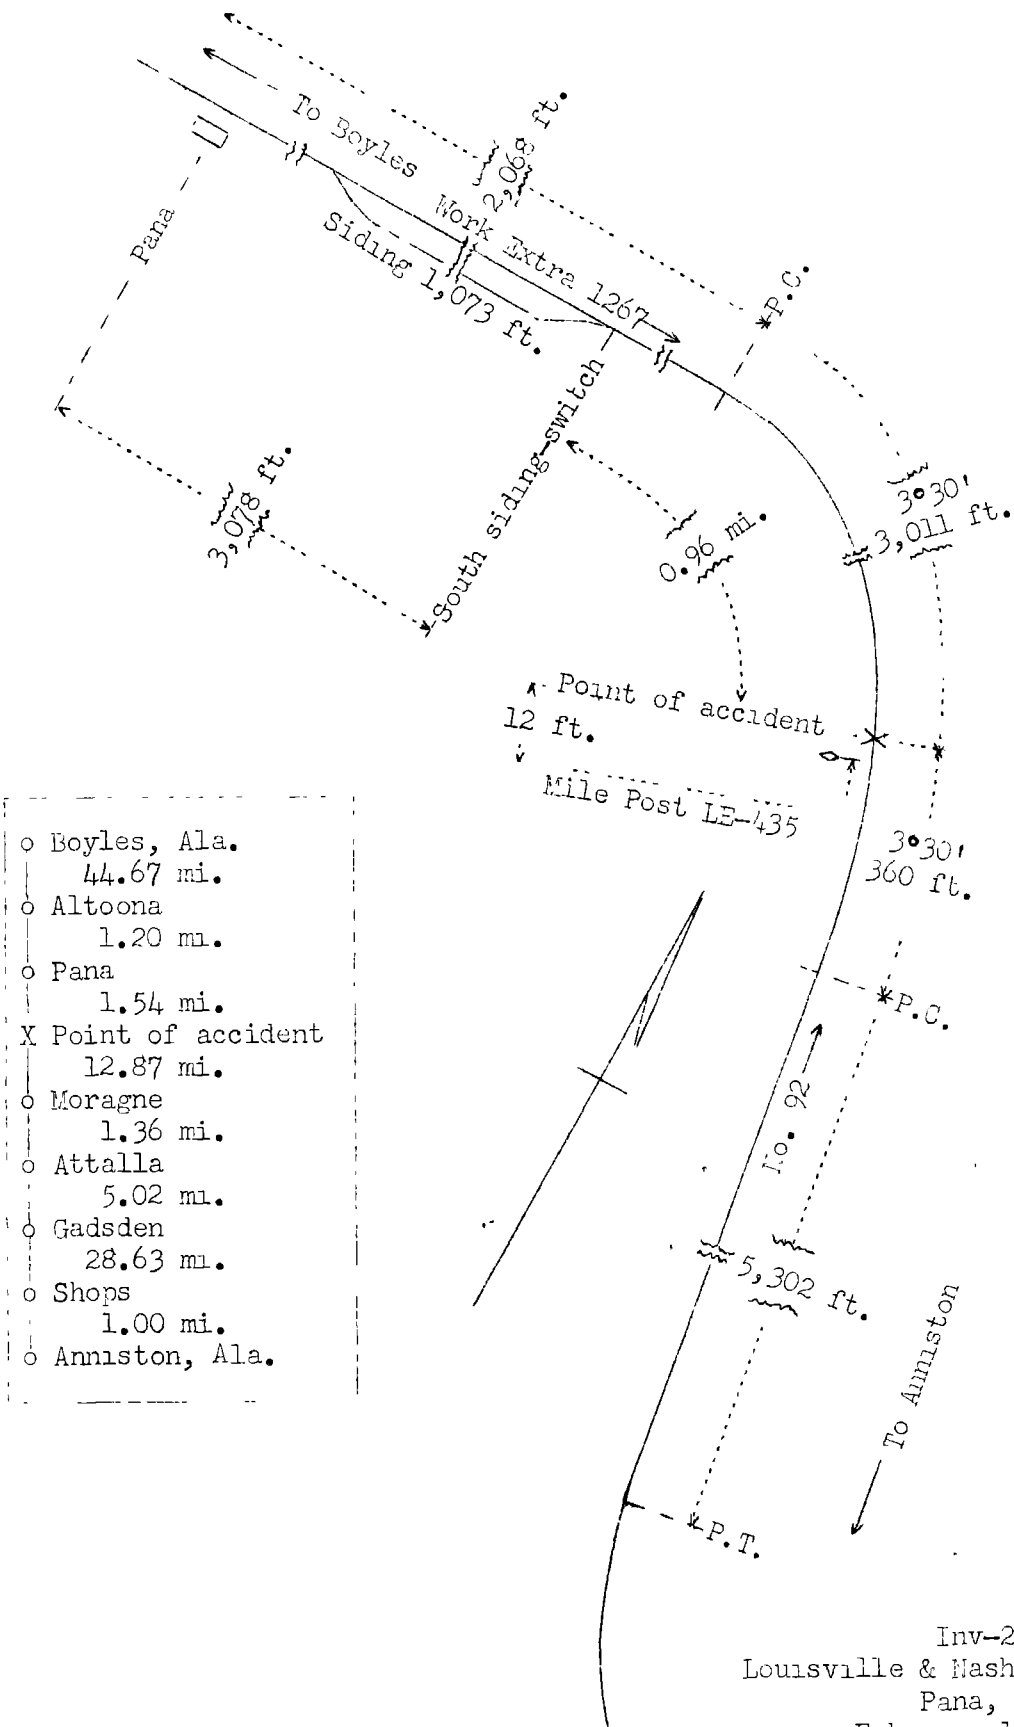
- o Boyles, Ala. 44.67 mi.
- o Altoona 1.20 mi.
- o Pana 1.54 mi.
- X Point of accident 12.87 mi.
- o Moragne 1.36 mi.
- o Attalla 5.02 mi.
- o Gadsden 28.63 mi.
- o Shops 1.00 mi.
- o Anniston, Ala.

This accident occurred on that part of the Birmingham Division which extends between Boyles and Anniston, Ala., a distance of 96.29 miles. In the vicinity of the point of accident this is a single-track line over which trains are operated by timetable and train orders. There is no block system in use. At Pana a siding 1,073 feet in length parallels the main track on the west. The south switch of this siding is 3,078 feet south of the station. The accident occurred on the main track at a point 0.96 mile south of the south siding-switch. Approaching from the north there is a tangent 2,068 feet in length, which is followed by a 3°30' curve to the right 3,011 feet to the point of accident and 360 feet beyond. Approaching from the south there is a tangent 5,302 feet in length, which is followed by the curve on which the accident occurred. The grade for south-bound trains is 0.557 percent descending 1,500 feet, then there are, in succession, a vertical curve 400 feet, a 1.26 percent descending grade 800 feet, and a vertical curve 388 feet to the point of accident. The grade for north-bound trains is 0.967 percent descending 2,400 feet, then there are, in succession, a vertical curve 400 feet, level track 400 feet, and a vertical curve 12 feet to the point of accident.
