REPORT OF THE DIRECTOR
BUREAU OF SAFETY

ACCIDENT ON THE
LOUISVILLE & NASHVILLE RAILROAD

PATTO, KY.

INVESTIGATION NO. 2259

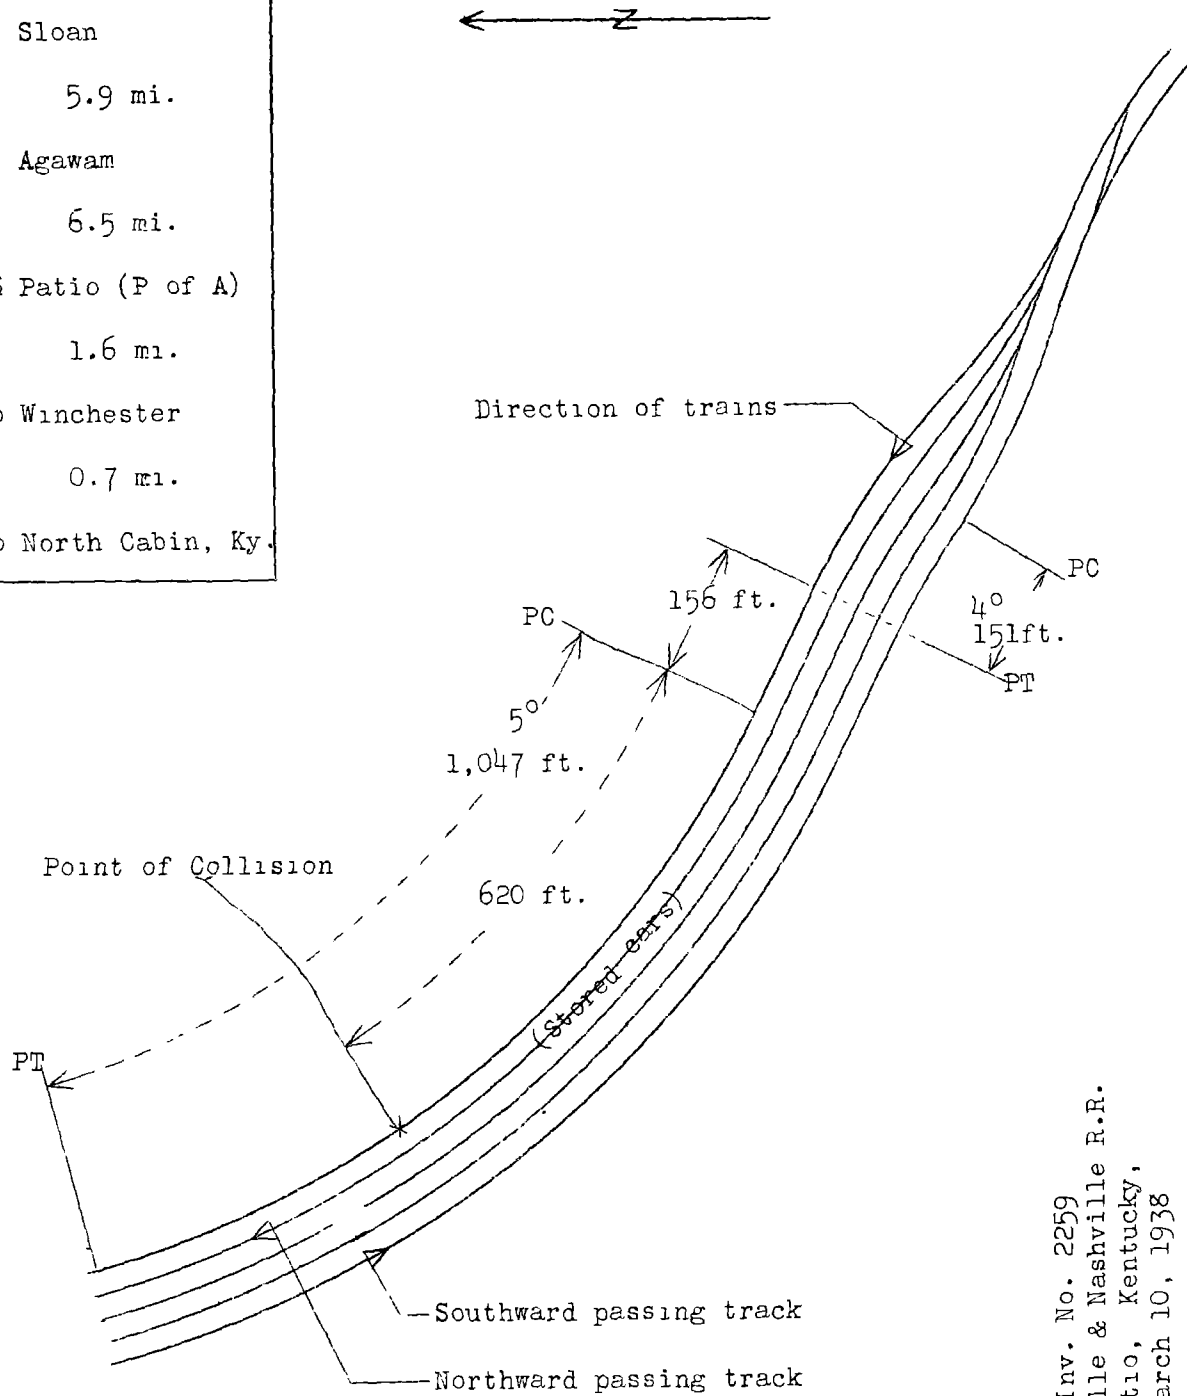
Inv. No. 2259
Louisville & Nashville R.R.
Patio, Kentucky,
March 10, 1938

o	Ravenna, Ky.
	13.3 mi.
o	Sloan
	5.9 mi.
o	Agawam
	6.5 mi.
X	Patio (P of A)
	1.6 mi.
o	Winchester
	0.7 mi.
o	North Cabin, Ky.

At Patio trains on the Eastern Kentucky Division cross the Cincinnati Division and in so doing move over 1.1 miles of that Division between Patio tower and North Cabin. At this point,
