INVESTIGATION NO. 2779
THE LOUISVILLE & NASHVILLE RAILROAD COMPANY
REPORT IN RE ACCIDENT
NEAR SPRINGFIELD, KY., ON
FEBRUARY 29, 1944

Accident near Springfield, Ky., on February 29, 1944,
caused by failure to provide protection for the
movement of a track motor-car.

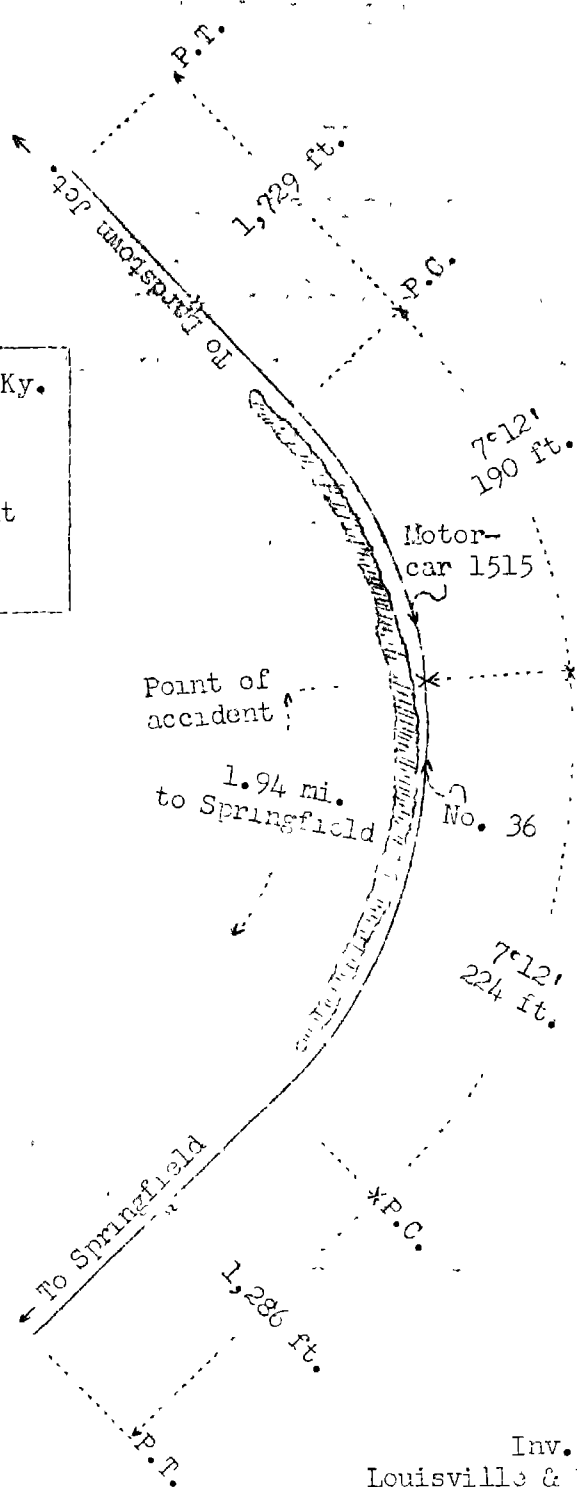
Inv. No. 2779
 Louisville & Nashville Railroad
 Springfield, Ky.
 February 29, 1944

- | | | |

| o | Bardstown Jct., Ky. | 31.69 mi. |
| X | Point of accident | 1.94 mi. |
| o | Springfield, Ky. | |
