INVESTIGATION NO. 2553
THE LOUISVILLE & NASHVILLE RAILROAD COMPANY
REPORT IN RE ACCIDENT
NEAR ST. FRANCIS, KY., ON
DECEMBER 20, 1941

Accident near St. Francis, Ky., on December 20, 1941, caused
by failure to obey a meet order.

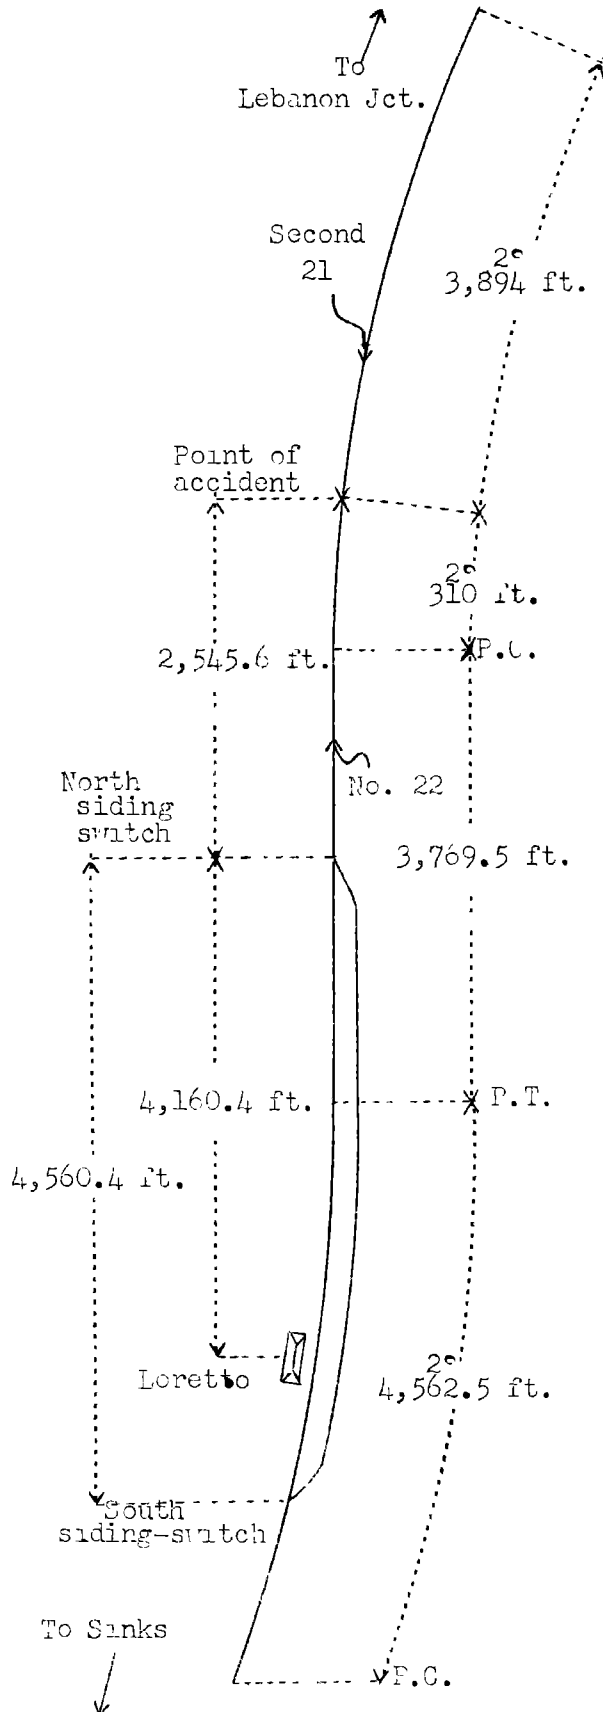
Inv. No. 2553
 usville & Nashville Railroad,
 St. Francis, Ky.,
 December 20, 1941.

○	Lebanon Jct., Ky.	15.85 mi.
●	New Haven	9.46 mi.
○	St. Francis	0.16 mi.
⊠	Point of accident	1.23 mi.
○	Loretto	10.21 mi.
○	Lebanon	55.32 mi.
○	Brodhead	14.99 mi.
○	Sinks, Ky.

This accident occurred on that part of the Louisville Division which extends between Lebanon Jct. and Sinks, Ky., a distance of 107.22 miles. In the vicinity of the point of accident this is a single-track line over which trains are operated by timetable and train orders. There is no block system in use. Time-table directions, which are north and south, are used in this report. At Loretto, 1.39 miles north of St. Francis, a siding 4,560.4 feet in length parallels the main track on the east. The north switch of this siding is located 4,160.4 feet north of the station. The accident occurred at a point 2,545.6 feet north of the north siding-switch. As the point of accident is approached from the south there are, in succession, a compound curve to the left 4,582.5 feet in length, the maximum curvature of which is 2°, a tangent 3,769.5 feet, and a 2° curve to the right 310 feet to the point of accident. As the point of accident is approached from the north there is a 2° curve to the left extending 3,894 feet to the point of accident. The grade for north-bound trains varies between 0.39 and 0.65 percent ascending 1,800 feet and then there is a vertical curve 300 feet to the point of accident. The grade for south-bound trains is 1.03 percent ascending 2,700 feet and then there is a vertical curve extending 800 feet to the point of accident.
