INVESTIGATION NO. 2905
THE MICHIGAN CENTRAL RAILROAD COMPANY
REPORT IN RE ACCIDENT
AT EATON RAPIDS, MICH., ON
JUNE 30, 1945

Accident at Eaton Rapids, Mich., on June 30, 1945, caused
by failure to obey a meet order.

Inv. No. 2905
 Michigan Central Railroad
 Eaton Rapids, Mich.
 June 30, 1945

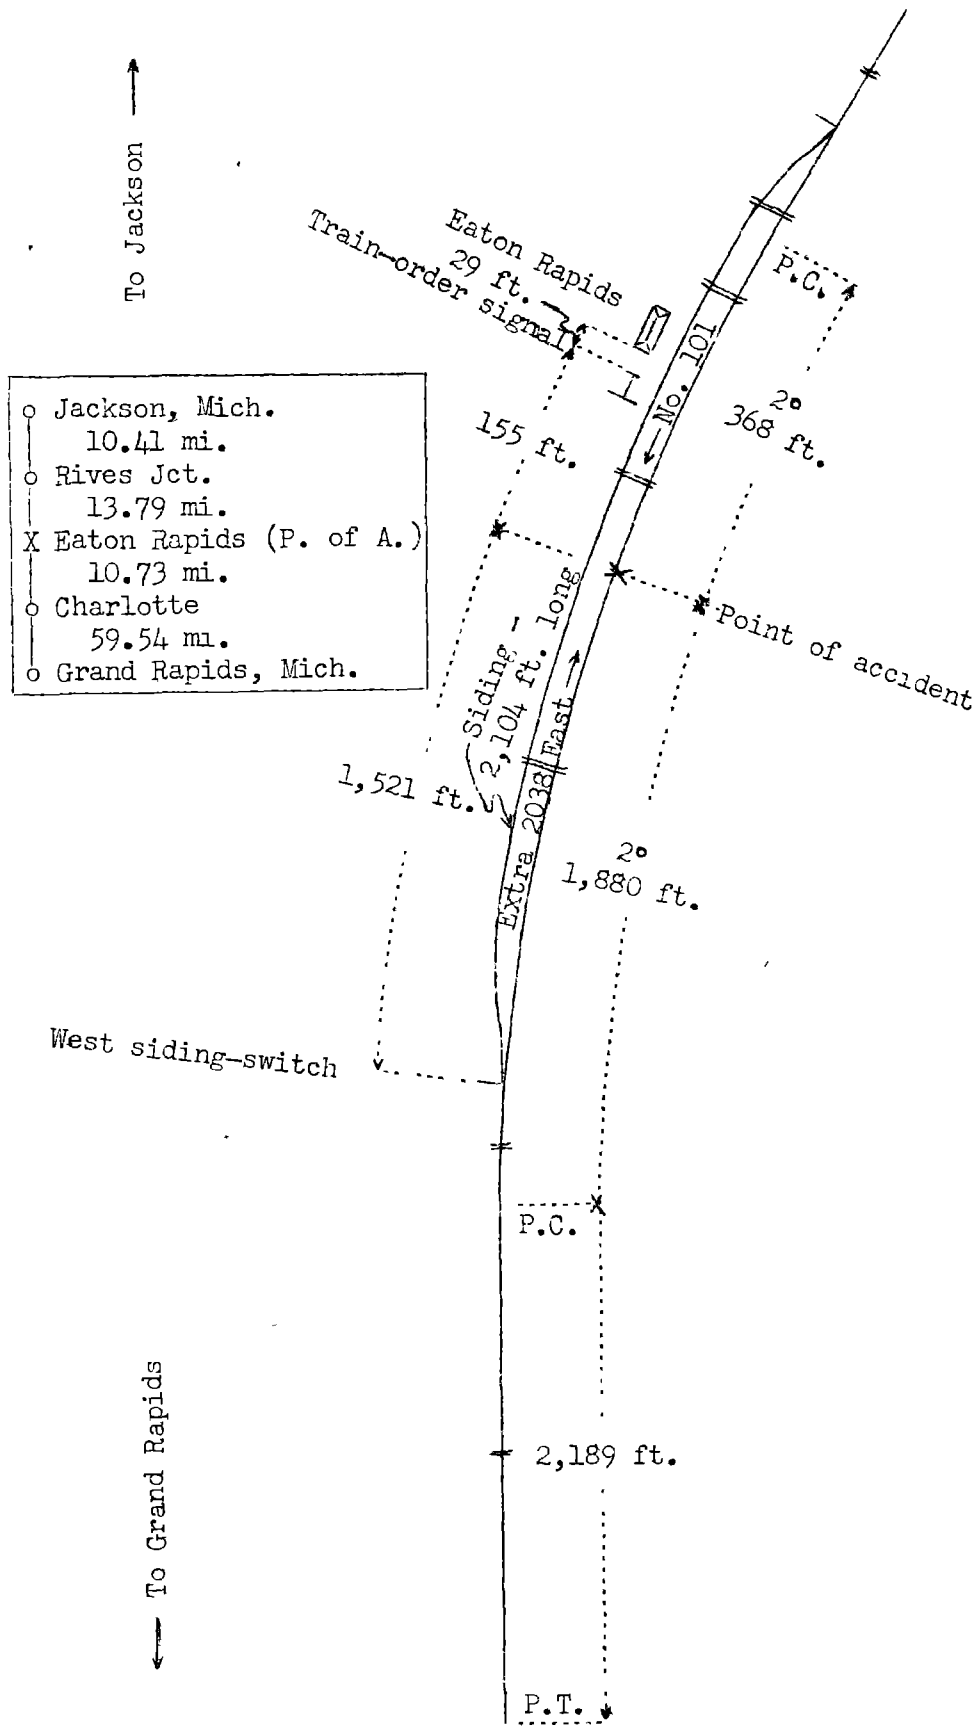
| o | Jackson, Mich. | 10.41 mi. |
| o | Rives Jct. | 13.79 mi. |
| X | Eaton Rapids (P. of A.) | 10.73 mi. |
| o | Charlotte | 59.54 mi. |
| o | Grand Rapids, Mich. | |

Location of Accident and Method of Operation

This accident occurred on that part of the Michigan Division extending westward from Jackson to Grand Rapids, Mich., 94.47 miles, a single-track line in the vicinity of the point of accident over which trains are operated by timetable, train orders and a manual-block system. At Eaton Rapids, 24.2 miles west of Jackson, a siding 2,104 feet long parallels the main track on the north. The west switch of this siding is 1,705 feet west of the station. The accident occurred on the main track 1,521 feet east of the west siding-switch. From the west there is a tangent 2,189 feet in length, which is followed by a 2° curve to the right 1,880 feet to the point of accident and 368 feet eastward. The grade for east-bound trains is, successively, 0.22 percent descending 400 feet, 0.02 percent ascending 1,000 feet, 0.02 percent descending 700 feet, 0.34 percent ascending 1,500 feet and 0.32 percent ascending 657 feet to the point of accident and 343 feet eastward.
