REPORT OF THE DIRECTOR  
BUREAU OF SAFETY

ACCIDENT ON THE  
MICHIGAN CENTRAL RAILROAD

MONROE, MICH.

INVESTIGATION NO. 2251

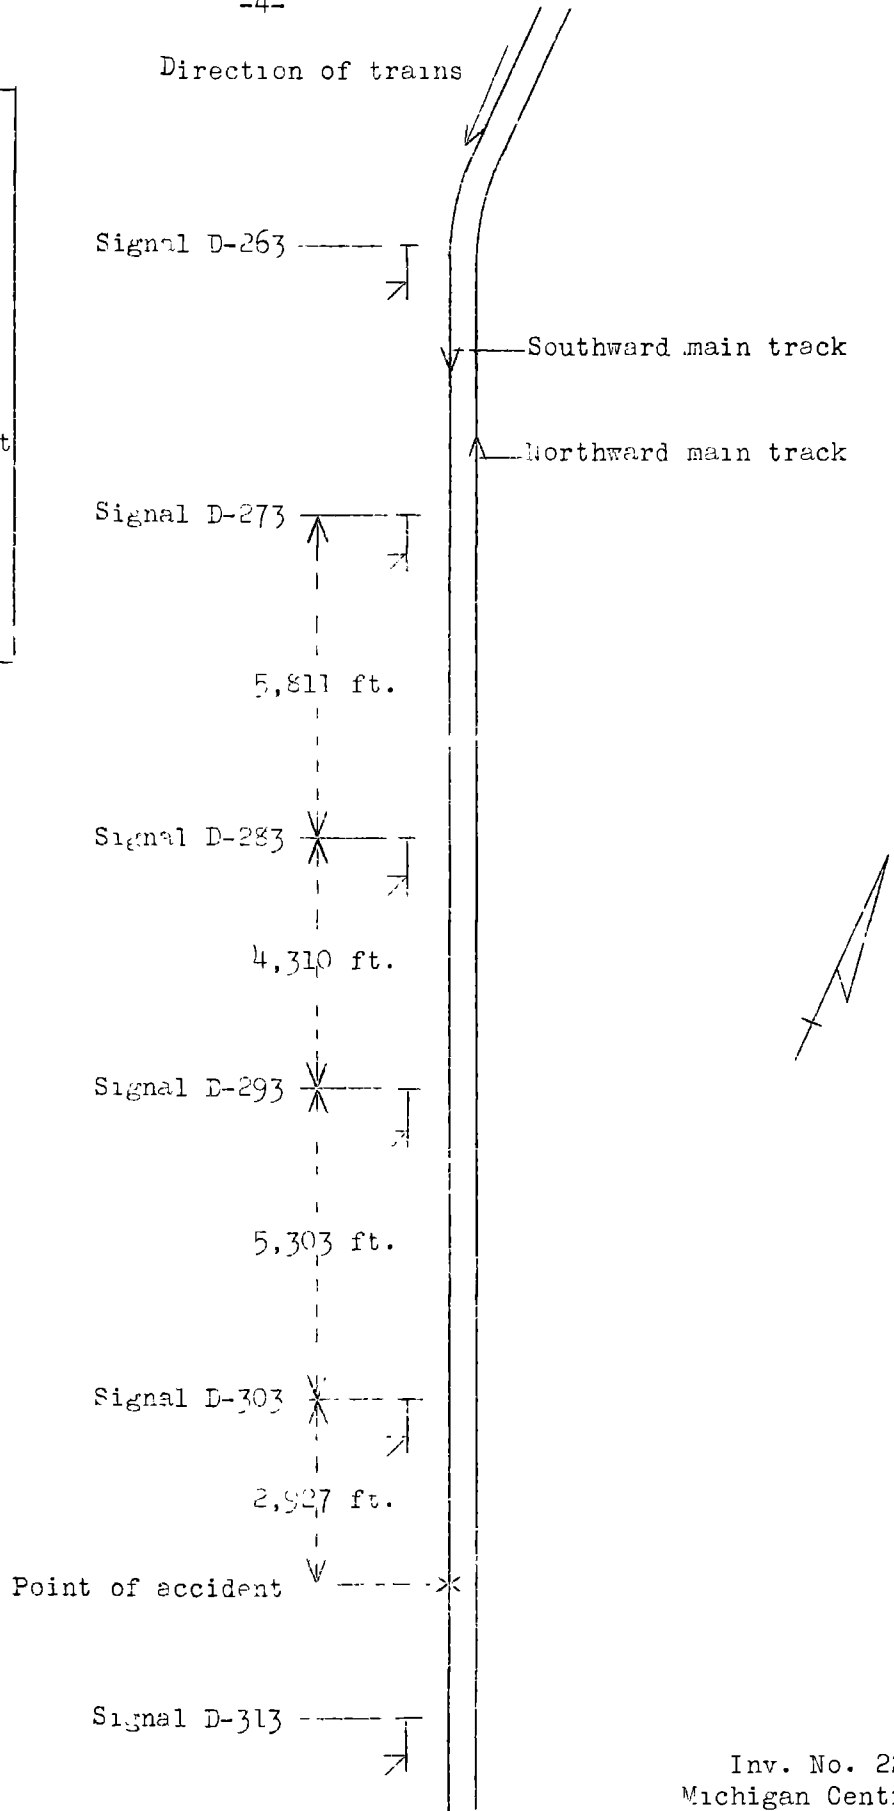
Inv. No. 2251  
 Michigan Central RR  
 Monroe, Mich.  
 Feb. 13, 1938

Direction of trains

o	Detroit, Mich.
	14.66 mi.
o	Trenton
	6.16 mi.
o	Rockwood
	5.62 mi.
o	Newport
	3.35 mi.
X	Point of accident
	4.03 mi.
o	Monroe
	23.75 mi.
o	Toledo, Ohio

This accident occurred on that part of the Detroit Division which extends between Detroit, Mich., and Toledo, Ohio, a distance of 57.57 miles. In the vicinity of the point of accident this is a double-track line over which trains are operated by timetable, train orders, and an automatic block-signal system supplemented by automatic train-stop devices of the intermittent-inductive type. The accident occurred on the southward main track at a point approximately 4 miles north of the station at Monroe. Approaching this point from the north the track is tangent for a distance of more than 5 miles to the point of accident, and for several miles beyond. The grade is practically level.
