INVESTIGATION NO. 2855  
THE MICHIGAN CENTRAL RAILROAD COMPANY  
REPORT IN RE ACCIDENT  
AT SIBLEY, MICH., ON  
DECEMBER 28, 1944

Railroad: Michigan Central  
Date: December 28, 1944  
Location: Sibley, Mich.  
Kind of accident: Collision  
Equipment involved: Passenger train : Automobile  
Train number: 228 :  
Engine number: 4691 :  
Consist: 6 cars :  
Estimated speed: 65 m. p. h. : Standing  
Operation: Automatic block and train-stop systems  
Track: Double; tangent; practically level  
Highway: Tangent; crosses track at right angles; level  
Weather: Foggy  
Time: About 11:37 p. m.  
Casualties: 2 killed; 25 injured  
Cause: Automobile becoming stalled on highway grade crossing

Accident at Sibley, Mich., on December 28, 1944, caused  
by an automobile becoming stalled on a highway  
grade crossing.

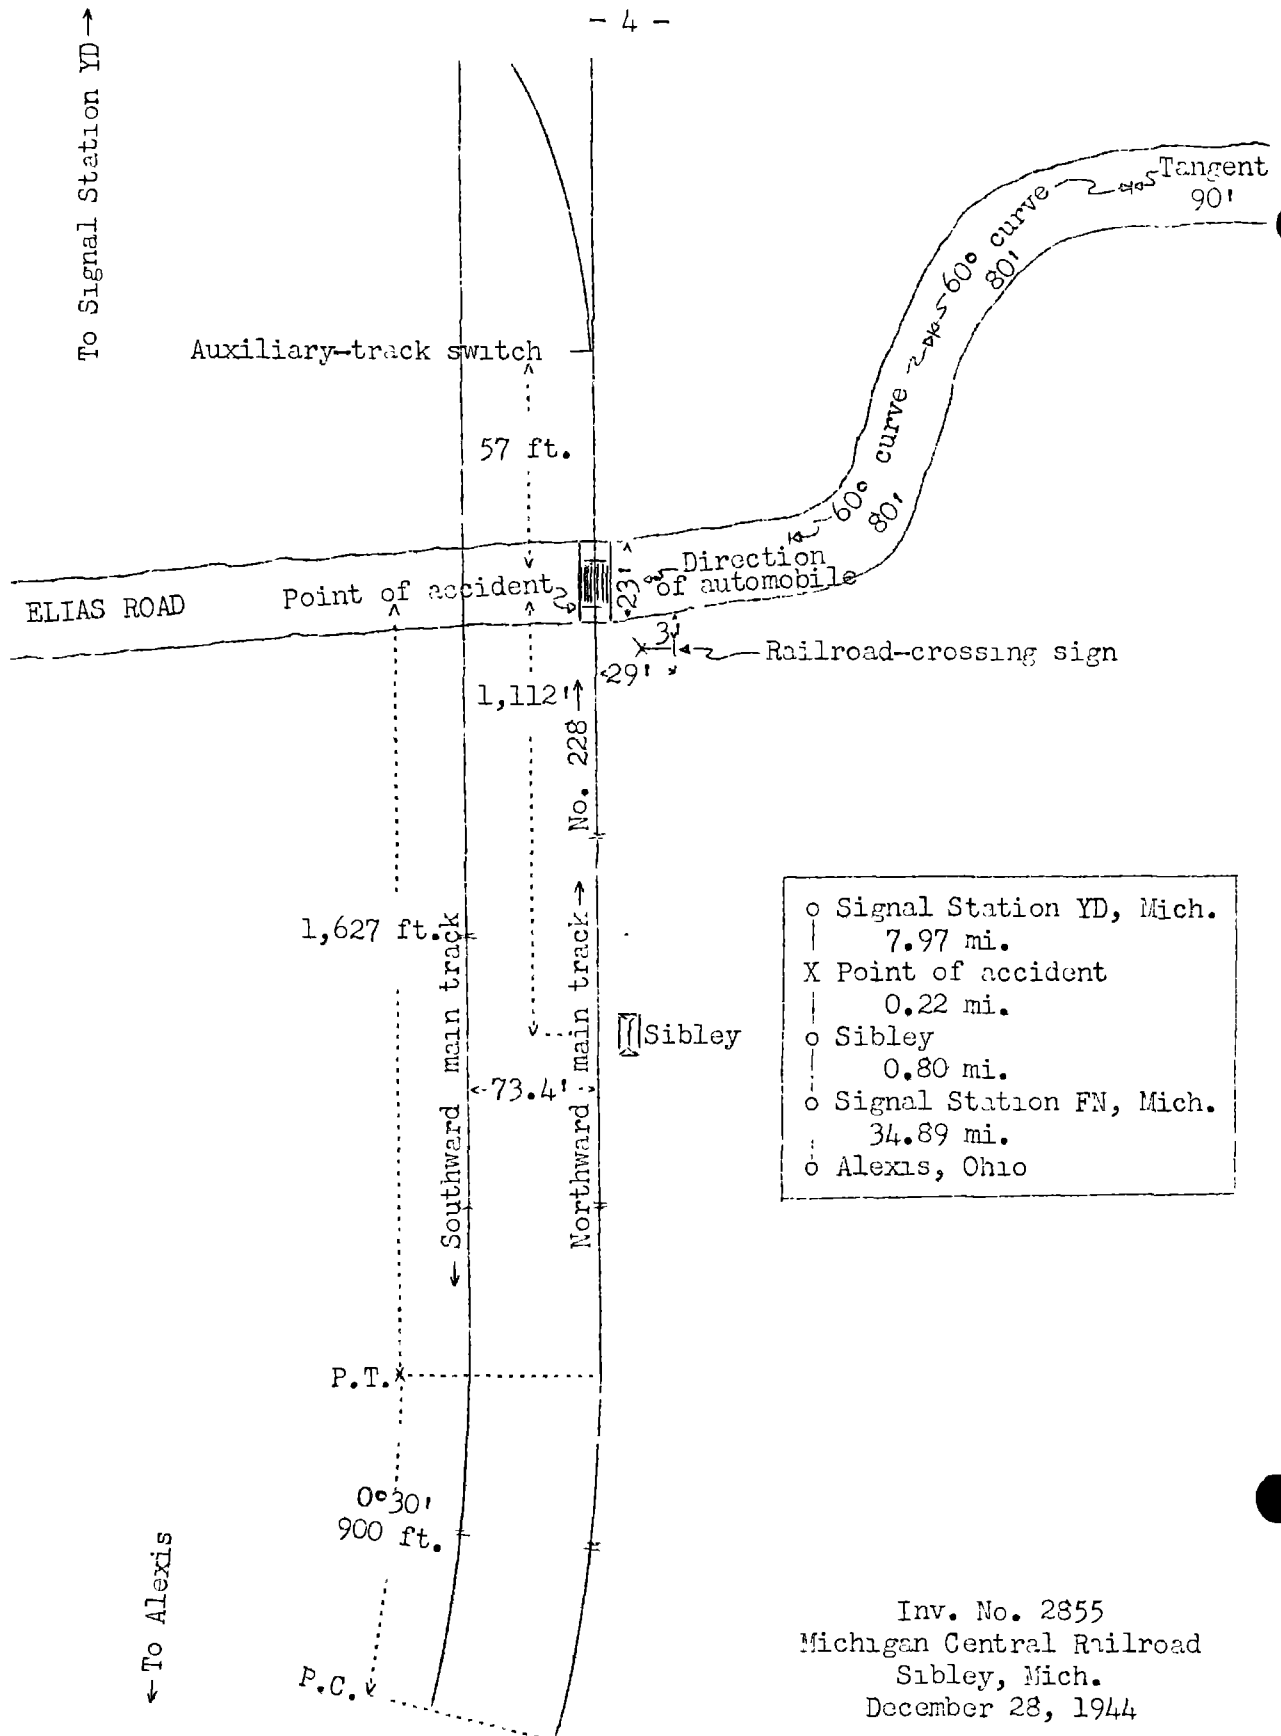
Inv. No. 2855  
 Michigan Central Railroad  
 Sibley, Mich.  
 December 28, 1944

- o Signal Station YD, Mich. 7.97 mi.
- X Point of accident 0.22 mi.
- o Sibley 0.80 mi.
- o Signal Station FN, Mich. 34.89 mi.
- o Alexis, Ohio

Location of Accident and Method of Operation
