INTERSTATE COMMERCE COMMISSION
WASHINGTON

REPORT OF THE DIRECTOR
BUREAU OF SAFETY

ACCIDENT ON THE
MINNEAPOLIS & ST. LOUIS RAILROAD

MORNING SUN, IOWA

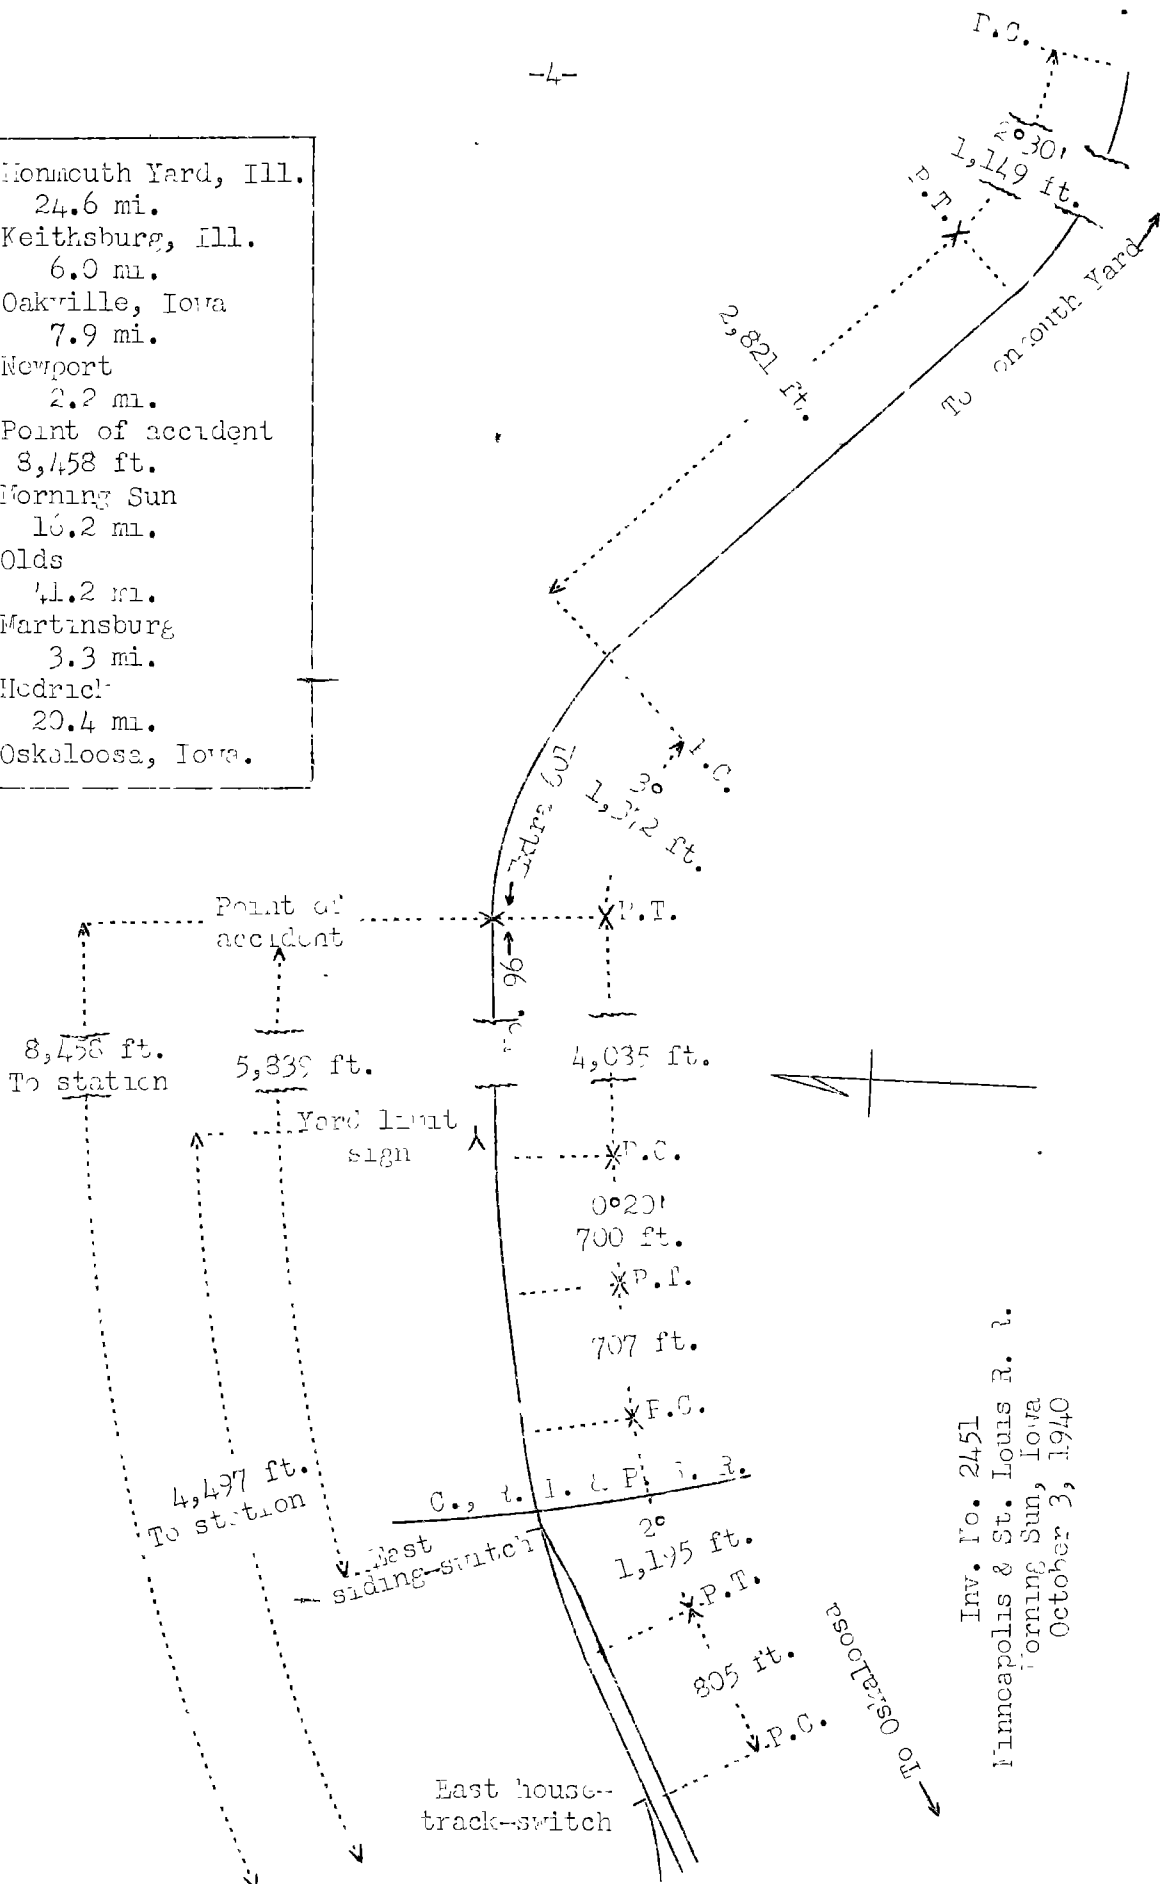
Inv. No. 2451
 Minneapolis & St. Louis R. R.
 Morning Sun, Iowa
 October 3, 1940

○	Monmouth Yard, Ill.	24.6 mi.
○	Keithsburg, Ill.	6.0 mi.
○	Oakville, Iowa	7.9 mi.
○	Newport	2.2 mi.
X	Point of accident	3,458 ft.
○	Morning Sun	16.2 mi.
○	Olds	41.2 mi.
○	Martinsburg	3.3 mi.
○	Hedrick	20.4 mi.
○	Oskaloosa, Iowa.

This accident occurred on that part of the railroad designated as the Eleventh District which extends between Oskaloosa, Iowa, and Monmouth Yard, Ill., a distance of 123.4 miles. In the vicinity of the point of accident this is a single-track line over which trains are operated by timetable and train orders; there is no block system in use. At Morning Sun a siding 3,357 feet in length parallels the main track on the south. The accident occurred at a point 5,339 feet east of the east switch of the siding, and 3,458 feet east of the station. As the point of accident is approached from the east, there are, in succession, a 2°30' curve to the right 1,149 feet in length, a tangent 2,821 feet in length, and a 3° curve to the left 1,372 feet in length; the accident occurred at the west end of the latter curve. As the point of accident is approached from the west, there are, in succession, a tangent 805 feet in length, a 2° curve to the right 1,195 feet in length, a tangent 707 feet in length, a 0°20' curve to the right 700 feet in length, and a tangent 4,085 feet in length; the accident occurred at the east end of the last-mentioned tangent. At the point of accident the grade for west-bound trains is 1 percent ascending.

The east yard-limit board at Morning Sun is located 4,497 feet east of the depot. Oakville is located 11.7 miles east of Morning Sun. There is no siding between these points.
