INVESTIGATION NO. 2692
THE MINNEAPOLIS & ST. LOUIS RAILROAD COMPANY
REPORT IN RE ACCIDENT
NEAR ST. LOUIS PARK, MINN., ON
APRIL 11, 1943

Accident near St. Louis Park, Minn., on April 11, 1943,
caused by failure of the preceding train to clear
the time of a following superior train and then by
failure to provide adequate flag protection.

Inv. No. 2692
 Minneapolis & St. Louis Railroad
 St. Louis Park, Minn.
 April 11, 1943

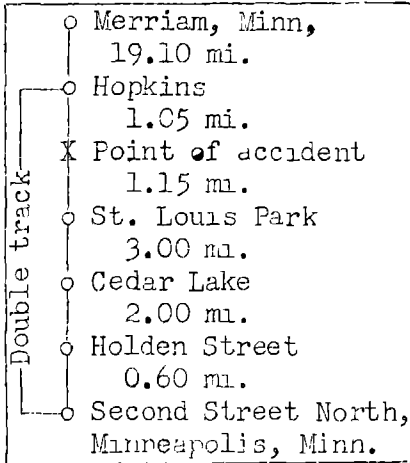
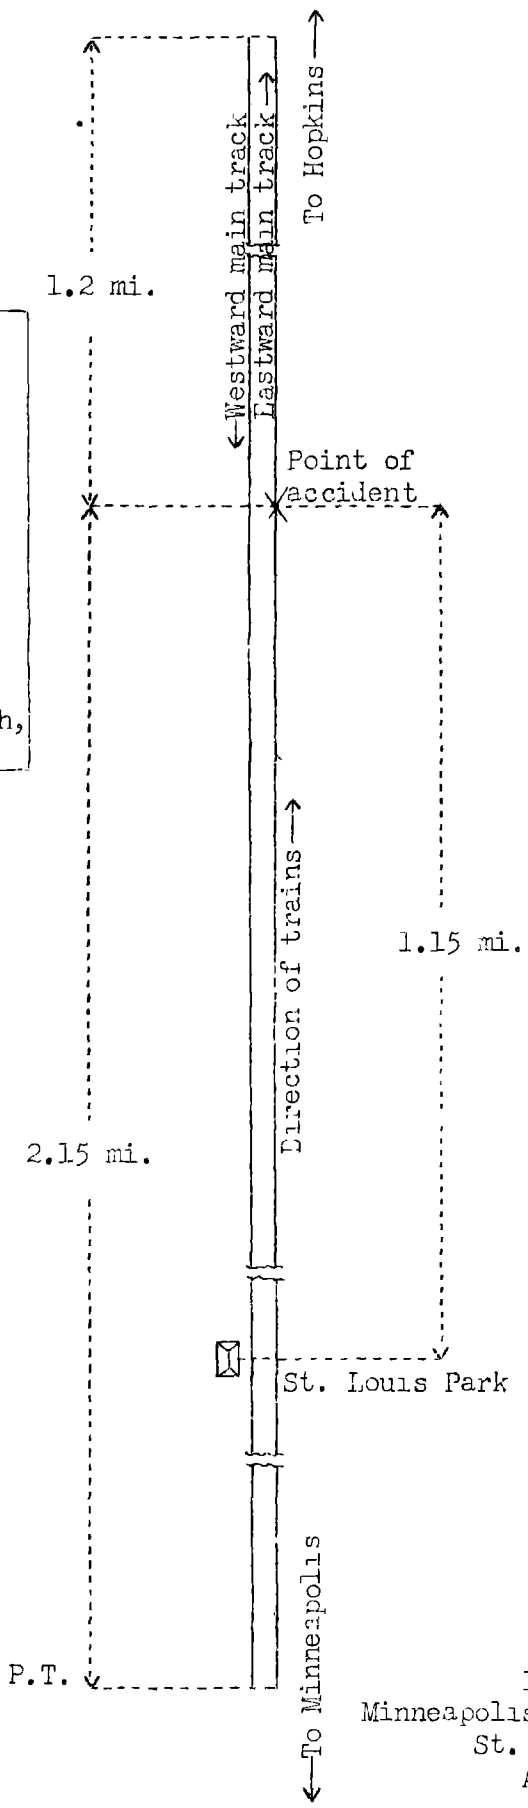
Location of Accident and Method of Operation

Trains of the Chicago, St. Paul, Minneapolis & Omaha Railway, hereinafter referred to as the C. St. P. M. & O., are operated over the Minneapolis & St. Louis Railroad, hereinafter referred to as the M. & St. L., between Holden Street, Minneapolis, and Merriam, Minn., 26.3 miles. This accident occurred on that part of the First District extending between Second Street North, Minneapolis, and Hopkins, Minn., 7.8 miles. This is a double-track line, within yard limits, over which trains moving with the current of traffic are operated by timetable and operating rules. There is no block system in use and there are no sidings between Minneapolis and Hopkins. The accident occurred on the eastward main track 6.75 miles east of Second Street North, Minneapolis, and 1.15 miles east of the station at St. Louis Park. Approaching from the west the track is tangent 2.15 miles to the point of accident and 1.2 miles beyond. In the vicinity of the point of accident the grade for east-bound trains is 0.12 percent ascending.
