REPORT NO. 3344
MINNEAPOLIS, ST. PAUL & SAULT STE. MARIE
RAILROAD COMPANY
IN RE ACCIDENT
AT PAYNESVILLE, MINN., ON
JULY 13, 1950

Accident at Paynesville, Minn., on July 13, 1950, caused by
failure to make proper delivery of a train order.

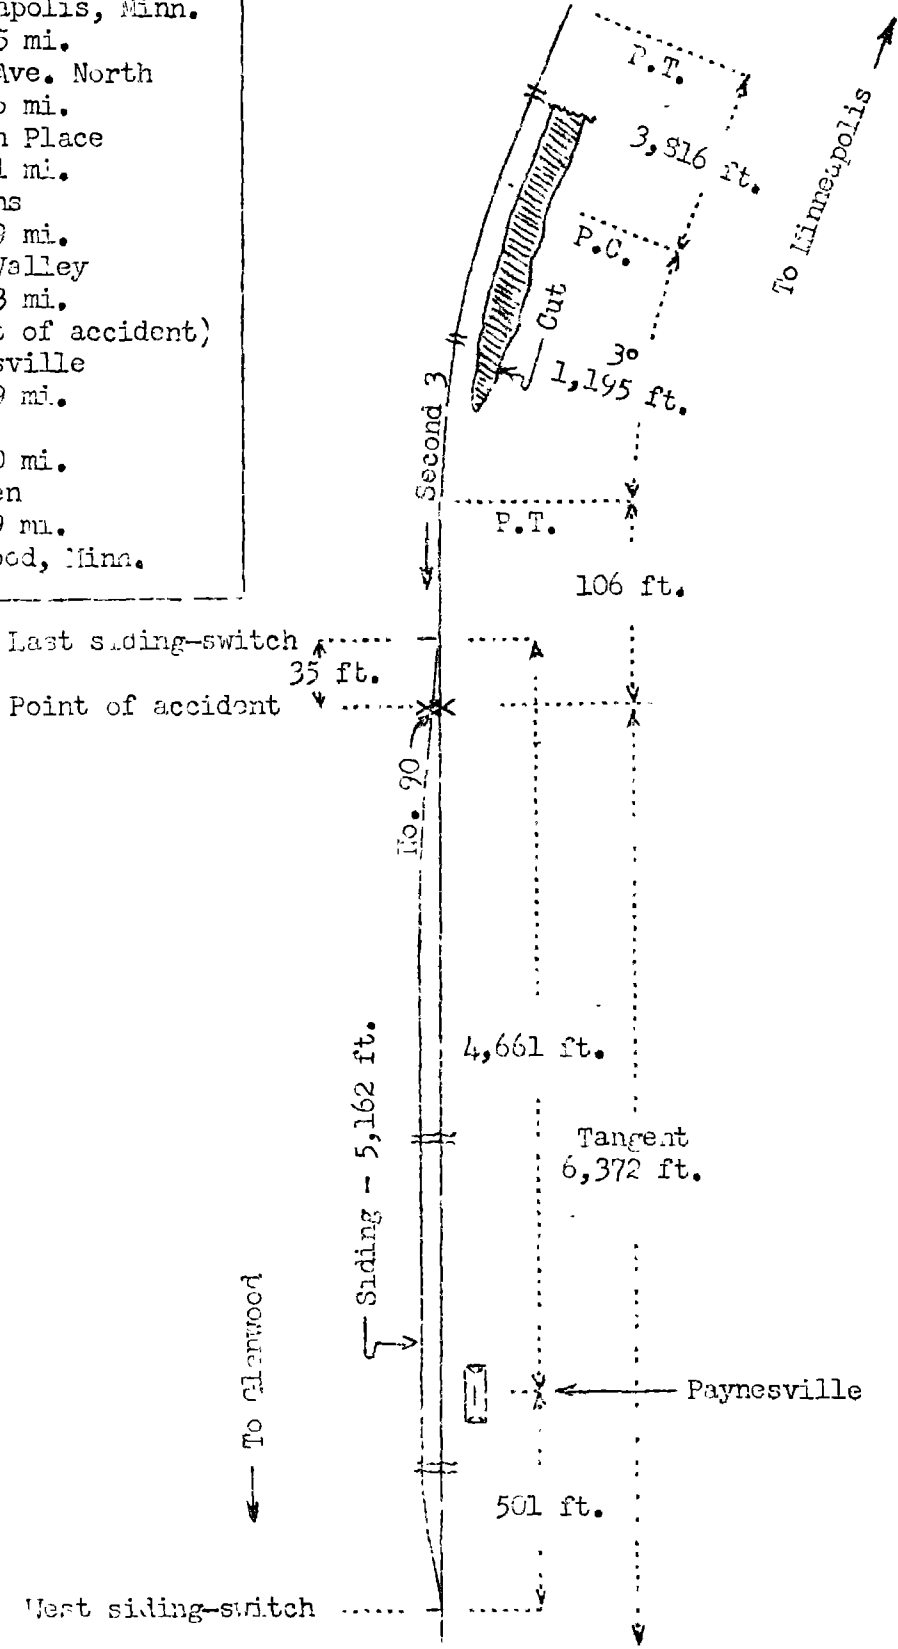
Report No. 3344
 Minneapolis, St. Paul & Sault Ste. Marie Railroad
 Paynesville, Minn.
 July 13, 1950

- Minneapolis, Minn.
- | 1.5 mi.
- 14th Ave. North
- | 1.6 mi.
- Camden Place
- | 63.1 mi.
- Watkins
- | 6.9 mi.
- Eden Valley
- | 9.3 mi.
- X (Point of accident)
- | Paynesville
- | 6.9 mi.
- Regal
- | 15.0 mi.
- Proton
- | 15.9 mi.
- Glenwood, Minn.
