INTERSTATE COMMERCE COMMISSION  
WASHINGTON

REPORT NO. 3360  
MINNEAPOLIS, ST. PAUL & SAULT STE. MARIE  
RAILROAD COMPANY  
IN RE ACCIDENT  
AT PHILLIPS, WIS., ON  
AUGUST 31, 1950

Accident at Phillips, Wis., on August 31, 1950, caused by failure to provide protection for a train advanced to the meeting point where the opposing train was to receive the meet order.

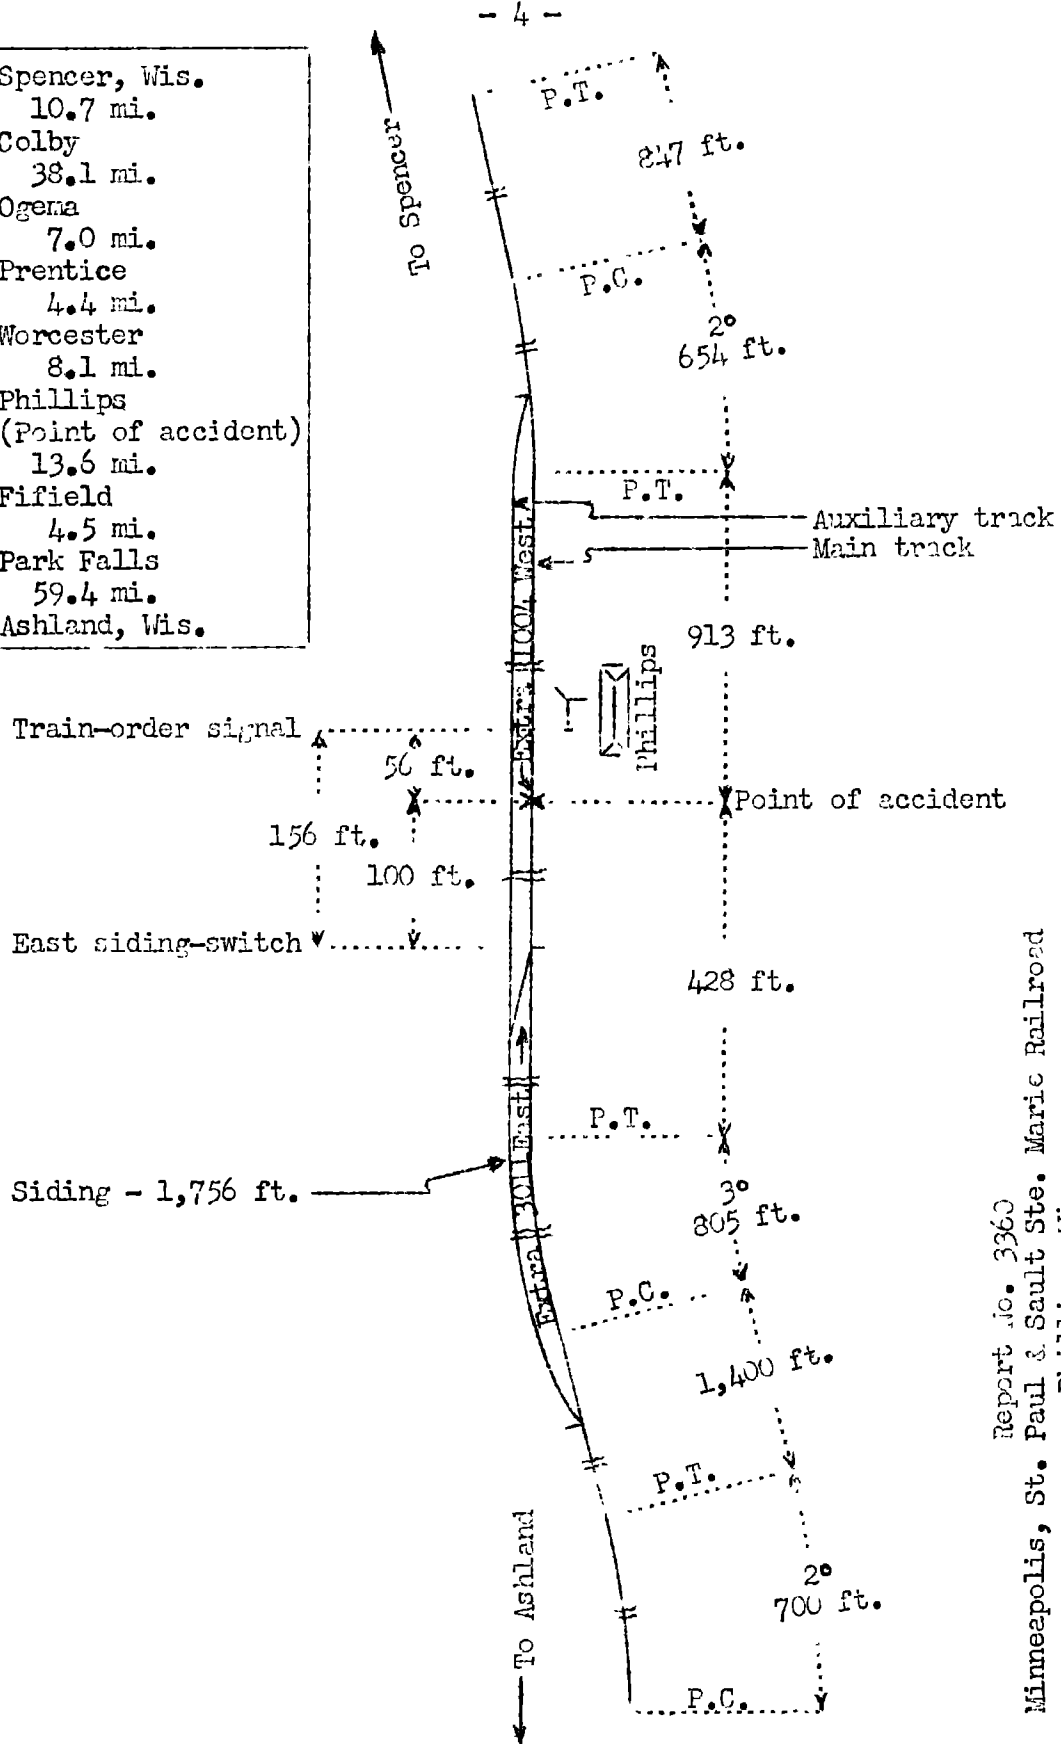
Report No. 3360  
 Minneapolis, St. Paul & Sault Ste. Marie Railroad  
 Phillips, Wis.  
 August 31, 1950

- o Spencer, Wis. | 10.7 mi.
- o Colby | 38.1 mi.
- o Ogema | 7.0 mi.
- o Prentice | 4.4 mi.
- o Worcester | 8.1 mi.
- X Phillips (Point of accident) | 13.6 mi.
- o Fifield | 4.5 mi.
- o Park Falls | 59.4 mi.
- o Ashland, Wis.
