INVESTIGATION NO. 2460

THE MINNEAPOLIS, ST. PAUL & SAULT STE. MARIE  
RAILWAY COMPANY

REPORT IN RE ACCIDENT

AT WATKINS, MINN., ON

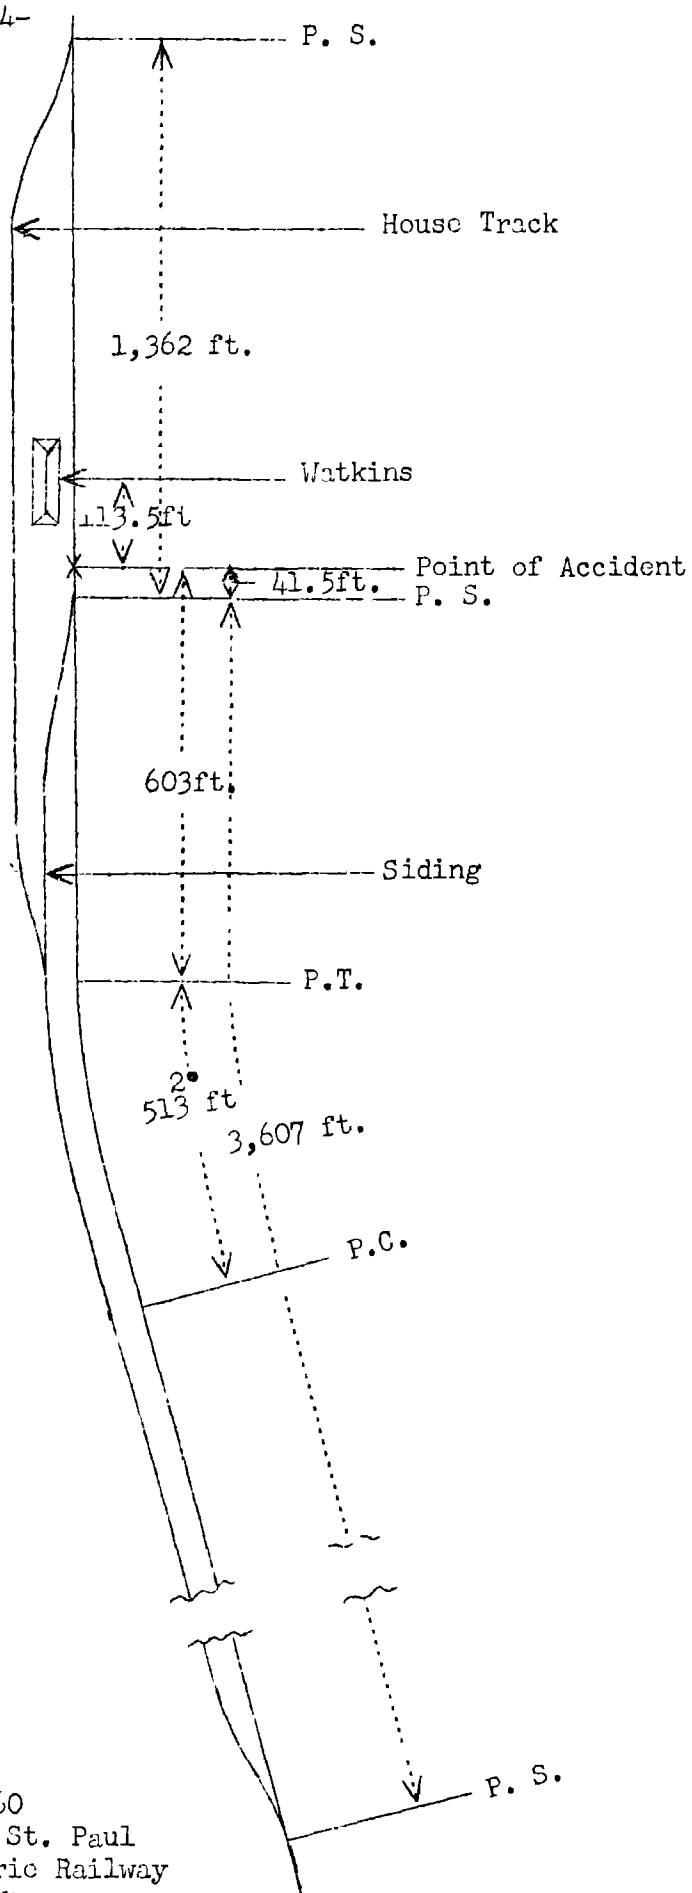
Inv-2460  
 Minneapolis, St. Paul  
 & Sault Ste. Marie Railway  
 Watkins, Minn.  
 November 11, 1940

○	Minneapolis, Minn.
○	15th Avenue North
	1.6 mi.
○	Camden Place
	18.2 mi.
○	Loretto
	34.3 mi.
○	South Haven
	5.2 mi.
○	Kimball
	5.4 mi.
✗	Watkins
✗	Point of Accident
	6.9 mi.
○	Eden Valley
	9.3 mi.
○	Paynesville
	37.8 mi.
○	Glenwood, Minn.
