INVESTIGATION NO. 2503  
THE MISSOURI PACIFIC RAILROAD COMPANY  
AND  
THE KANSAS CITY SOUTHERN RAILWAY COMPANY  
REPORT IN RE ACCIDENT  
NEAR FULLER, KANS., ON  
MAY 10, 1941

Accident near Fuller, Kans., on May 10, 1941, caused by  
failure properly to control speed of K.C.S. train in com-  
pliance with interlocking signal indications.

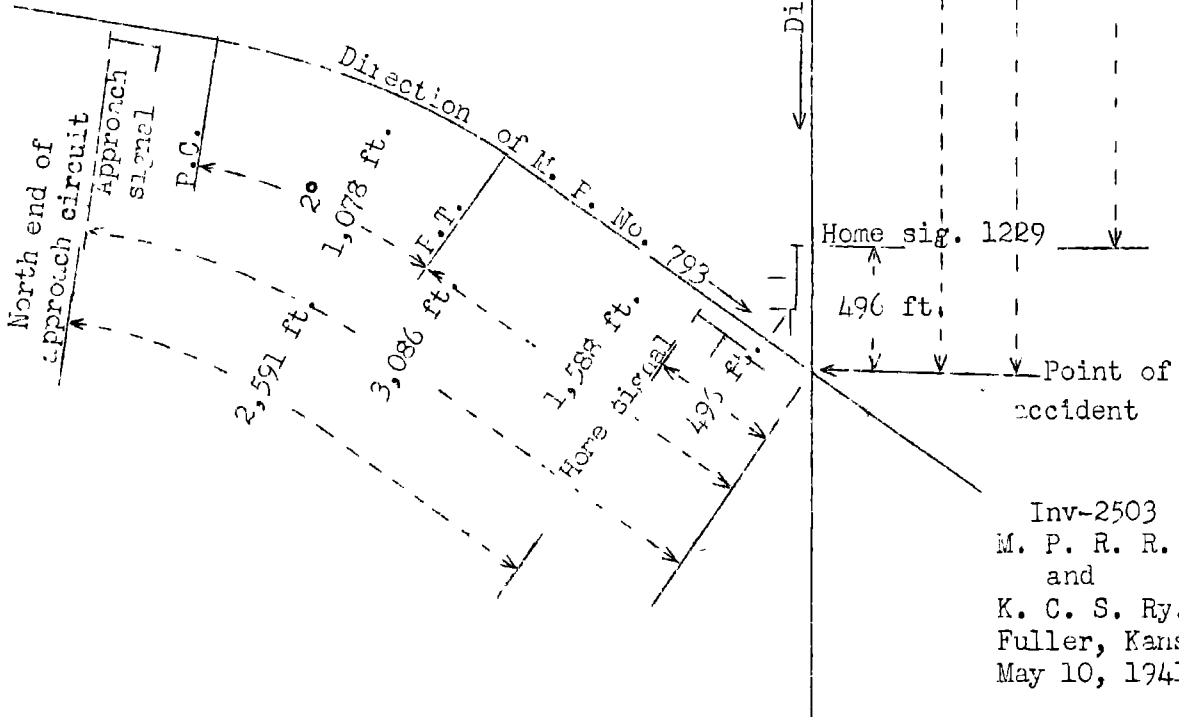
Inv-2503  
 M. P. R. R.  
 and  
 K. C. S. Ry.  
 Fuller, Kans.  
 May 10, 1941

- K. C. S. Ry.
- o Kansas City, Mo. 5.3 mi.
  - o Air Line Jct., Mo. 112.9 mi.
  - o Mulberry 2.5 mi.
  - o Fuller, Kans. 2.3 mi.
  - X Mo. Pac. Crossing (Point of accident) 6.3 mi.
  - o Pittsburg, Kans.

- M. P. R. R.
- o Ft. Scott, Kans. 0.16 mi.
  - o Joplin Div. Jct. 22.57 mi.
  - o Arma 4.69 mi.
  - X K. C. S. Crossing (Point of accident) 2.27 mi.
  - o Cornell Jct., Kans.
