REPORT OF THE DIRECTOR
BUREAU OF SAFETY

ACCIDENT ON THE
MISSOURI PACIFIC RAILROAD

GALE, ILL.

INVESTIGATION NO. 2203

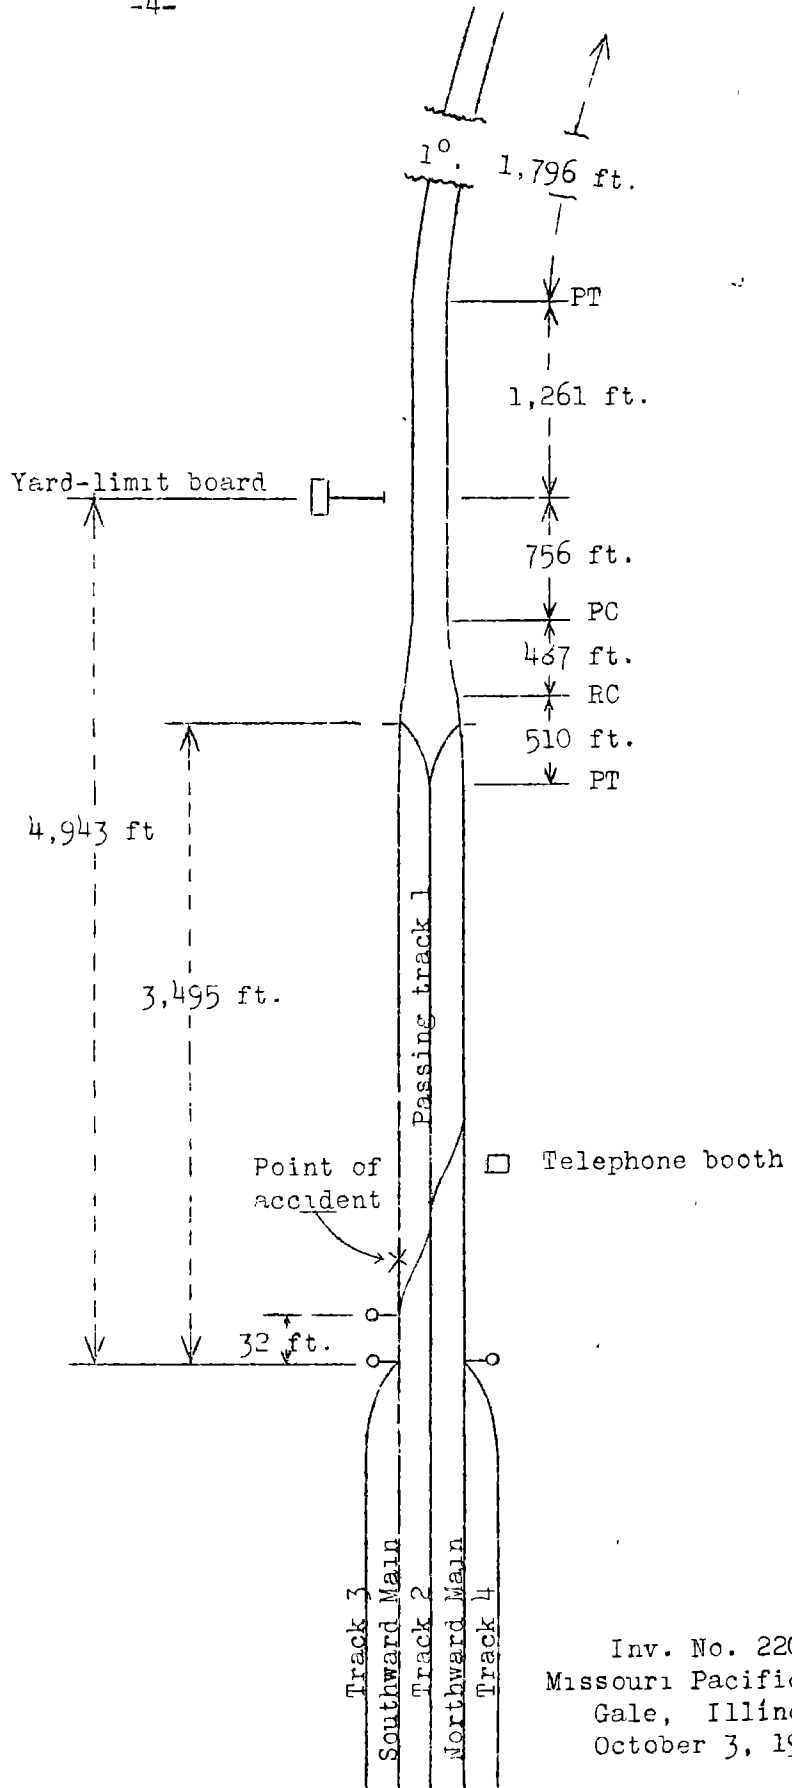
Inv. No. 2203
Missouri Pacific R.R.
Gale, Illinois
October 3, 1937

o	Valley Jct., Ill.
	91.17 mi.
o	Halsey
	22.2 mi.
o	McClure
	4.16 mi.
X	Point of accident
o	Gale
	1.8 mi
o	North Jct., Ill.

The point of collision is located 4,843 feet south of the north yard-limit board at Gale. In the vicinity of this station there are five tracks, designated from west to east as track 3, southward main, track 2, northward main, and track 4. The north ends of tracks 3 and 4 merge with the southward and northward mains, respectively, at a point approximately 4,950 feet south of the north yard-limit board. From a point 32 feet north of the switch which connects track 3 with the southward main two continuous cross-overs, directed from southwest to northeast, connect the southward main with the middle track and the northward main. The middle track, which is a continuation of track 2 and is called Passing Track 1 north of the cross-over switches, extends northward about 3,200 feet and by means of facing-point turnouts connects with both main tracks. The main line switches at the north end of track 3 and the south end of the cross-overs described above are equipped with lamps which display green when the route is set for the main track, and red when the route is lined against the main track. The lamp on the switch at the north end of track 3 is 7 feet 6 inches above the cross tie while that on the switch at the south end of the cross-over is 6 feet 5 inches above the cross tie.

Approaching the point of accident from the north there is a 1° curve to the left 1,796 feet long followed by a tangent 2,017 feet long, then a 30' curve to the right 487 feet long, a 30' curve to the left 510 feet long and a tangent which extends 3,090 feet to the point of accident and some distance beyond. In this vicinity the track is level.
