ACCIDENT ON THE  
MISSOURI PACIFIC RAILROAD

LONE TREE, MO.

JANUARY 4, 1936

INVESTIGATION NO. 2030

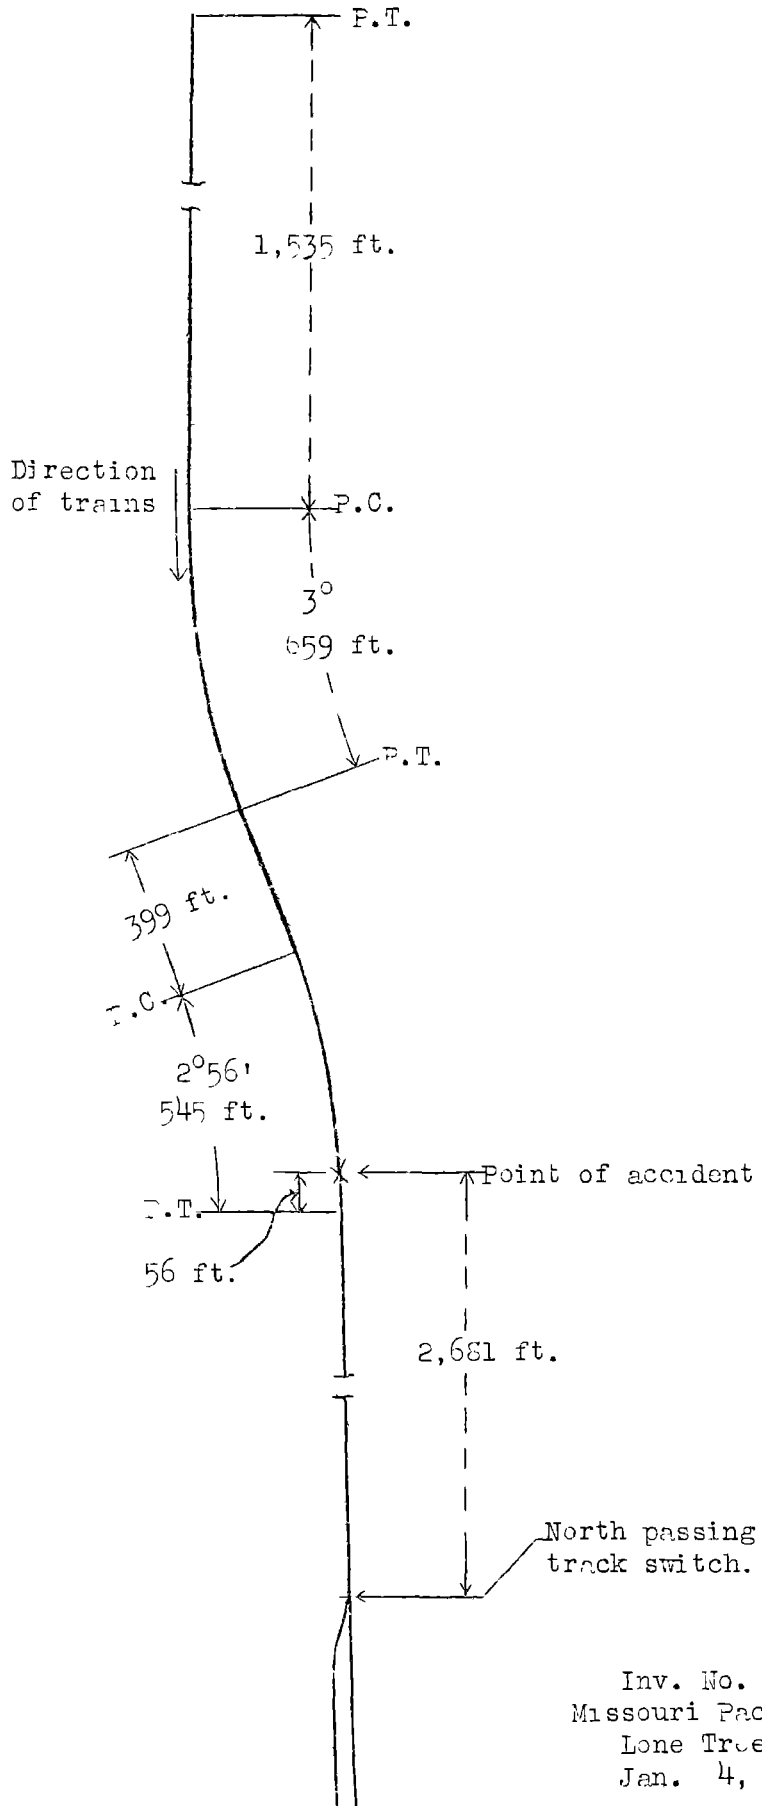
Inv. No. 2030  
 Missouri Pacific R.R.  
 Lone Tree, Mo.  
 Jan. 4, 1936

•Fleasant Hill, Mo.	1.11 mi.
•Gowdy	3.36 mi.
•Ore	3.12 mi.
•Euber	1.97 mi.
•Harrisonville	6.64 mi.
* (Point of accident)	
•Lone Tree	6.29 mi.
•Archie	92.27 mi.
•White River Div. Jc., Mo.

This accident occurred on the Pleasant Hill District of the Joplin Division, which extends between Pleasant Hill and White River Division Junction, Mo., a distance of 114.76 miles; in the vicinity of the point of accident this is a single-track line over which trains are operated by time table and train orders, no block-signal system being in use. The accident occurred at a point 2,681 feet north of the north switch of the passing track at Lone Tree; approaching this point from the north, the track is tangent for a distance of 1,535 feet, followed by a 3° curve to the left 659 feet in length, tangent track for a distance of 399 feet, and then a 2°56' curve to the right 545 feet in length, the accident occurring on this latter curve at a point 56 feet from its southern end. The grade in the vicinity is undulating and at the point of accident is 0.3 percent ascending for south-bound trains.
