INVESTIGATION NO. 2798  
THE MISSOURI PACIFIC RAILROAD COMPANY  
REPORT IN RE ACCIDENT  
AT MARQUAND, MO., ON  
MAY 10, 1944

Accident at Marquand, Mo., on May 10, 1944, caused by  
failure properly to control the speed of the fol-  
lowing train moving within yard limits.

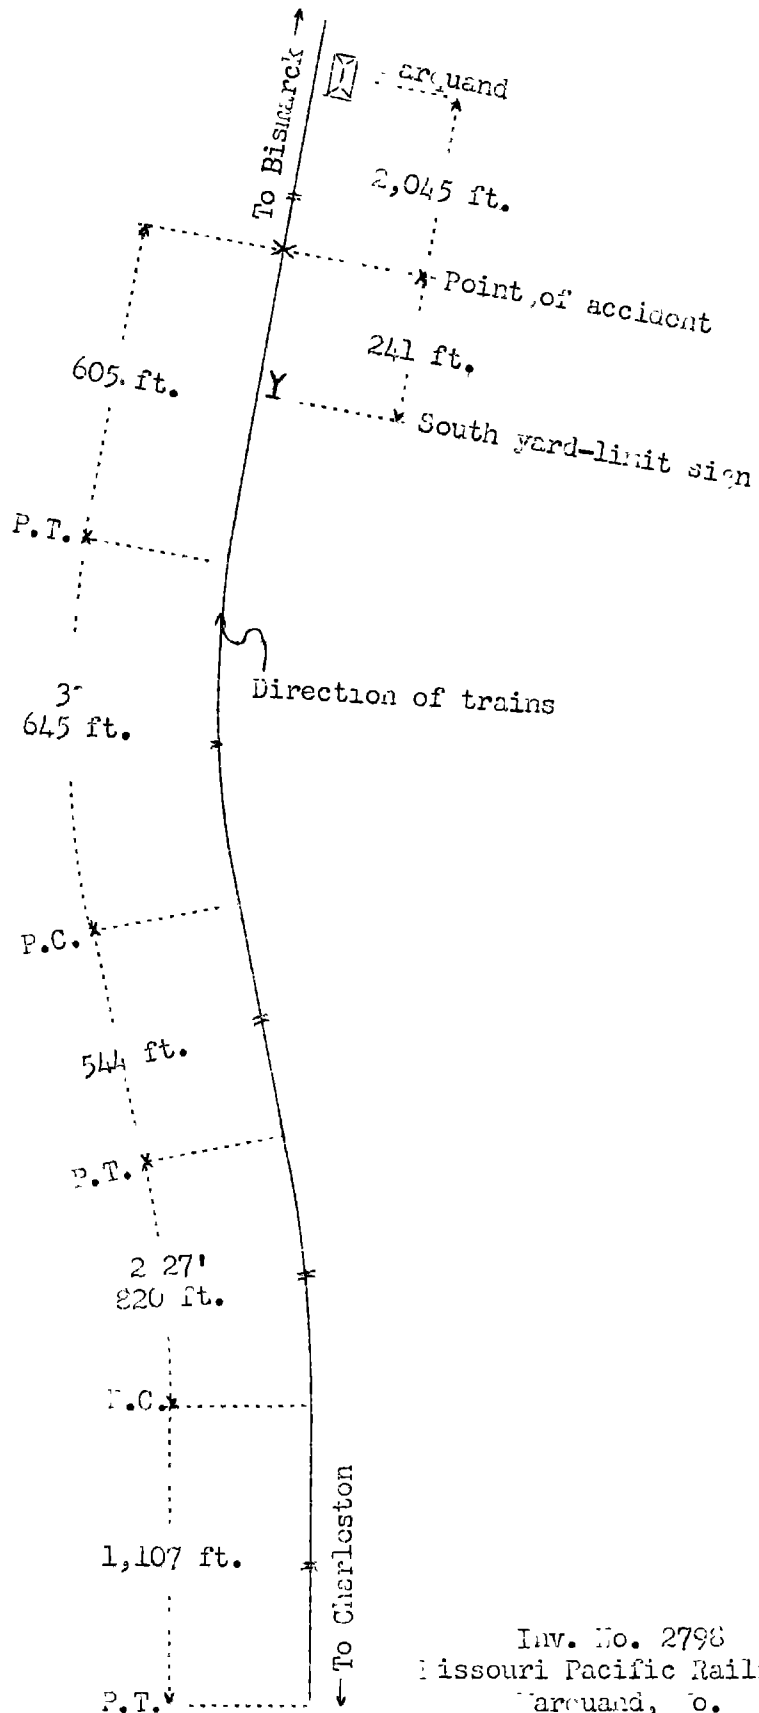
Inv. No. 2798  
 Missouri Pacific Railroad  
 Marquand, Mo.  
 May 10, 1944

o	Bismarck, Mo.
	42.67 mi.
X	Marquand (P. of A.)
	60.26 mi.
o	Charleston, Mo.

Location of Accident and Method of Operation
