INVESTIGATION NO. 2603
THE MISSOURI PACIFIC RAILROAD COMPANY
REPORT IN RE ACCIDENT
NEAR MARSHALL JCT., MO , ON
JULY 17, 1942 ,

Accident near Marshall Jct., Mo., on July 17, 1942, caused
by failure to provide adequate flag protection for
preceding train.

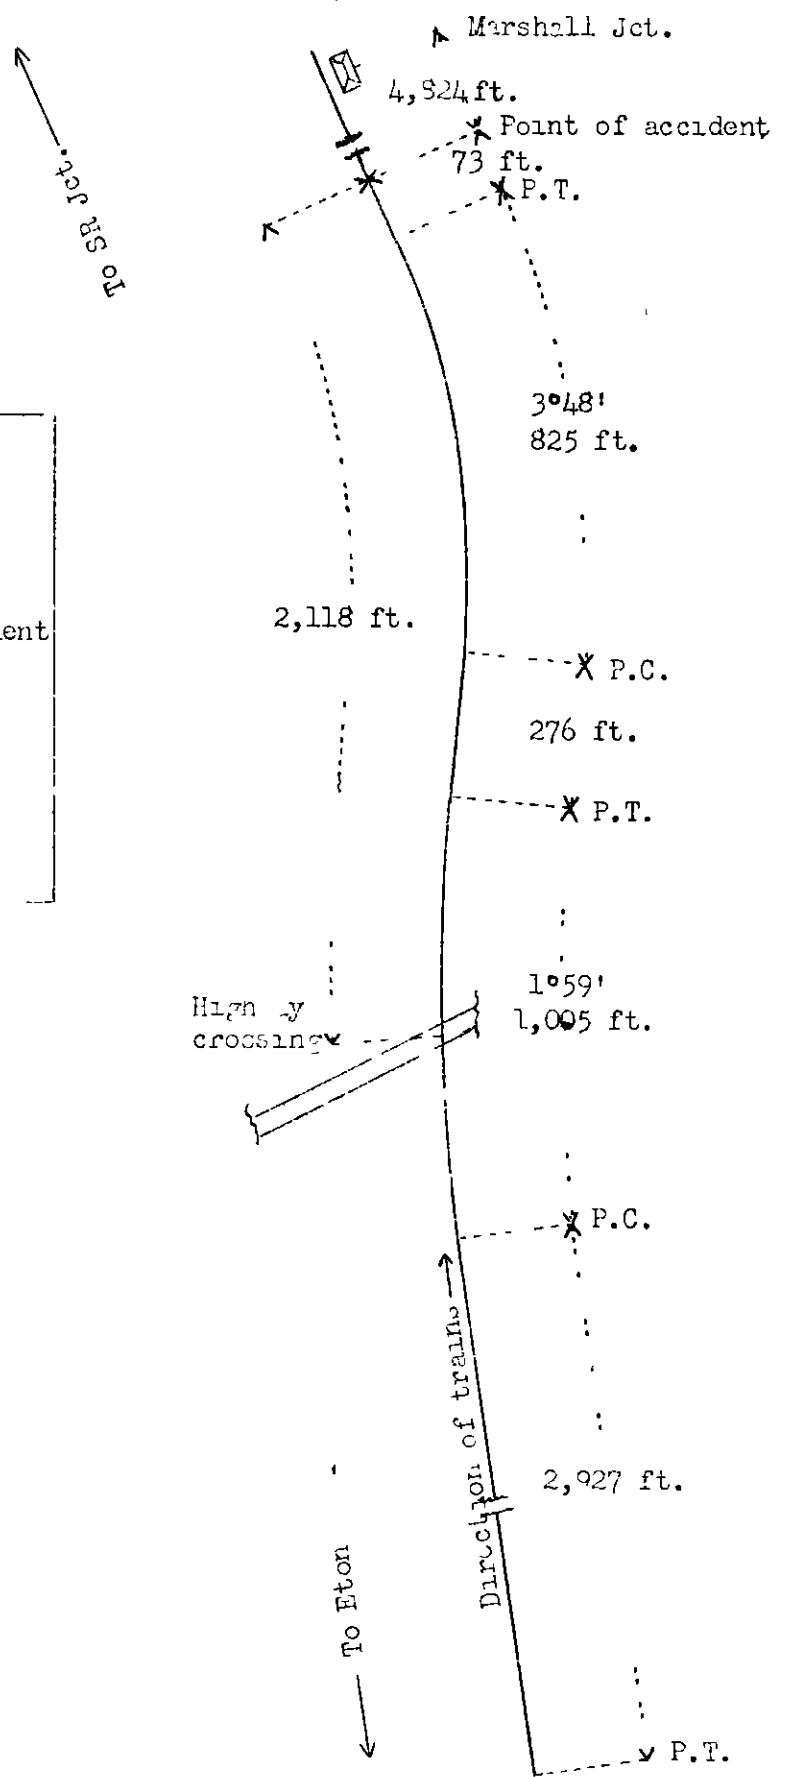
Inv. No. 2603
 Missouri Pacific Railroad
 Marshall Jct., Mo.
 July 17, 1942

○	SR Jct., Mo.	1.43 mi.
○	Cole, Mo.	72.79 mi.
○	Marshall Jct.	0.90 mi.
✕	Point of accident	12.16 mi.
○	Malta Bend	9.34 mi.
○	Waverly	23.06 mi.
○	Myrick	28.60 mi.
○	Eton, Mo.
