ACCIDENT ON THE
MISSOURI PACIFIC RAILROAD

POPLAR BLUFF, MO.

DECEMBER 27, 1937

INVESTIGATION NO. 2240

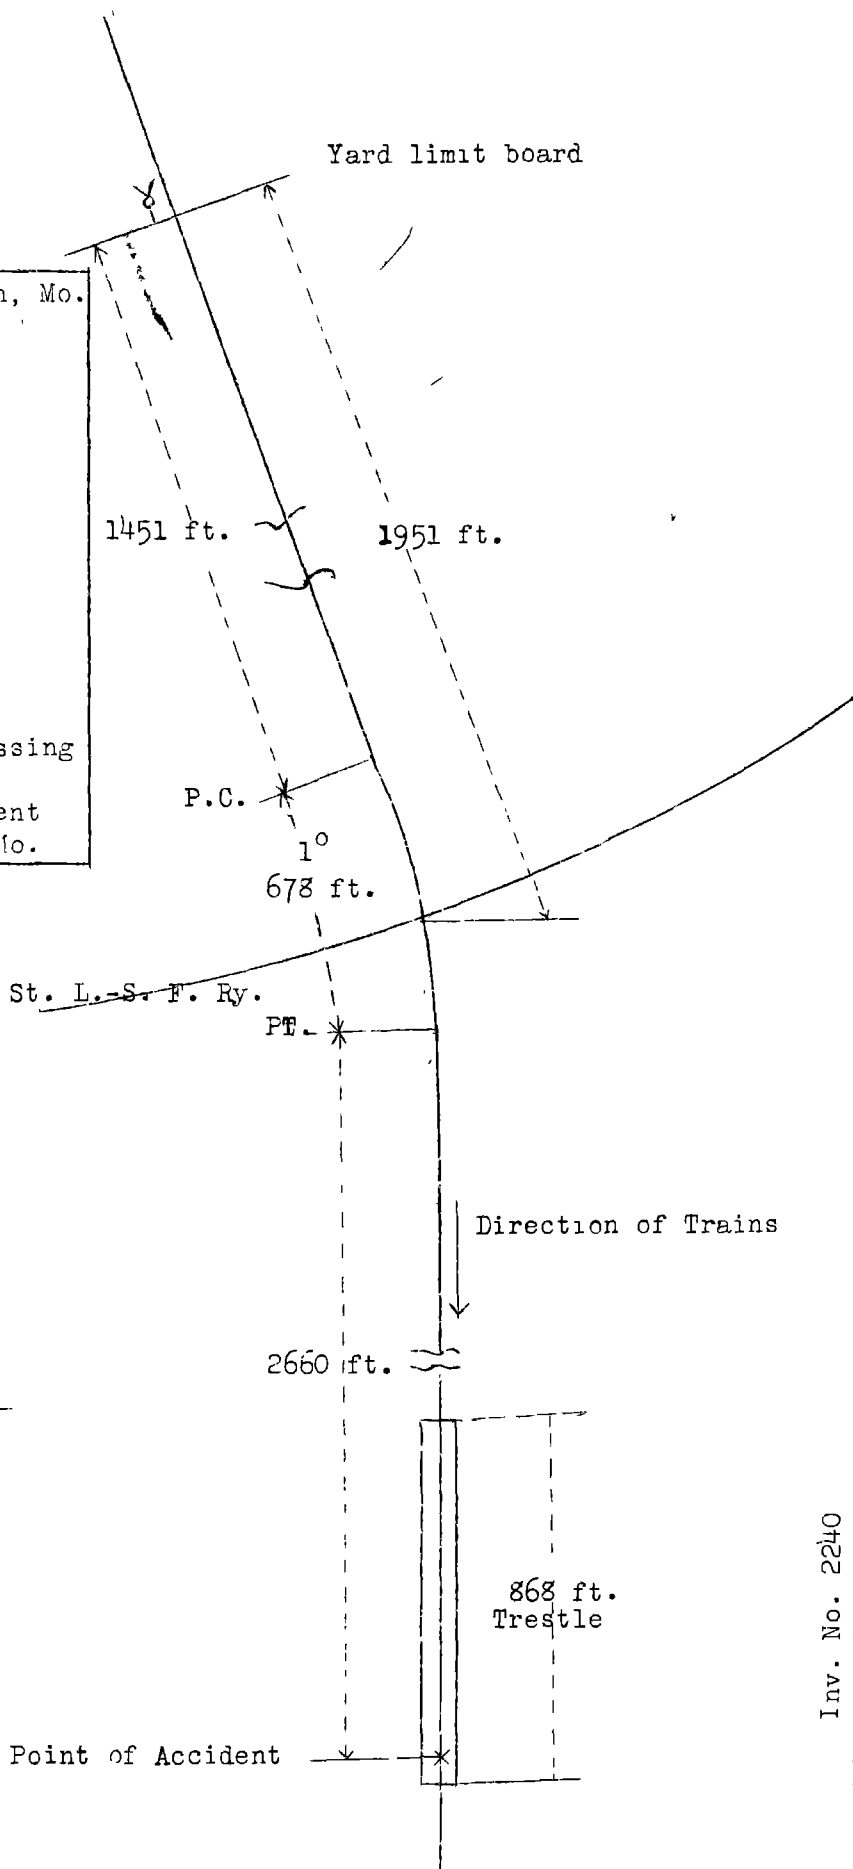
Inv. No. 2240
 Missouri Pacific R.R.
 Poplar Bluff, Mo.
 Dec. 27, 1937

○ Dexter Junction, Mo.	1.21 mi.
○ Dexter	7.22 mi.
○ Dudley	4.16 mi.
○ Ives	2.61 mi.
○ Fisk	1.44 mi.
○ Ash Hill	2.85 mi.
○ Junland	5.02 mi.
○ St. L.-S. F. Crossing	1.28 mi.
X Point of accident	
○ Poplar Bluff, Mo.

A main track of the St. L.-S. F. Ry. crosses the Mo. Pac. R. R. track at a point approximately 1,951 feet south of the yard-limit board. The north end of an open-deck trestle, 868 feet in length, is located approximately 3,931 feet south of the yard-limit board; the accident occurred on this bridge at a point about 10 feet from the south end. The view approaching the scene of the accident was unobstructed.
