REPORT NO. 3422  
MISSOURI PACIFIC RAILROAD COMPANY  
IN RE ACCIDENT  
NEAR ROHWER, ARK., ON  
AUGUST 13, 1951

Kind of accident: Head-end collision

Accident near Rohwer, Ark., on August 13, 1951, caused by  
failure to provide adequate protection for the movement  
of a track motor-car.

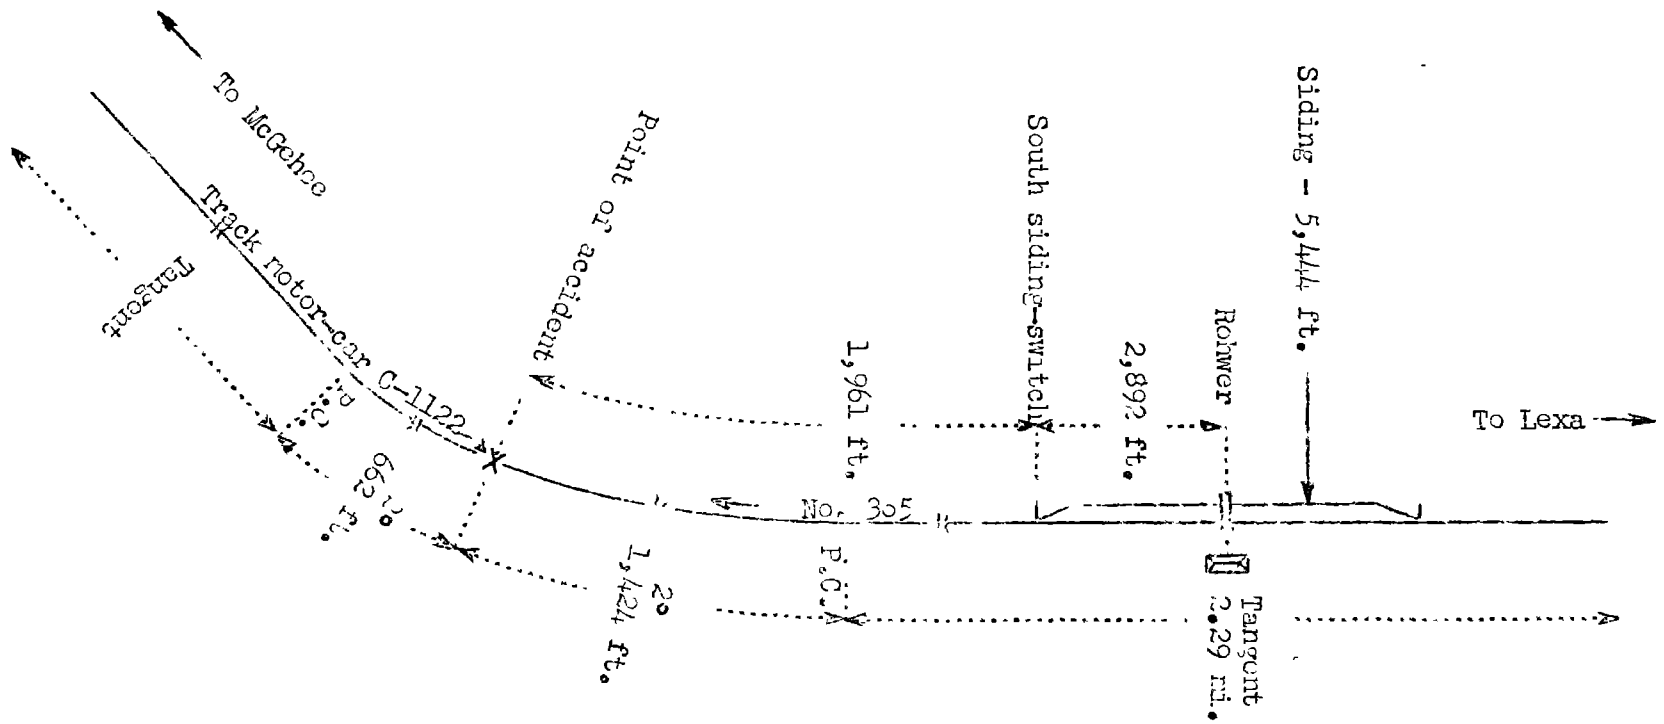
Report No. 3422  
 Missouri Pacific Railroad  
 Rohwer, Ark.  
 August 13, 1951

o	Lexa, Ark.
	61.51 mi.
o	Wabson
	9.41 mi.
o	Rohwer
	0.02 mi.
Z	Point of accident
	2.15 mi.
o	McGehee
	5.42 mi.
o	McGehee, Ark.
