Railroad: Missouri Pacific  
Date: March 26, 1935  
Location: Shields, Kans.  
Kind of accident: Side collision  
Trains involved: Passenger : Freight  
Train Numbers: Second No. : Second No.  
12 : 77  
Engine Numbers: 1422 : 1426  
Consist: 3 baggage, : 42 cars  
11 Pullman :  
1 dining :  
Speed: 6-7 m.p.h. : 3-10 m.p.h.  
Track: 0°30' curve; grade slightly undulating  
Weather: Clear.  
Time: 3:50 a.m.  
Casualties: 39 injured  
Cause: Failure of Engineman of Train Second No.  
77 properly to control speed of train  
when approaching meeting point; Train  
Second No. 12, taking siding, had not  
cleared main line.

INTERSTATE COMMERCE COMMISSION

REPORT OF THE DIRECTOR OF THE BUREAU OF SAFETY CONCERNING AN  
ACCIDENT ON THE MISSOURI PACIFIC RAILROAD AT SHIELDS,  
KANS., ON MARCH 26, 1935.

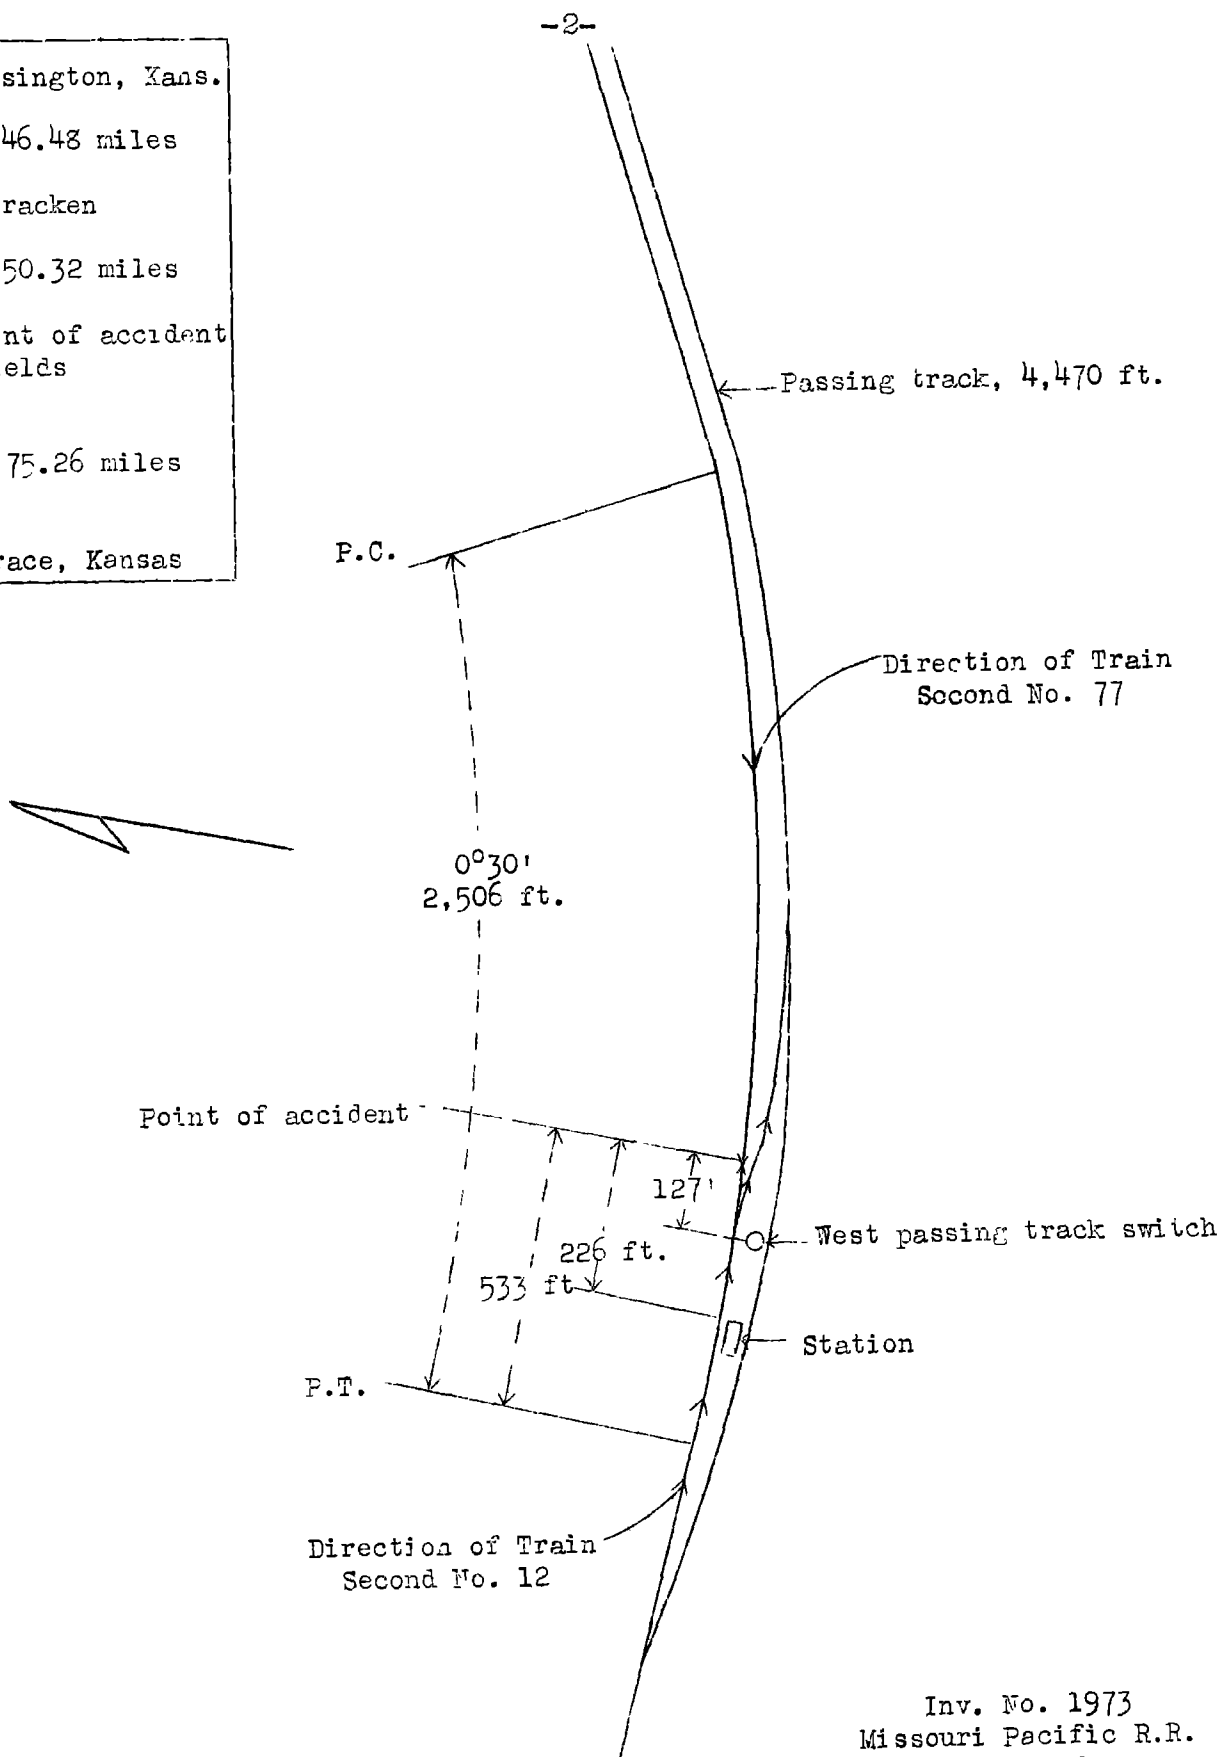
Inv. No. 1973  
 Missouri Pacific R.R.  
 Shields, Kans.  
 March 26, 1935

•Hoisington, Kans.
46.48 miles
•McCracken
50.32 miles
*Point of accident
•Shields
75.26 miles
•Horace, Kansas

This accident occurred on that part of the Hoisington District of the Colorado Division which extends between McCracken and Horace, Kans., a distance of 125.58 miles. In the vicinity of the point of accident this is a single-track line over which trains are operated by time table and train orders, no block signal system being in use. The accident occurred at the fouling point of the west switch of the passing track at Shields; the passing track is 4,470 feet in length and parallels the main track on the south. Approaching this point from the east the track is tangent for a distance of more than 4 miles, followed by a  $90^{\circ}30'$  curve to the right 2,506 feet in length, the accident occurring on this curve at a point 533 feet from its western end. Approaching from the west the track is tangent for 9 miles followed by the curve on which the accident occurred. The grade for west-bound trains varies from 0.17 to 0.47 percent ascending for a distance of 4,100 feet, followed by 0.03 percent descending grade for a distance of 600 feet and then 0.12 percent ascending for a distance of approximately 500 feet to the point of accident.
