INTERSTATE COMMERCE COMMISSION

REPORT OF THE DIRECTOR

ACCIDENT ON THE

MISSOURI PACIFIC RAILROAD

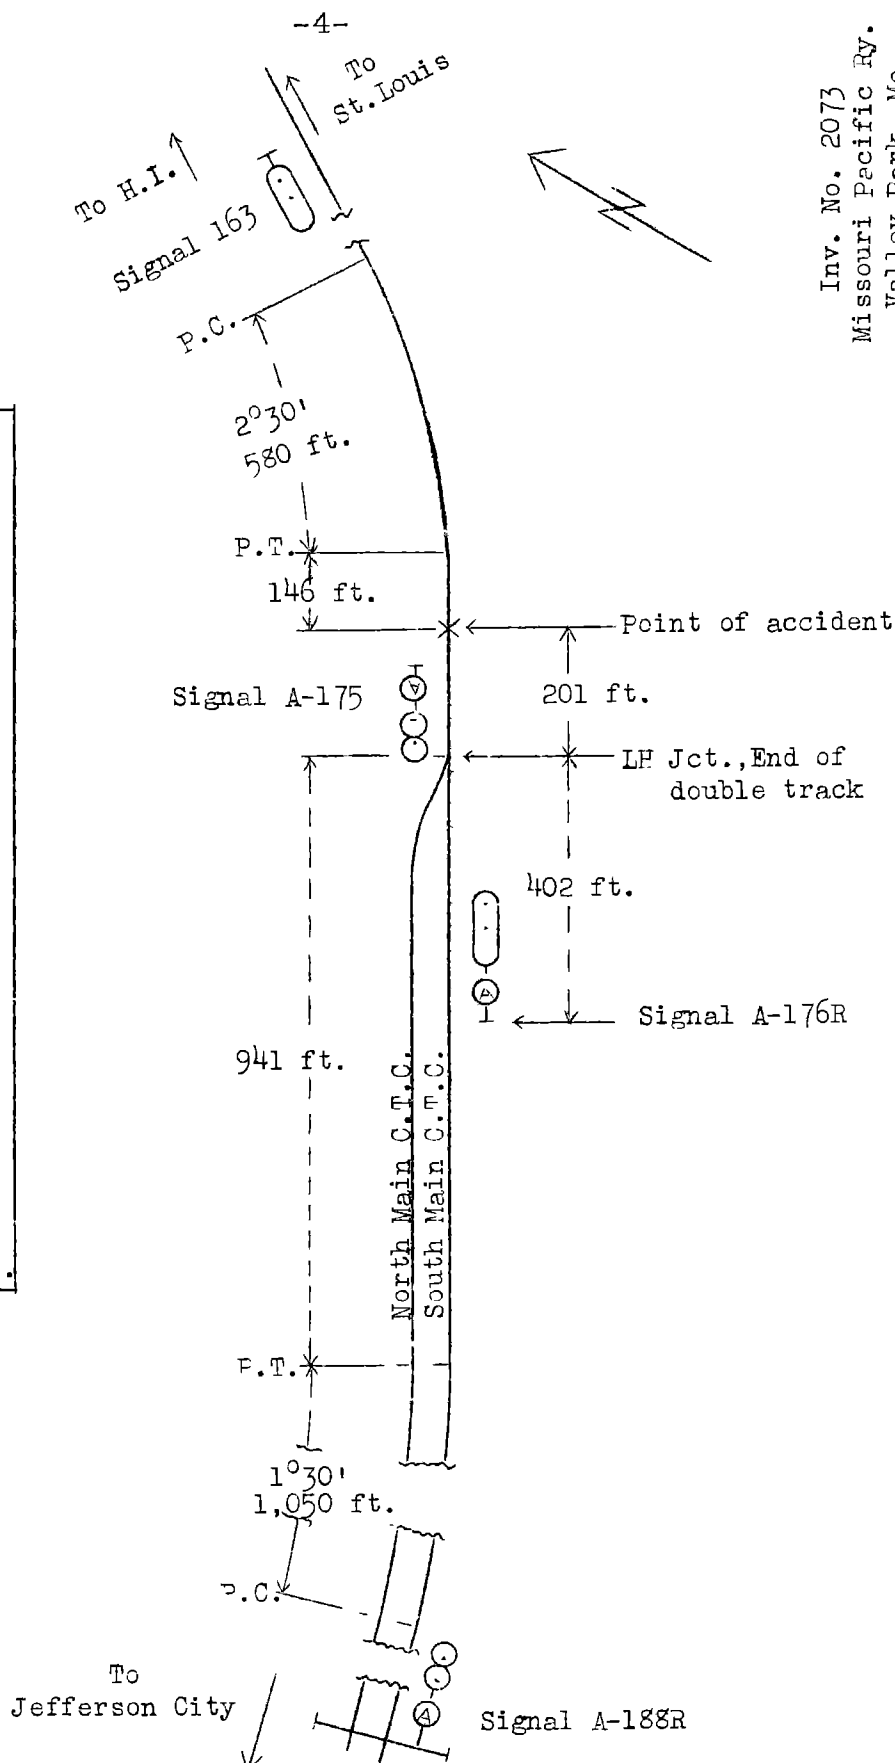
Inv. No. 2073  
Missouri Pacific Ry.  
Valley Park, Mo.  
June 23, 1936

o	St. Louis, Mo.
	13.48 mi.
o	Kirkwood
	0.99 mi.
o	H. I.
	3.04 mi.
X	LH Jct. (P of A)
	1.45 mi.
o	Valley Park
	15.88 mi.
o	Pacific
	11.73 mi.
o	H. D.
	5.18 mi.
o	Washington
	73.58 mi.
o	Jefferson City, Mo.

A view of signal A-176R can be had from the fireman's side of an east-bound engine, for a distance of 2,072 feet and for a distance of 858 feet from the engineman's side; on account of track curvature and a deep cut, the view of signal A-175 as seen from a west-bound engine, is restricted to about 1,560 feet.
