INVESTIGATION NO. 2610  
THE MISSOURI PACIFIC RAILROAD COMPANY  
REPORT IN RE ACCIDENT  
NEAR WAVERLY, MO., ON  
AUGUST 1, 1942

Accident near Waverly, Mo., on August 1, 1942, caused by  
failure to provide adequate protection for preceding  
train.

Inv. No. 2610  
Missouri Pacific Railroad  
Waverly, Mo.  
August 1, 1942

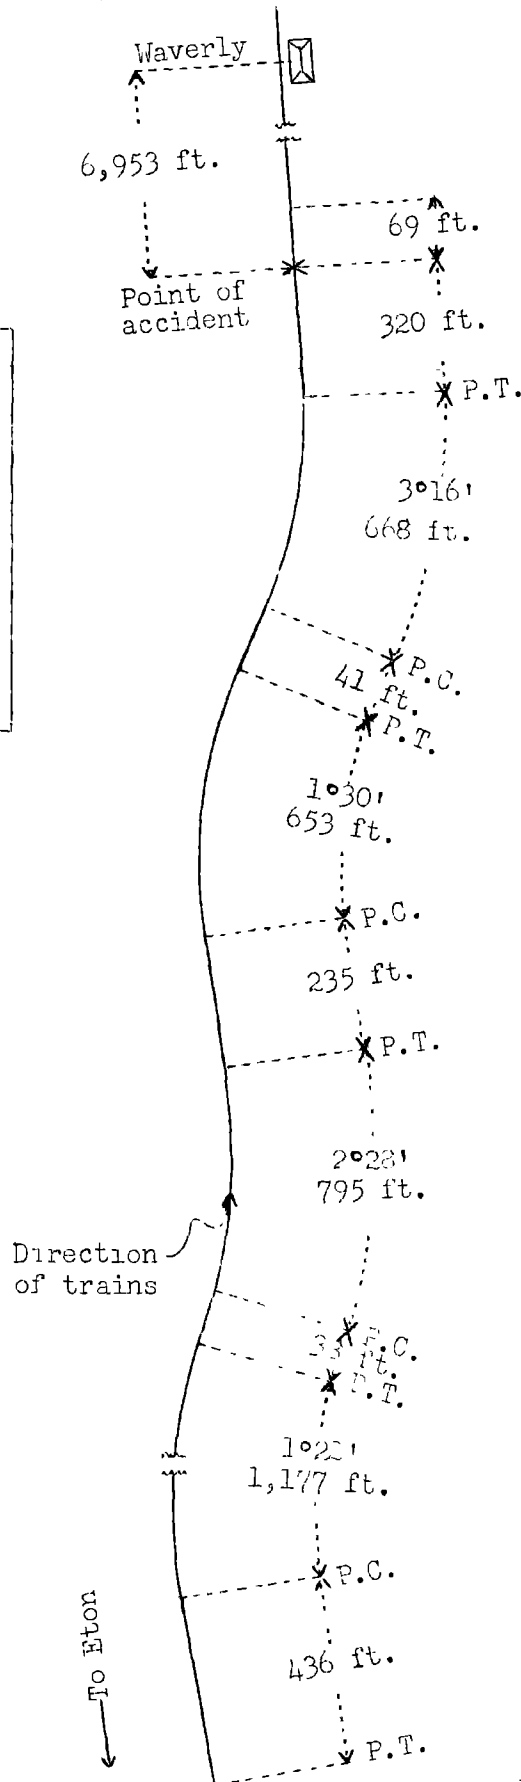
River Subdivision	○ SR Jct., Mo.
	96.62 mi.
	○ Waverly
	1.31 mi.
	X Point of accident
	21.75 mi.
	○ Myrick
○ Eton	28.60 mi.
	10.56 mi.
	○ East Yard,
	Kansas City, Mo.

Marks made by an exploded torpedo were found after the accident on the head of the south rail at a point 2,331 feet west of the point of accident. The remains of a freshly burned fusee were found at a point 1,359 feet west of the point of accident.
