INTERSTATE COMMERCE COMMISSION

REPORT OF THE DIRECTOR OF THE BUREAU OF SAFETY CONCERNING AN
ACCIDENT ON THE MISSOURI-KANSAS-TEXAS RAILROAD OF
TEXAS NEAR BRUCEVILLE, TEX., ON JULY 31, 1935.

October 26, 1935.

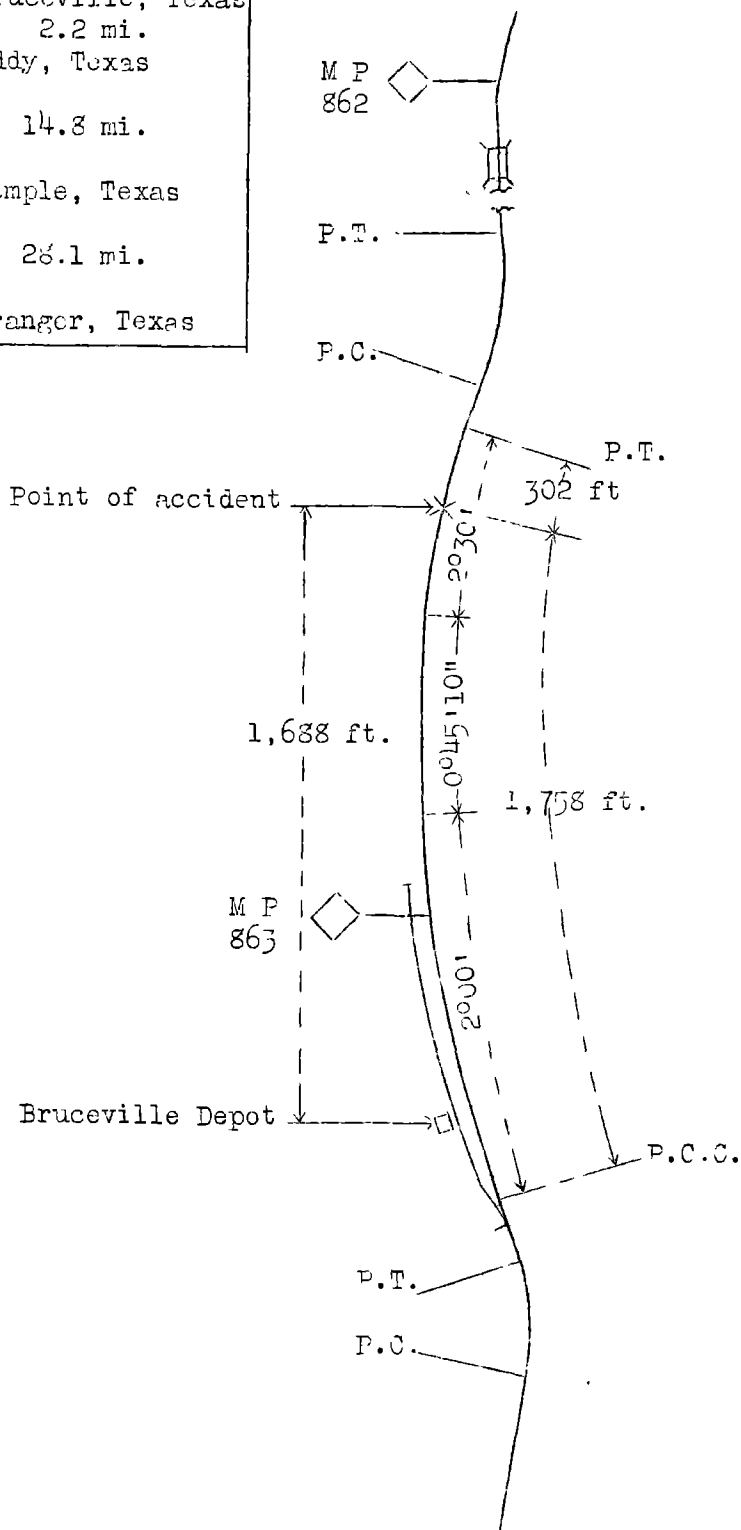
Inv. No. 1997
Missouri-Kansas-Texas R.R. of Texas
Bruceville, Texas.
July 31, 1935

• Bellmead, Texas
20.0 mi.
× Point of accident
• Bruceville, Texas
2.2 mi.
• Eddy, Texas
14.8 mi.
• Temple, Texas
28.1 mi.
• Granger, Texas
