INTERSTATE COMMERCE COMMISSION

REPORT OF THE DIRECTOR

MISSOURI-KANSAS-TEXAS RAILWAY

NOXIE, OKLA.

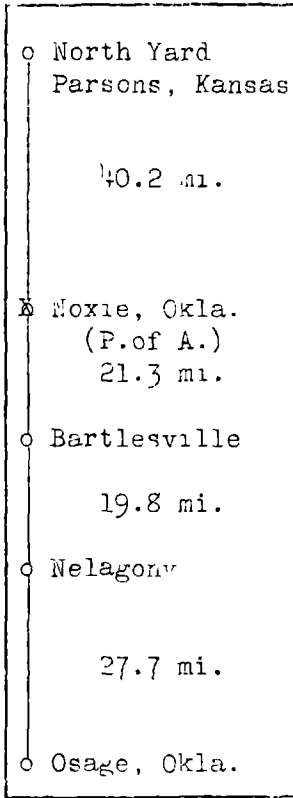
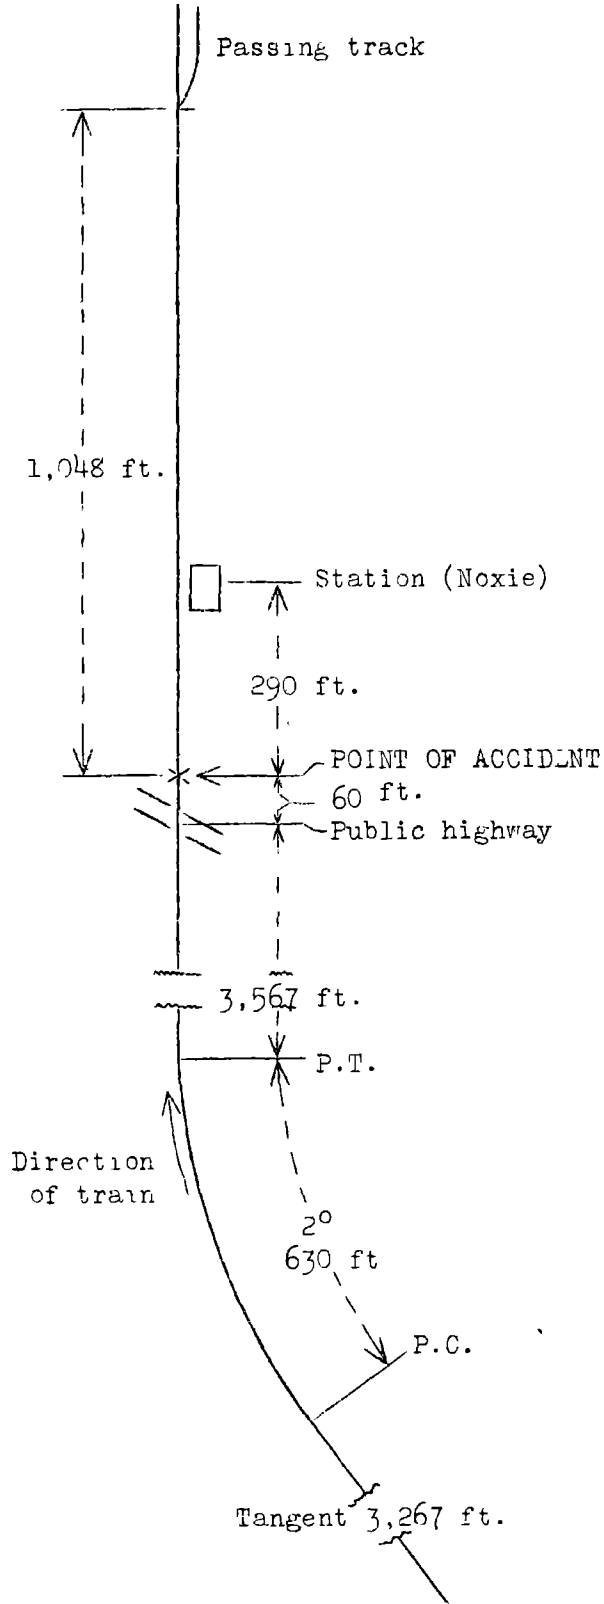
Inv. No. 2181
Missouri-Kansas-Texas R.R.
Noxie, Okla.
June 12, 1937

The locomotive and first 20 cars of the train remained coupled and stopped about 2300 feet north of the point of final derailment. The following 13 cars were piled up within a distance of approximately 162 feet and immediately caught fire. The next 8 cars were partially derailed but remained upright on the roadbed and sustained some damage. The remainder of the train was not derailed or damaged. The track was badly damaged and partially torn out northward from the switch for about 500 feet.
