INVESTIGATION NO. 2966
MISSOURI-KANSAS-TEXAS RAILROAD COMPANY OF TEXAS
REPORT IN RE ACCIDENT
NEAR ROYSE CITY, TEX., ON
JANUARY 18, 1946

Accident near Royse City, Tex., on January 13, 1946, caused
by an inferior train occupying the main track on the
time of an opposing superior train.

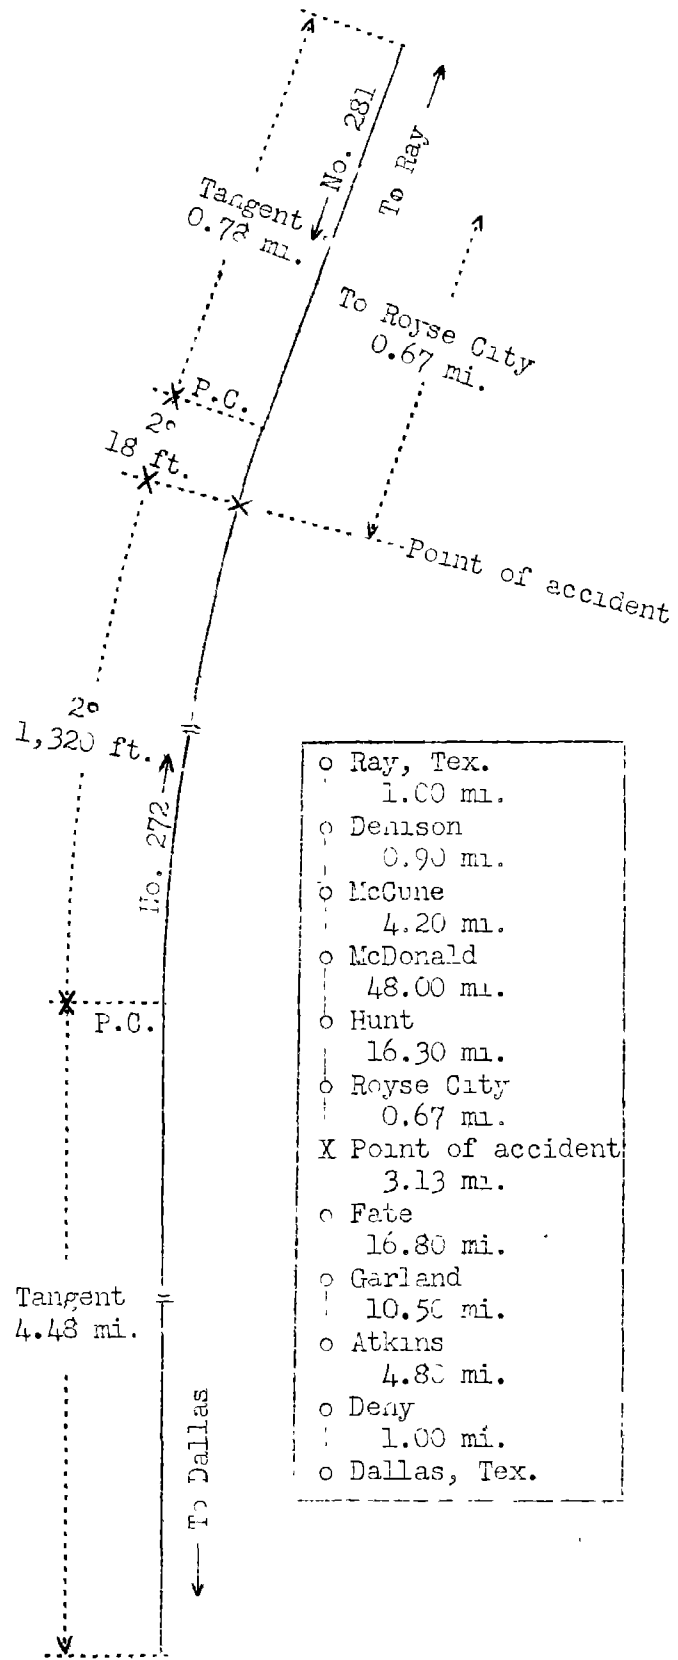
Inv. No. 2966
 Missouri-Kansas-Texas Railroad Company of Texas
 Royse City, Tex.
 January 18, 1946

| X | Point of accident | 3.13 mi. |
