INVESTIGATION NO. 2583
THE MISSOURI-KANSAS-TEXAS RAILROAD COMPANY
REPORT IN RE ACCIDENT
NEAR FLORA, OKLA., ON
APRIL 24, 1942

Accident near Flora, Okla., on April 24, 1942, caused by
collapse of a bridge which had been weakened by flood
water.

Inv-2533
 Missouri-Kansas-Texas Railroad
 Flora, Okla.
 April 24, 1942

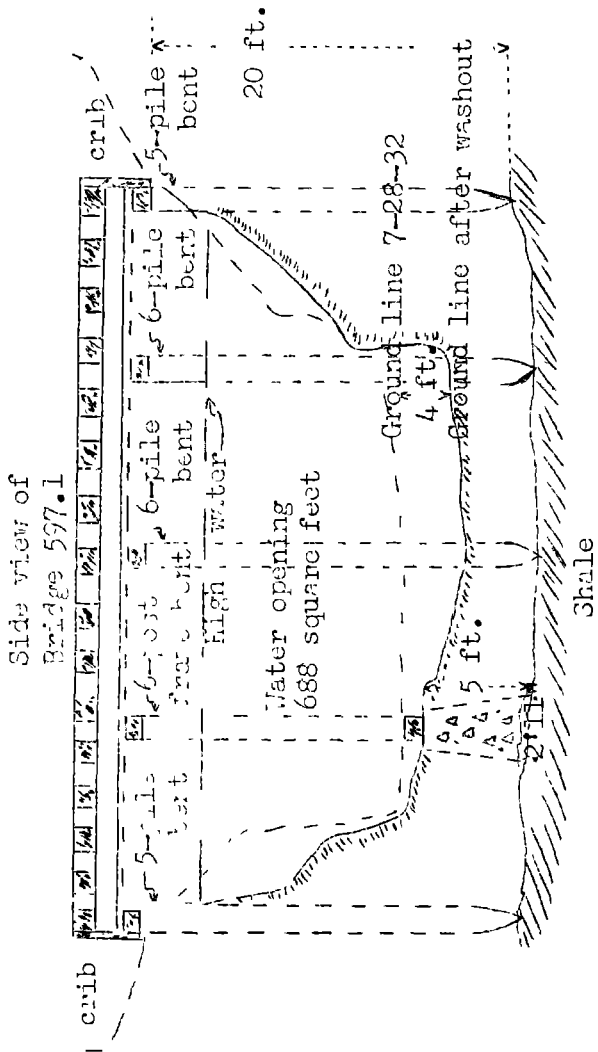
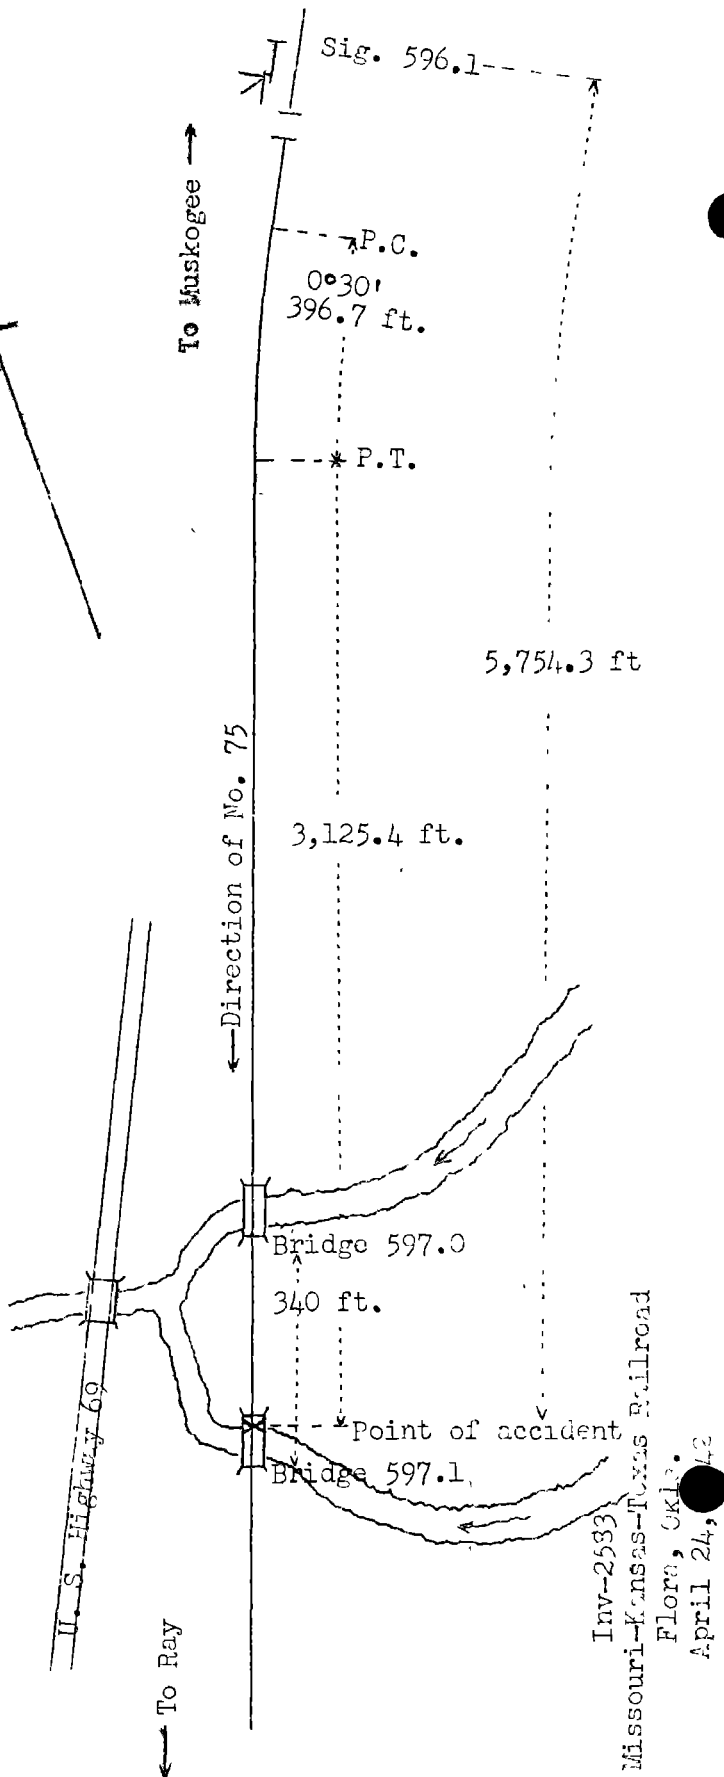
- o Muskogee, Okla. 62.4 mi.
- o McAlester 28.0 mi.
- o Chockie 3.23 mi.
- X Point of accident 1.17 mi.
- o Flora, Okla. 62.5 mi.
- o Denison, Texas 1.0 mi.
- o Ray, Texas

Bridge 597.1, an open-deck 5-bent pile-and-timber trestle, constructed in 1919 to replace a similar bridge, was a four-panel structure, 55 feet in length. The bents were numbered consecutively from north to south. Bents Nos. 1 and 5 consisted of 5 piles each, 20 feet in length, driven to a depth of almost 20 feet. Bent No. 2 consisted of 6 piles, 22 feet in length, driven to a depth of 6 feet. Bent No. 3 consisted of 6 piles, 22 feet in length, driven to a depth of 5 feet. Bent No. 4 was of post-frame design, and consisted of 6 posts, 12 inches square and 15-1/2 feet in length. This bent rested on a sill 12 inches square, which in turn rested on a concrete pedestal. The pedestal was 23 feet 9 inches long, 5 feet high, 20 inches wide at the top and 2 feet 11 inches wide at the base, and rested on shale. All piles were driven to shale. The outer piles of the bents were placed in a batter of 2 inches to 1 foot. Sway braces of timbers measuring 4 inches by 8 inches were provided on bents Nos. 2, 3 and 4. The caps were 14 inches square by 14 feet in length. Two 4-ply chords of 8-inch by 16-inch stringers were provided. Longitudinal braces were 6 inches by 8 inches, and were dapped 3 inches at the caps of the bents.

Engine 839 and its tender, remaining coupled, were derailed and stopped, badly damaged, on their right sides, parallel to the track and 37 feet west of it, with the front end of the engine 87 feet south of the south end of the bridge. The cab was badly damaged. The tender frame was broken and the rear of the tender was crushed inward. The first to tenth cars, inclusive, were derailed and stopped at various angles in the channel and across the track. The front truck of the eleventh car was derailed. The tenth car was loaded with matches, which became ignited, and the fire consumed four cars.

After the accident, some of the material of Bridge 597.1 was found under the wreckage in the channel, and some of the piles were lodged against a highway bridge, 285 feet west of the track. Between bents Nos. 2 and 3 of Bridge 597.1 the channel was scoured to a depth of approximately 4 feet.
